**RE:** *City of St. Albans IDDE 2022 Summary and 2023 Proposed Work*

This memorandum is being prepared to summarize the Illicit Discharge Detection and Elimination (IDDE) work Watershed Consulting completed during the 2022 field season and is proposing for work during the 2023 season.

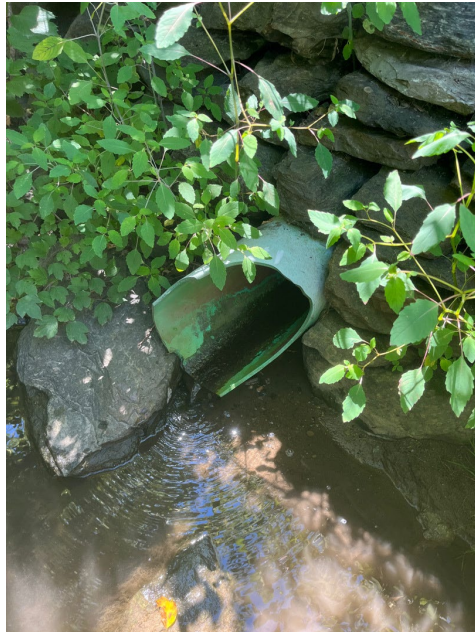
## 1. Outfall 11

Site Location: 29 Barlow Street

Indicators: Anionic surfactants, Conductivity

Possible Sources: Drinking water leak and/or washwater contamination.

Priority Level: Low

Figure 1. Outfall 11 located on Barlow Street, discharging to Stevens Brook.

Action Steps: Complete additional sampling to bracket the discharge and evaluate if additional parameter exceedances exist.

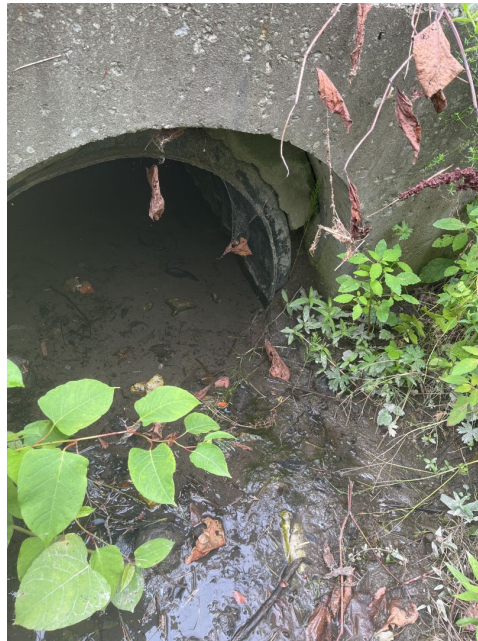
## 2. Outfall 38

Site Location: Under Aldis Street, where DPW yard and Stevens Brook meet.

Indicators: Anionic surfactants, Chlorine

Possible Sources: Possible drinking water leak or wastewater contamination.

Priority Level: Medium

Figure 2. Outfall 38 collecting a portion of stormwater runoff from Aldis Street and discharging to Stevens Brook.

Action Steps: Complete additional sampling to bracket the discharge and evaluate if additional parameter exceedances exist. The catch basins on the opposite side of the road along the baseball field should be sampled.

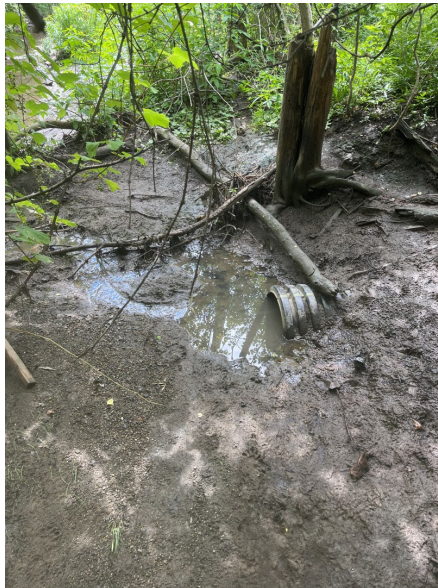
### 3. Outfall 39.2

Site Location: Outlets from the DPW yard into Stevens Brook

Indicators: Conductivity, Chlorine, Ammonia, Anionic surfactants, *E. coli*

Possible Sources: Possible drinking water leak or washwater contamination and possible wastewater leak or cross contamination.

Priority Level: High

Figure 3. Outfall 39.2 from the DPW yard, discharging into Stevens Brook.

Action Steps: The outfall should be resampled. Complete additional sampling of catch basins in the DPW yard to bracket the discharge and evaluate if additional parameter exceedances exist.

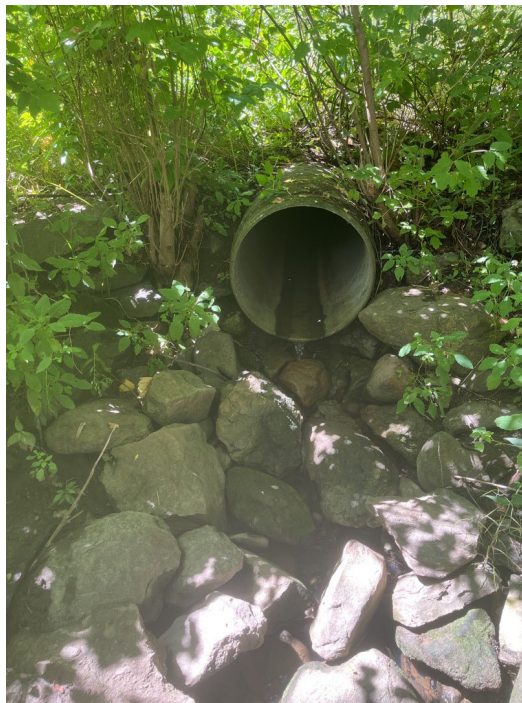
#### 4. Outfall 40

Site Location: Four Winds Apartments off North Elm Street

Indicators: Chlorine, Anionic surfactants, Fluoride, *E. coli*

Possible Sources: Possible drinking water leak or washwater contamination and possible wastewater leak or cross contamination.

Priority Level: High

Figure 4. Outfall 40, discharging stormwater runoff from North Elm Street and the Four Winds Apartment, discharging to Stevens Brook.

Action Steps: The outfall should be resampled. Complete additional sampling of catch basins along the driveway for the apartment buildings to bracket the discharge to evaluate if additional parameter exceedances exist. Complete further testing up the stormline for the catch basins if no definitive results surface from the apartment complex. The stormline crosses the sewer line prior to the outfall. It is possible that there is a leak or cross contamination that should be investigated with smoke testing or televising of the stormline.

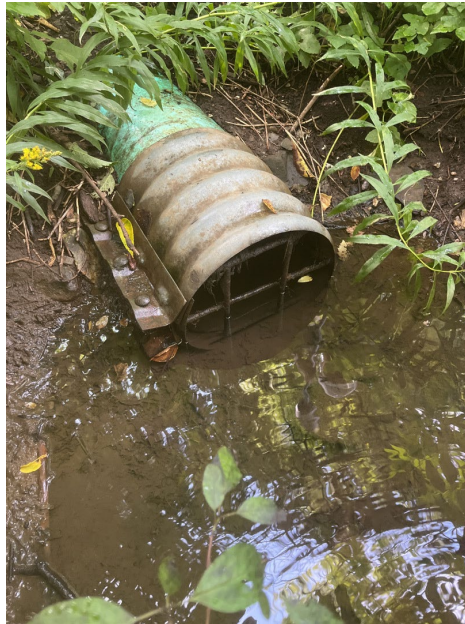
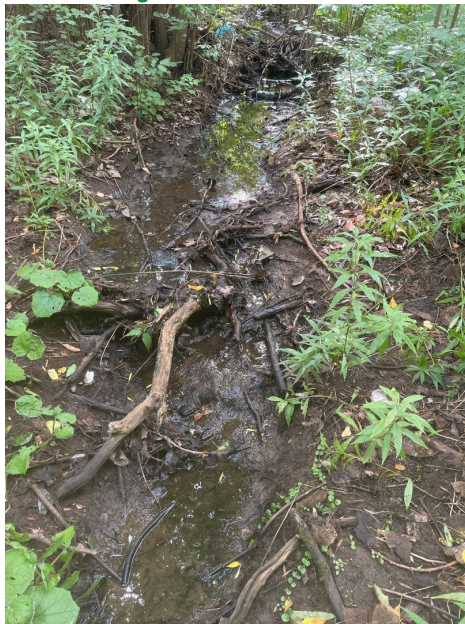
## 5. Outfall 50

Site Location: behind 85 Pearl Street, abutting the railroad.

Indicators: Anionic surfactants, Ammonia, *E. coli*

Possible Sources: Possible wastewater leak or cross contamination.

Priority Level: Medium

Figure 5. Outfall 50.

Figure 6. Outfall 50 discharges to an open drainage channel, noted as Outfall 51 which enters Stevens Brook.

Action Steps: Complete additional sampling to bracket the discharge and evaluate if additional parameter exceedances exist.

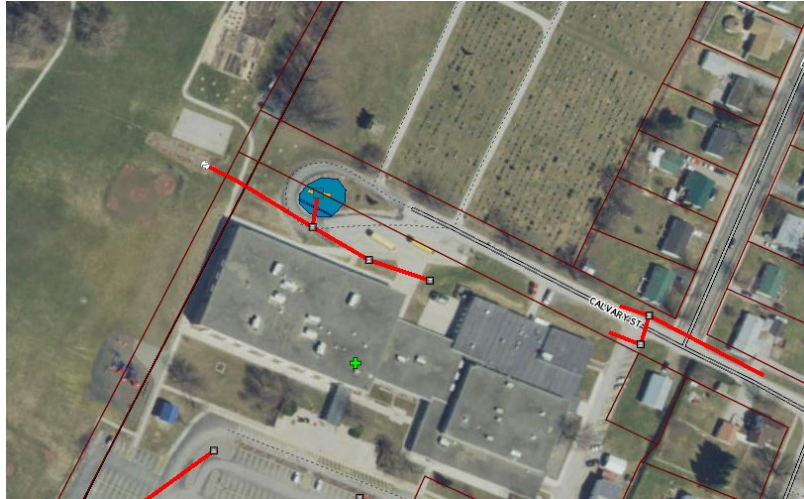
Site Location: St. Albans City Elementary School. This outfall is located at the end of the stormwater system discharges outflow from a rain garden in the loop of Calvary Street (Figure 7).

Figure 7. Outfall 54 can be seen at the end of the stormline. The blue polygon indicates an existing rain garden on the map.

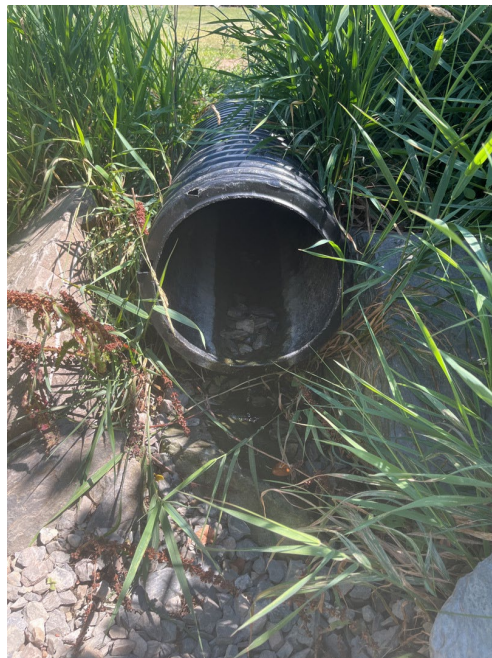
## 6. Outfall 54

Indicators: Chlorine, Anionic surfactants, Fluoride

Possible Sources: Possible drinking water leak or washwater contamination.

Priority Level: Medium

Figure 8. Outfall 54 in the back of the St. Albans City Elementary School.

Action Steps: The outfall should be resampled. Complete additional sampling of catch basins in the bus parking area to bracket the discharge and evaluate if additional parameter exceedances exist.
