Re: **Dr. Joseph G. Perrault House**
235 Lake Street
St. Albans, Franklin County, Vermont

Adaptive re-use rehabilitation – application for VCDP funding

This letter report and request for Section 106 review is the follow up to the Determination of Eligibility and is intended to provide information about the condition of the building and its components, proposed scope of rehabilitation work, as well as preservation analysis. This letter provides recommendations for a determination of effect for the schematic plans proposed in anticipation of a VCDP application for funding and potentially other state and federal sources to be identified in the future. **A future phase of the project is also presented and reviewed here because it will be applying for VCDP funds as well.**

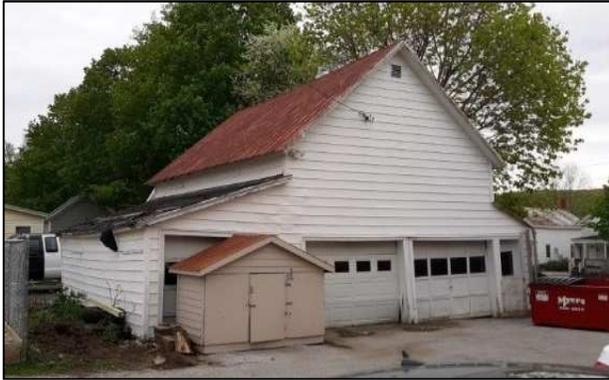
Close up view of garage showing older 2-story barn/garage altered with added shed addition and then by conversion to garage with more modern overhead garage bay doors. Note poor condition.

The extant 2-story gable-roofed portion of the barn/garage was constructed between 1912 and 1920 but likely at the time of the present house which is c. 1915. The barn was converted to a garage by 1926 when a one story wing was added and a residential duplex was added to the lot fronting on North Elm Street. Sometime after 1946 the duplex was removed and the barn/garage structure further altered when the protruding front of the 1 story wing was cut back and three overhead garage doors were installed across the new flush facades. In the last 30 years or so the structures, like the house, were covered in vinyl siding. The location of the demolished c. 1925 duplex is the location of the present fenced playground. The barn/garage structure has been altered considerably, appears to have low architectural integrity and is in poor condition. Based on these factors, I recommend that it be considered **non-contributing to the potential historic district**. Its major alterations also occurred after the death of Dr. Perrault which diminishes any potential criterion B significance.

Also proposed is the removal of the c. 1915 rear barn/garage structure. The barn/garage structure has been altered considerably, appears to have low architectural and structural integrity and is in poor condition. In the short term, the removal of the unused structure in poor condition would enable additional parking on site without taking away from the playground. Its removal is proposed currently.

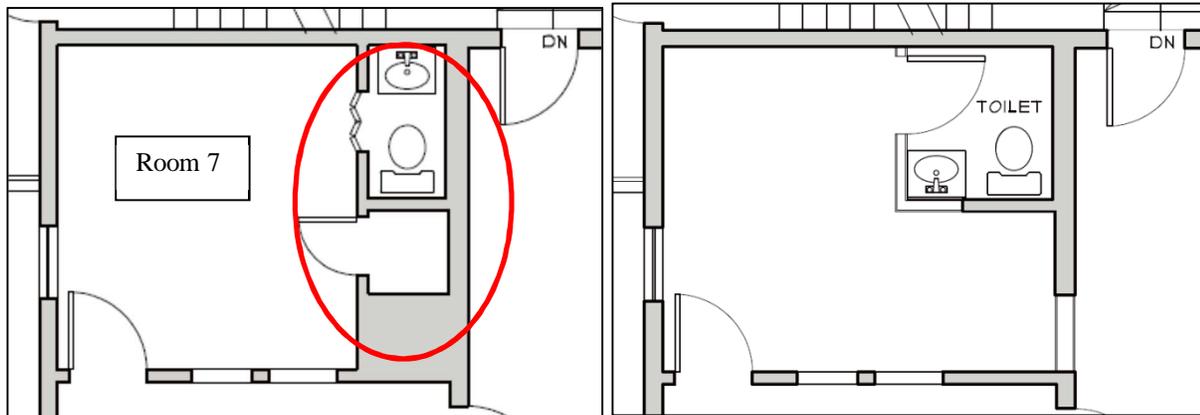
Left: Detail of existing 1st fl. plan of northwest rear room with area to be removed in red circle including toilet, closet and chimney; Right: Detail of proposed 1st fl. plan of same area

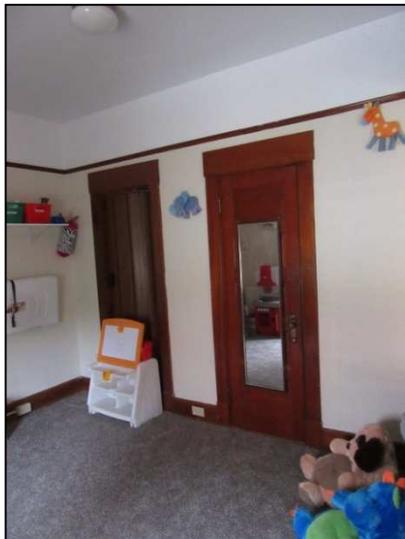
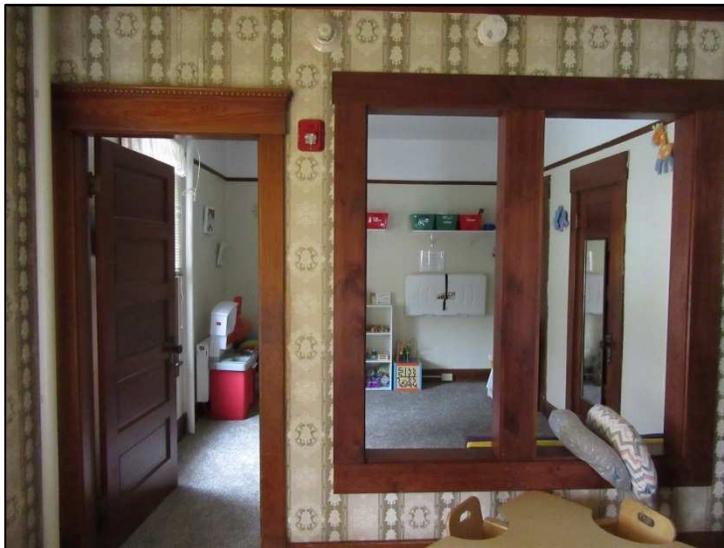
Below Left: 1) Northwest rear (Room 7) looking northeast at wall and two doors to be removed and area where new rest room will be constructed; Below Right: 2) Room 5 looking north to Room 7 through non historic double opening

On the first floor, the existing floor plan and historic features and finishes will all be preserved as is with one exception in the rearmost (northwestern) corner room. In that room, where a modern powder room had been added, the powder room and adjacent closet will be removed and a larger restroom for staff will be built in the northeast corner of the room. The exterior window and historic door to the next room on the south will be preserved as will a non-historic double opening in the wall between these rooms.

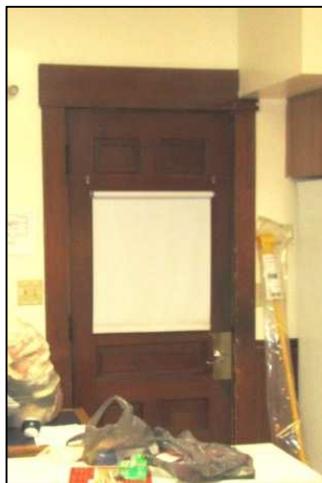
Left: 27) 2nd fl. Room 8, looking south at folding doors to be removed and part of wall beyond at doorway in room 6 to be removed; Center: 28) **Detail of 1st fl. kitchen door to back porch proposed to be repaired and to get a storm door;** Right: 29) Detail of front door to get new lock set and made operable

The only other changes proposed for the first floor will be to add some hand sinks in one of the rooms and **to repair a door in the kitchen leading to an unheated rear porch that doesn't close properly. A storm door will be added as well.** The elaborate original woodwork throughout the first floor will be preserved. The front door will be weather-stripped.

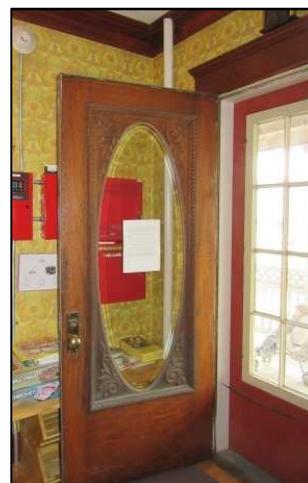
- The weather-stripping and lock replacement for the front door. The lock set doesn't function. **If the door can't be retrofitted to have a new lock set, the door would be replaced in-kind. If this becomes necessary, the applicant would submit a proposed replacement door to the VDHP for approval;**

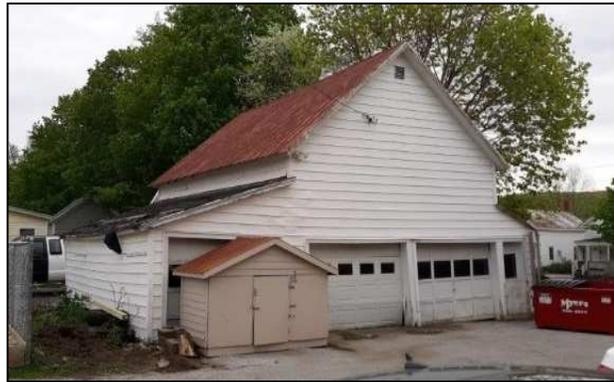
Left: 31) Driveway and altered garage, looking northeast from sidewalk with playground on left; Right: 32) Close up view of garage showing older 2-story barn/garage altered with added shed addition and then by conversion to garage with more modern overhead garage bay doors. Note poor condition.
