A. Permittee Information	
1. Name of MS4:	
2. Permit Number: - 9014	
B. Minimum Control Measures	
1. Public Education and Outreach	
1.1 Website address:	
1.2 Participation in Regional Outreach Strategy <input type="checkbox"/> No <input type="checkbox"/> Yes, summary of activities attached

2018 REPORT – CITY OF ST ALBANS – ILLICIT DISCHARGE DETECTION AND ELIMINATION STUDY

ST ALBANS, VERMONT

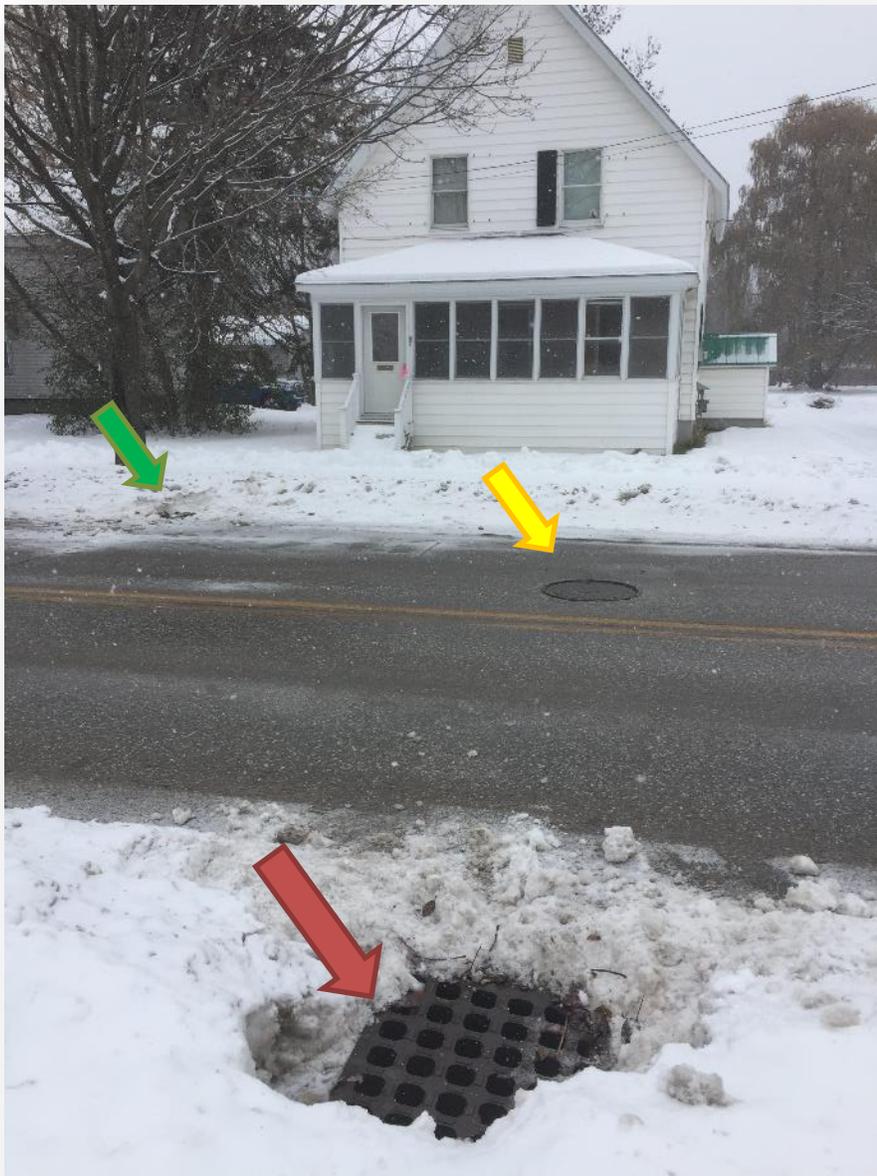
During smoke testing, Watershed found smoke coming from a catch basin opposite 67 North Elm Street while blowing smoke into the sanitary sewer from a manhole on lower Pearl Street (noted on the summary map). Watershed then blew smoke from the sanitary manhole directly adjacent to the catch basin - smoke immediately came out of the catch basin rim from the lower pipe in the catch basin. Watershed then cleared the line of smoke and blew smoke into the stormwater sewer from a nearby catch basin. Smoke came in from the upper pipe in the catch basin. The catch basin opposite 67 North Elm Street is tied to both the sanitary and storm sewer. As the pipe to the storm sewer is considerably higher than the pipe to the sanitary sewer, it would require a surcharge from the sanitary sewer of between 5-5.5' to cause sewage to flow into the stormwater sewer. However, this potential discharge should be eliminated as soon as possible.

Figure 1: Picture taken facing 67 North Elm Street (white house in the background). The catch basin in the foreground (red arrow) is directly connected to both the storm and sanitary sewers. The lower pipe in the catch basin flows directly to the sanitary manhole (yellow arrow). The catch basin in the background (green arrow) is not connected to the sanitary system.

- ❖ The crosstie found near 67 North Elm Street should be fixed as soon as possible. Once fixed, this area should be smoke tested again and the rest of system investigated for other possible illicit discharges.

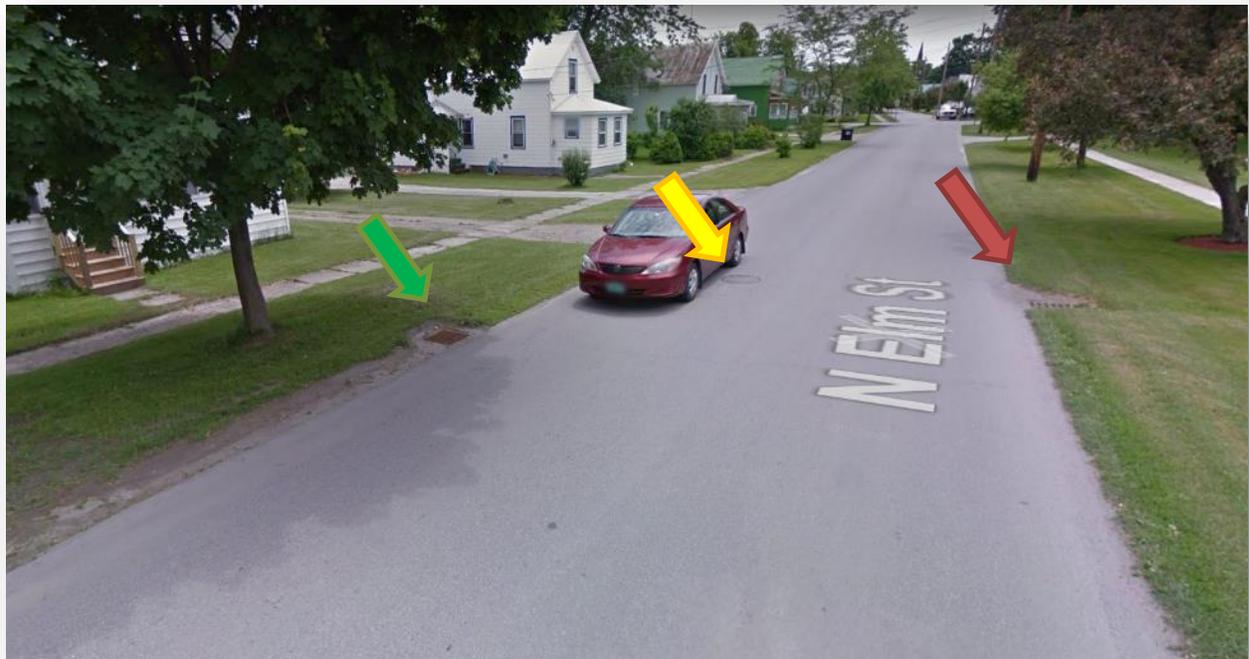
Figure 2: Image from Google StreetView. The red arrow indicates the catch basin connected to both the sanitary and storm sewers. The yellow arrow indicate the sanitary sewer manhole to which the catch basin is connected. The green arrow indicates the catch basin that is not connected to the sanitary sewer.

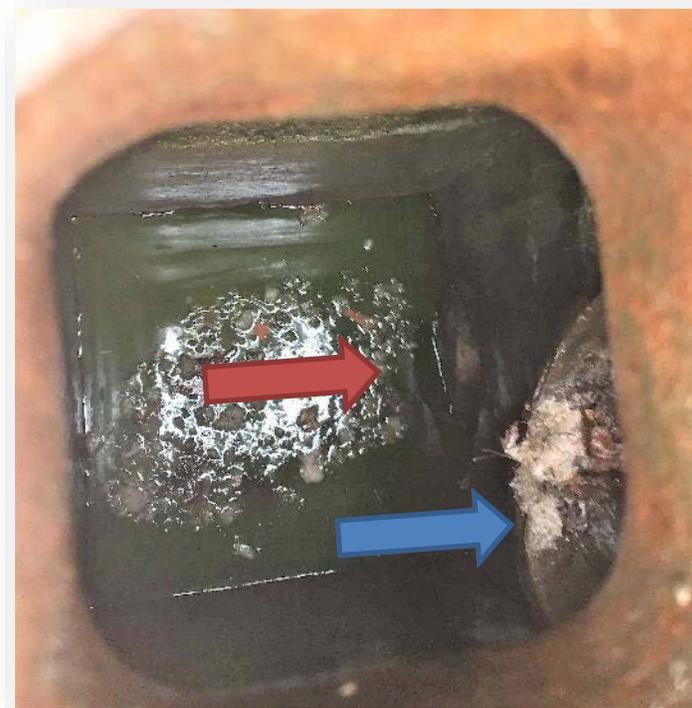
Figure 3: Picture of the catch basin connected to both the sanitary and storm sewers. The red arrow is pointing to the pipe that is directly connected to the sanitary sewer (lower pipe). The blue arrow points to the pipe that leads to the stormwater sewer. In runoff events most runoff would go into the sanitary sewer.

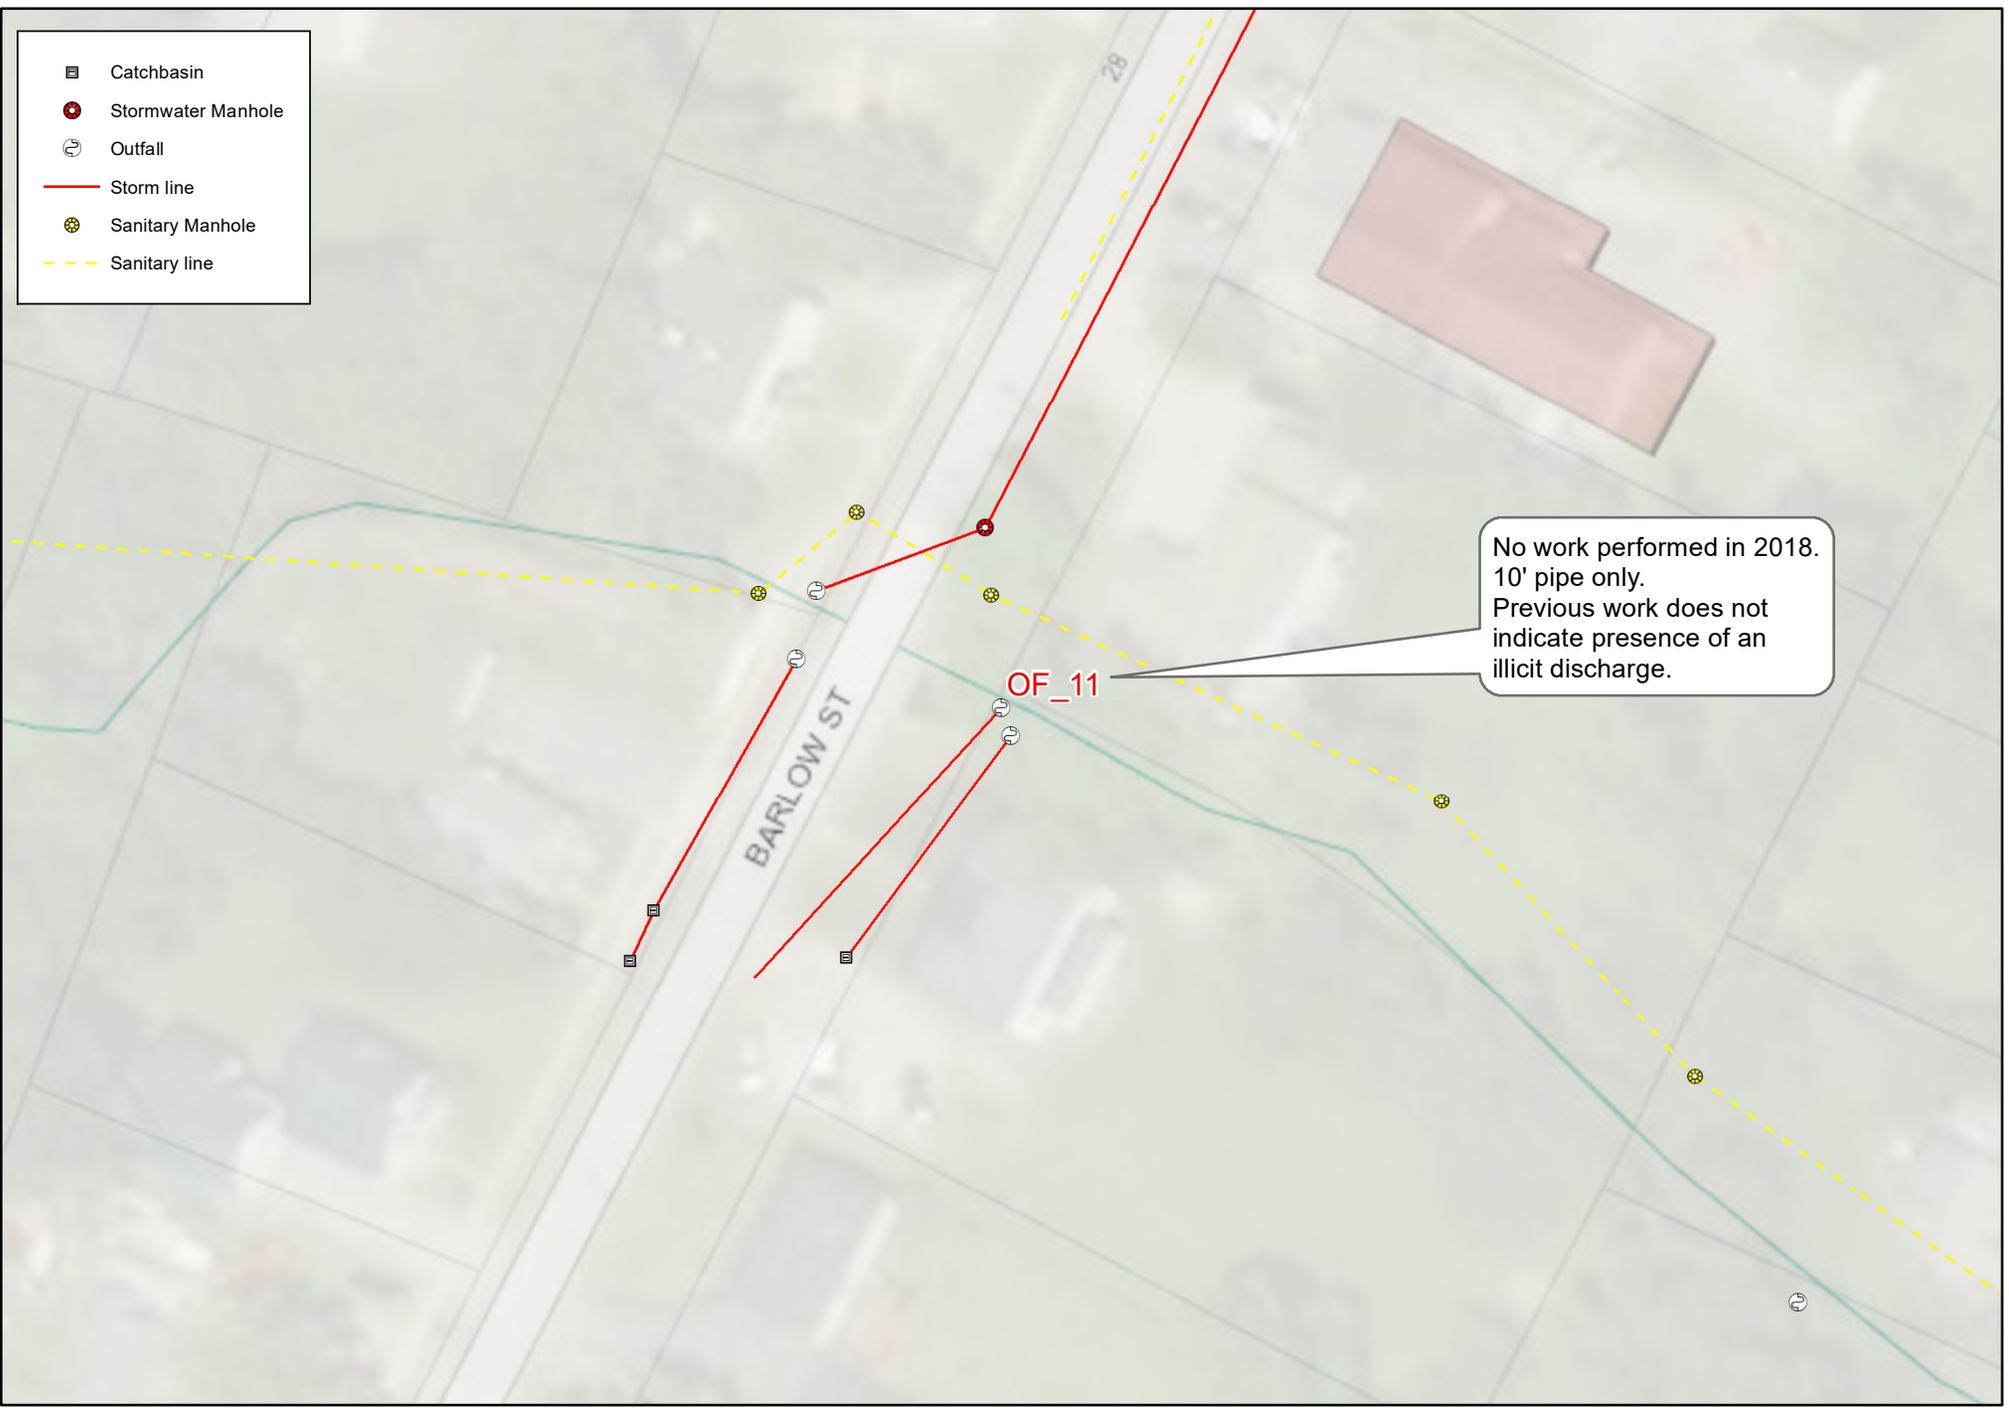
St. Albans IDDE AI - Summary Map
 Outfall 11

No work performed in 2018.
 10' pipe only.
 Previous work does not
 indicate presence of an
 illicit discharge.

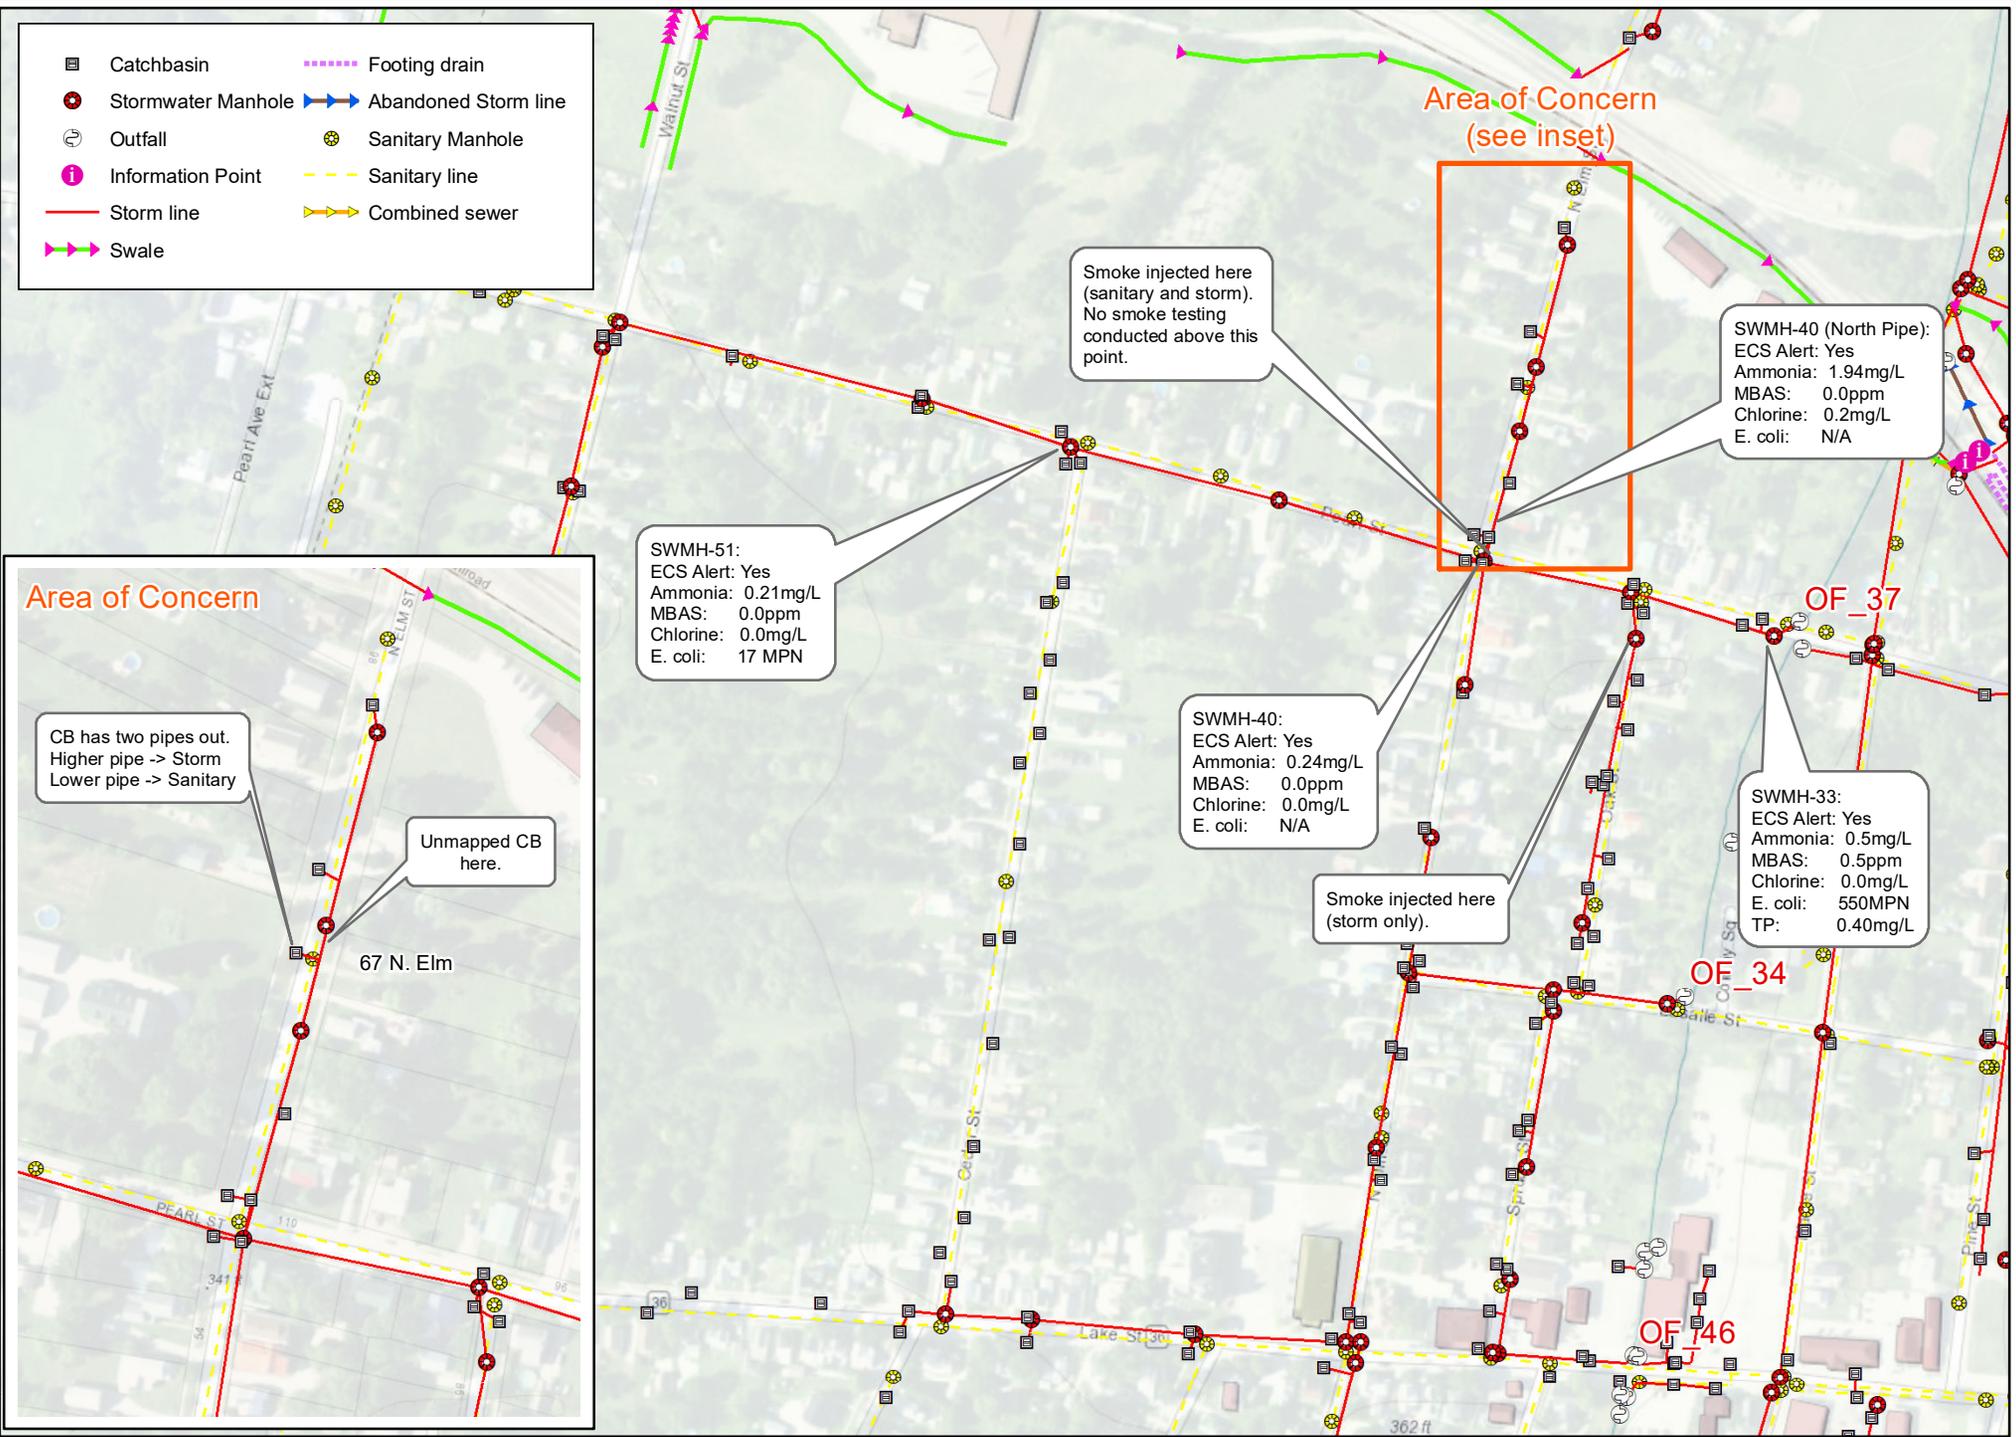
SWMH-51:
 ECS Alert: Yes
 Ammonia: 0.21mg/L
 MBAS: 0.0ppm
 Chlorine: 0.0mg/L
 E. coli: 17 MPN

Smoke injected here
 (sanitary and storm).
 No smoke testing
 conducted above this
 point.

SWMH-40 (North Pipe):
 ECS Alert: Yes
 Ammonia: 1.94mg/L
 MBAS: 0.0ppm
 Chlorine: 0.2mg/L
 E. coli: N/A

SWMH-33:
 ECS Alert: Yes
 Ammonia: 0.5mg/L
 MBAS: 0.5ppm
 Chlorine: 0.0mg/L
 E. coli: 550MPN
 TP: 0.40mg/L

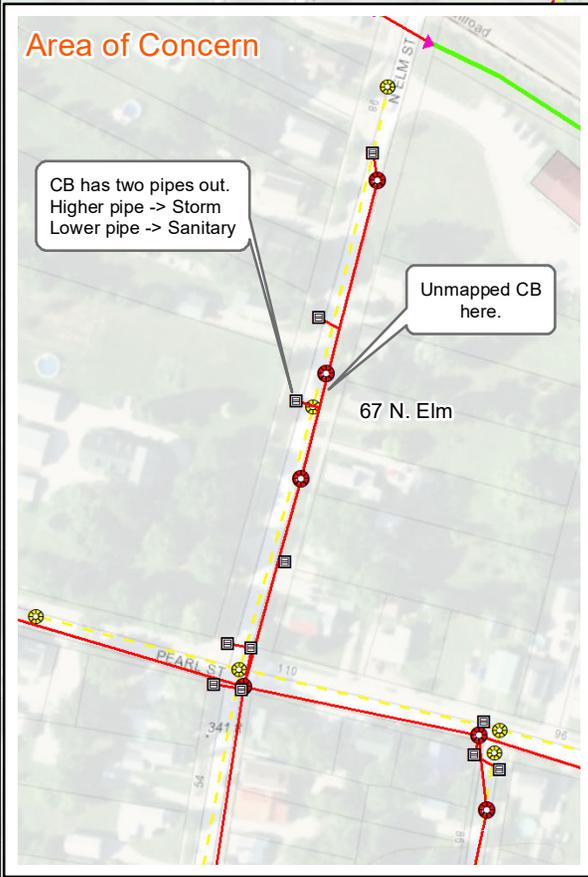
CB has two pipes out.
 Higher pipe -> Storm
 Lower pipe -> Sanitary

Unmapped CB
 here.

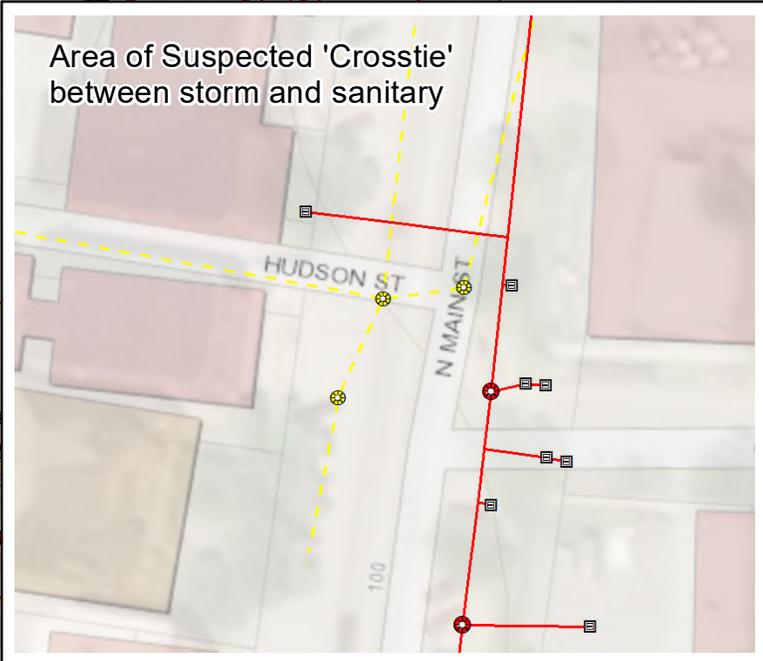
OF_16
General System Area

No investigation of this outfall was performed in 2018. The issue was studied in 2014 and found to be a sanitary sewer crosstie into the stormwater sewer at North Main and Hudson Streets. The City of St Albans was planning to disconnect this tie. No further study of this outfall should occur until this repair occurs as it could mask other potential illicit discharges to the stormwater system.

No work performed in 2018.
Will follow-up on this area
once crosstie is definitively
fixed.

- ❖ The crosstie found near Hudson and North Main Streets should be investigated and repaired by the City of St Albans.
- ❖ Once this work is done, water quality testing should be conducted within the drainage area.
- ❖ If indicated, this work should be followed by smoke testing in targeted locations.

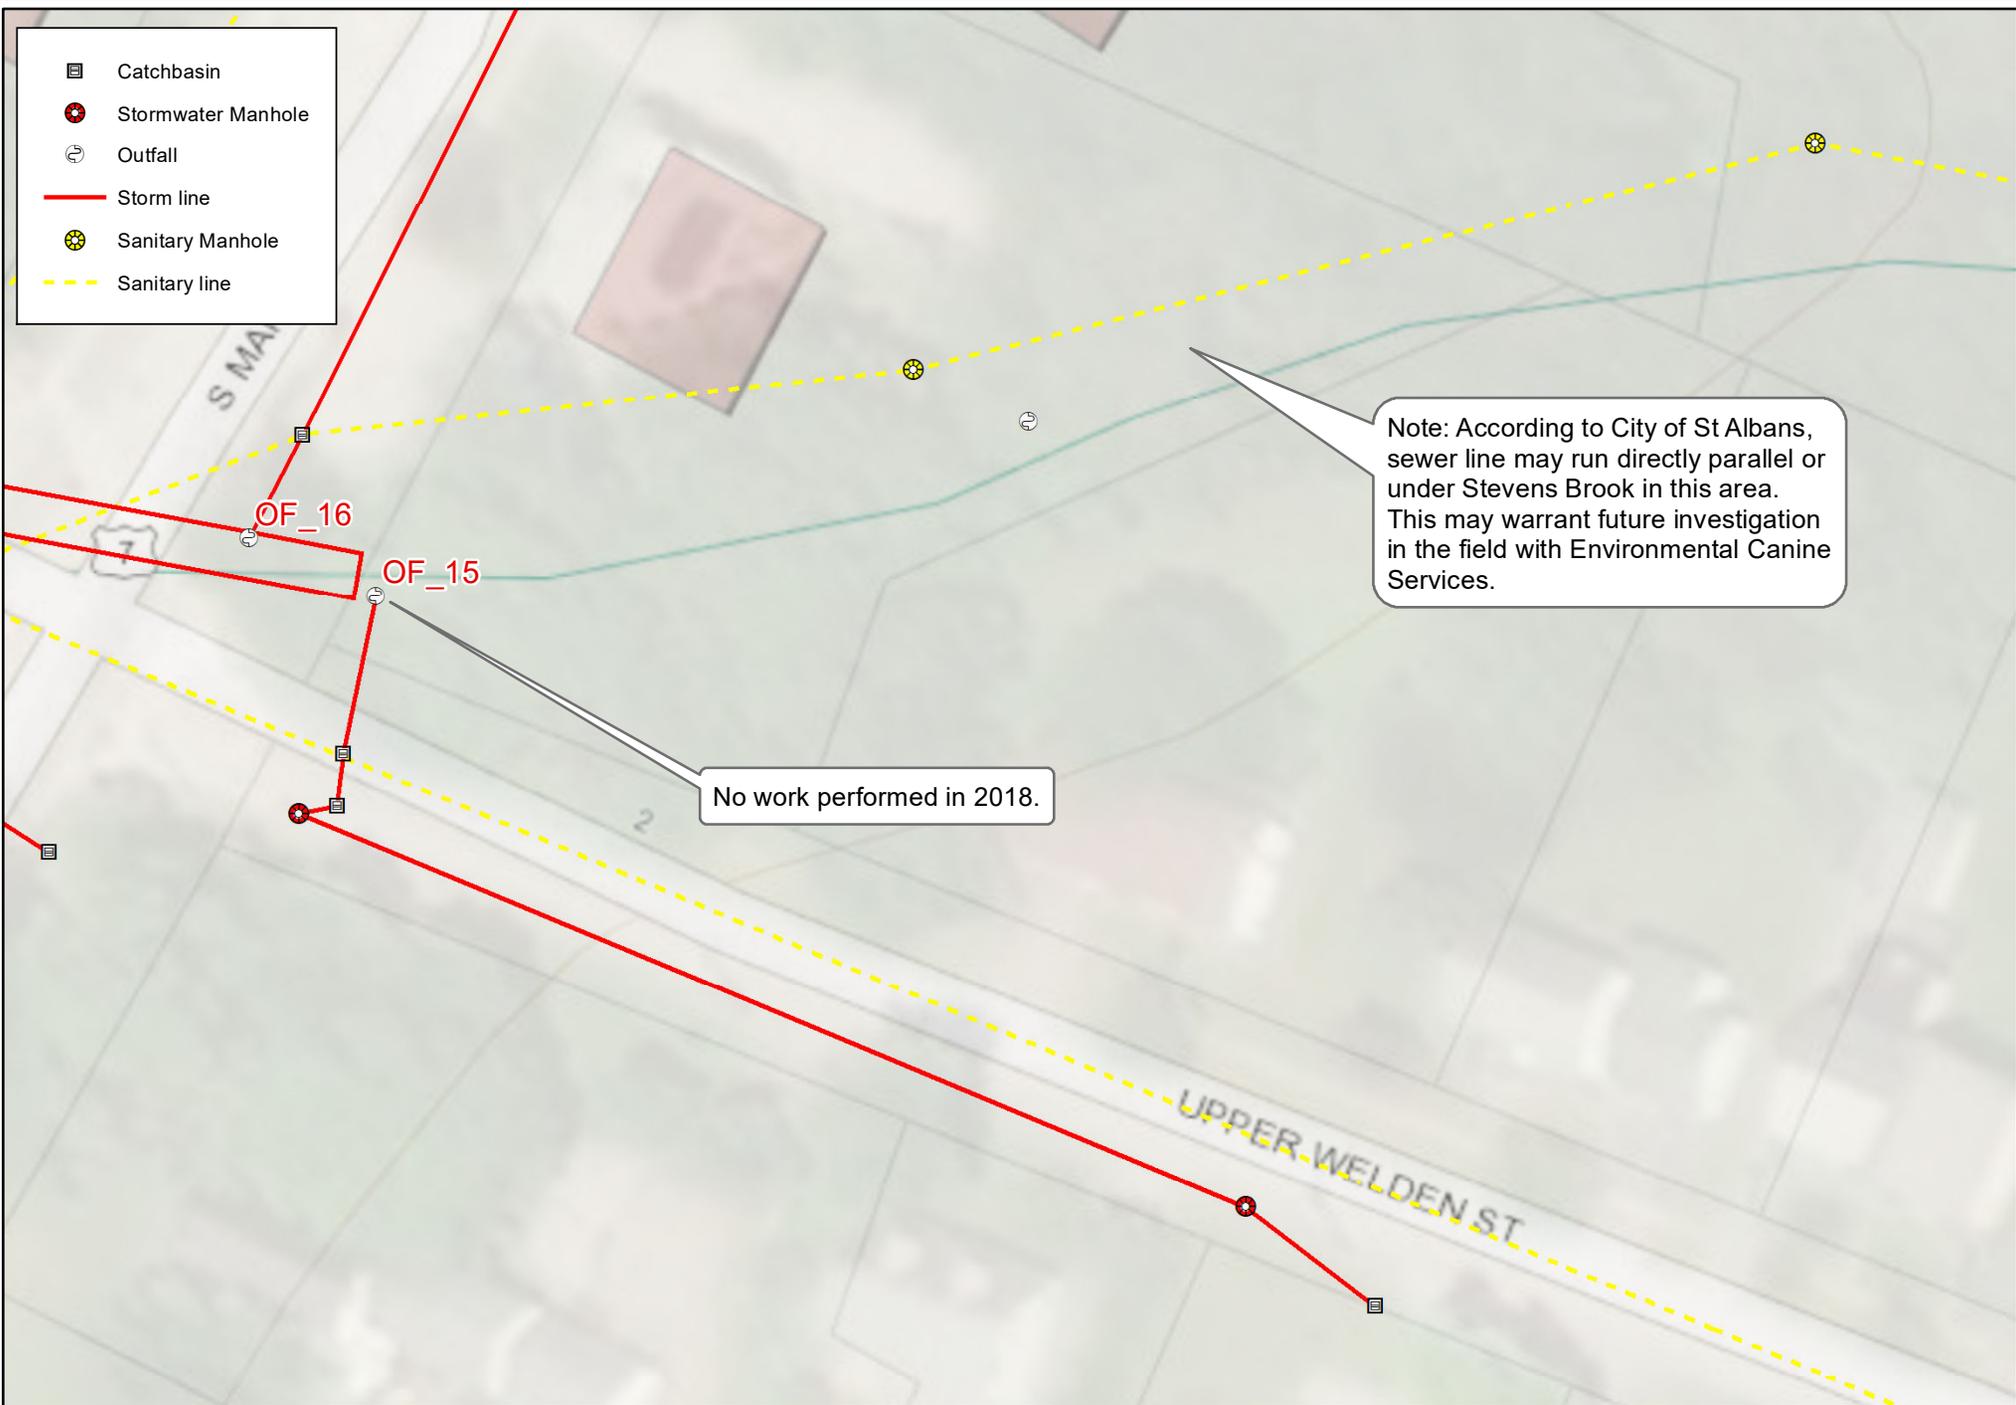
Note: According to City of St Albans, sewer line may run directly parallel or under Stevens Brook in this area. This may warrant future investigation in the field with Environmental Canine Services.

No work performed in 2018.

- ❖ Smoke testing of this outfall should be conducted to determine if prior water quality results were due to an illicit connection or to groundwater flow contaminated with farm field runoff as previously thought.
- ❖ The reach of Stevens Brook near Outfall 15 should be investigated using Environmental Canine Services Field Team to determine if and where the sanitary sewer main may be leaking into the Brook directly.

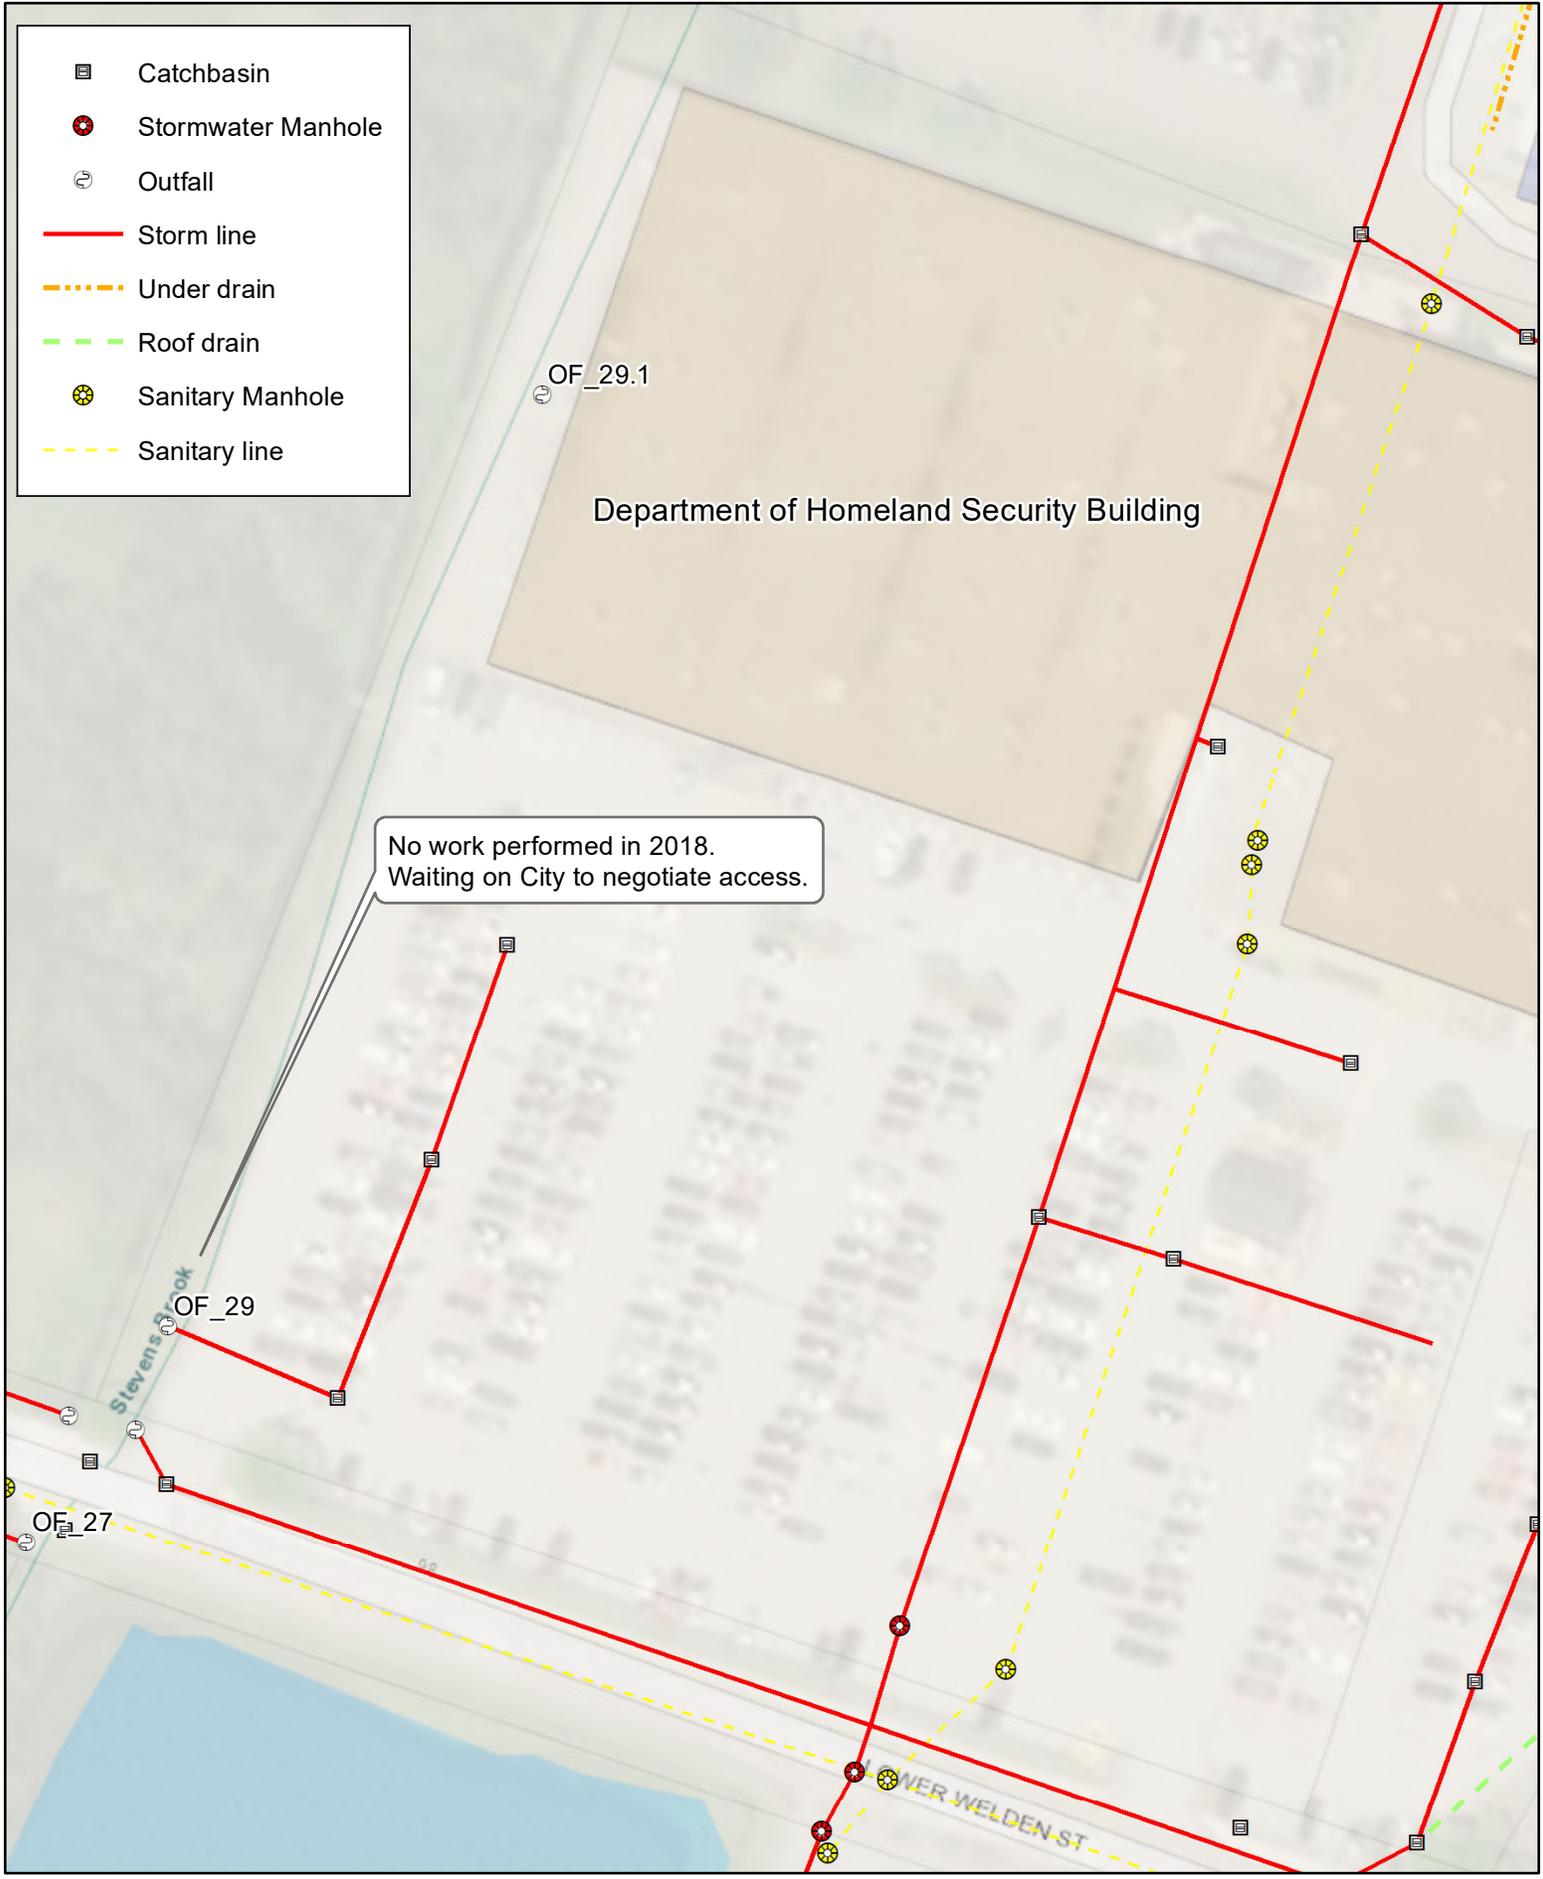
No investigation of this outfall was performed in 2018. The City of St Albans is still in the process of conducting outreach to the Department of Homeland Security for access to the site to conduct advanced investigation using either smoke, dye, or camera techniques. We would recommend that this system be investigated in 2019.

No work performed in 2018.
Waiting on City to negotiate access.

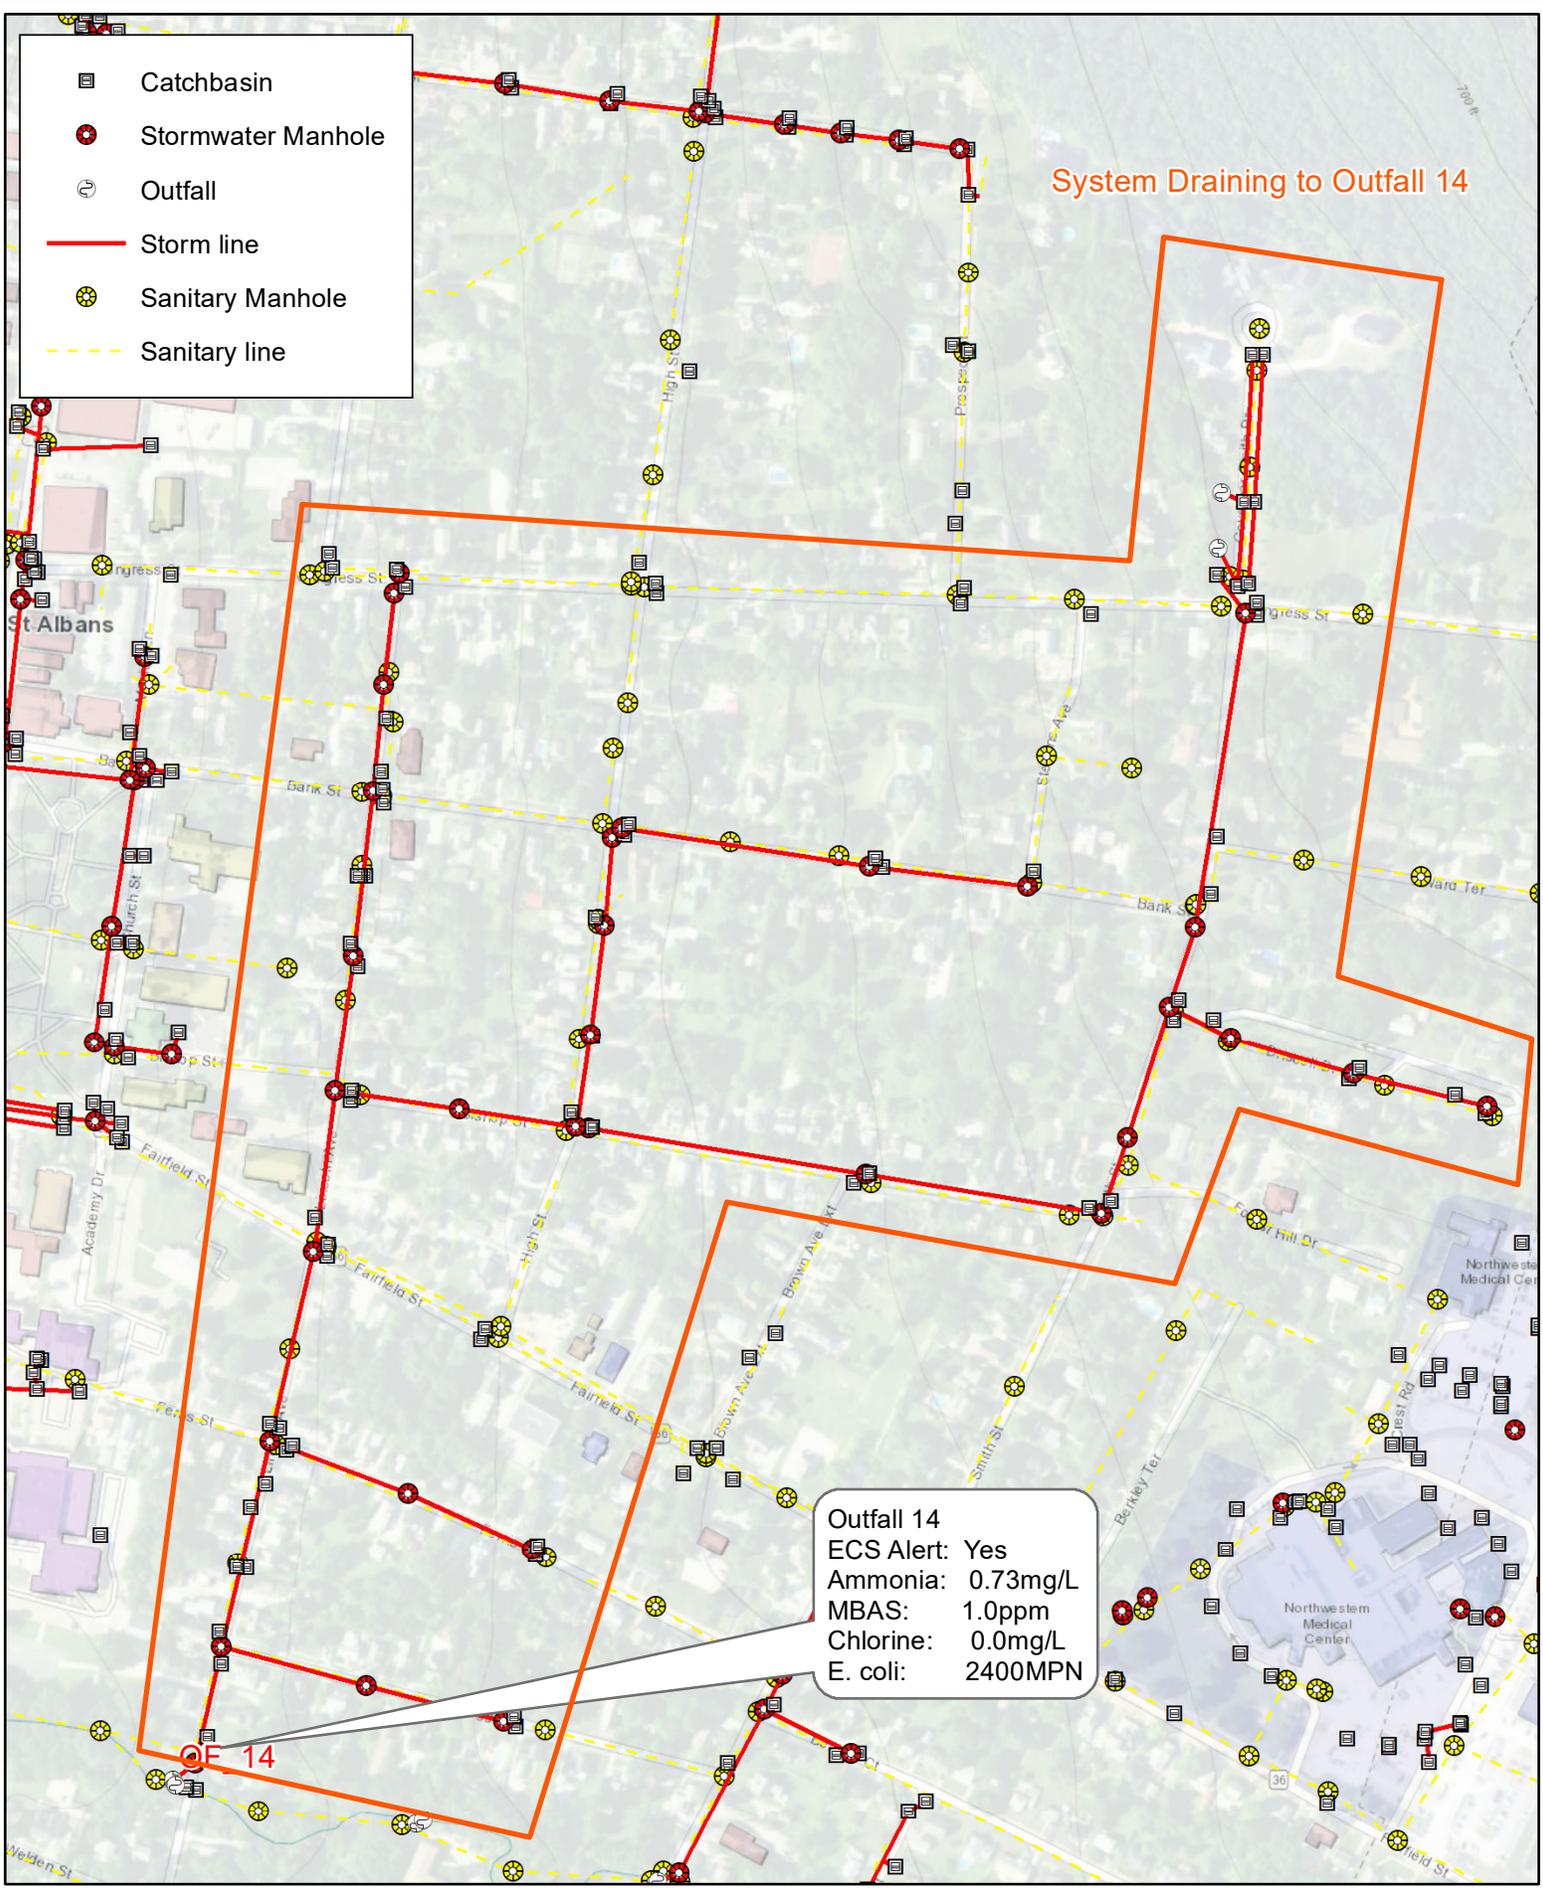
System Draining to Outfall 14

Only initial outfall sampling was conducted at this outfall in 2018. Ammonia was above threshold at 0.73 mg/L and detergents were 1.0 ppm, while *E. coli* was above threshold at 2400 MPN. ECS canines did alert on this sample as well. The system that drains to this outfall is large and will require additional bracket sampling at key system intersection points. This work was not performed in 2018 due to the early onset of wintry conditions. However, this work may be able to be performed during the winter of 2019 or spring/summer of 2019. We would recommend that bracket sampling be conducted first prior to smoke testing as the system is large and could prove challenging to smoke test efficiently unless better target areas are first established. We would recommend that this system be further investigated in 2019.

Outfall 14
 ECS Alert: Yes
 Ammonia: 0.73mg/L
 MBAS: 1.0ppm
 Chlorine: 0.0mg/L
 E. coli: 2400MPN

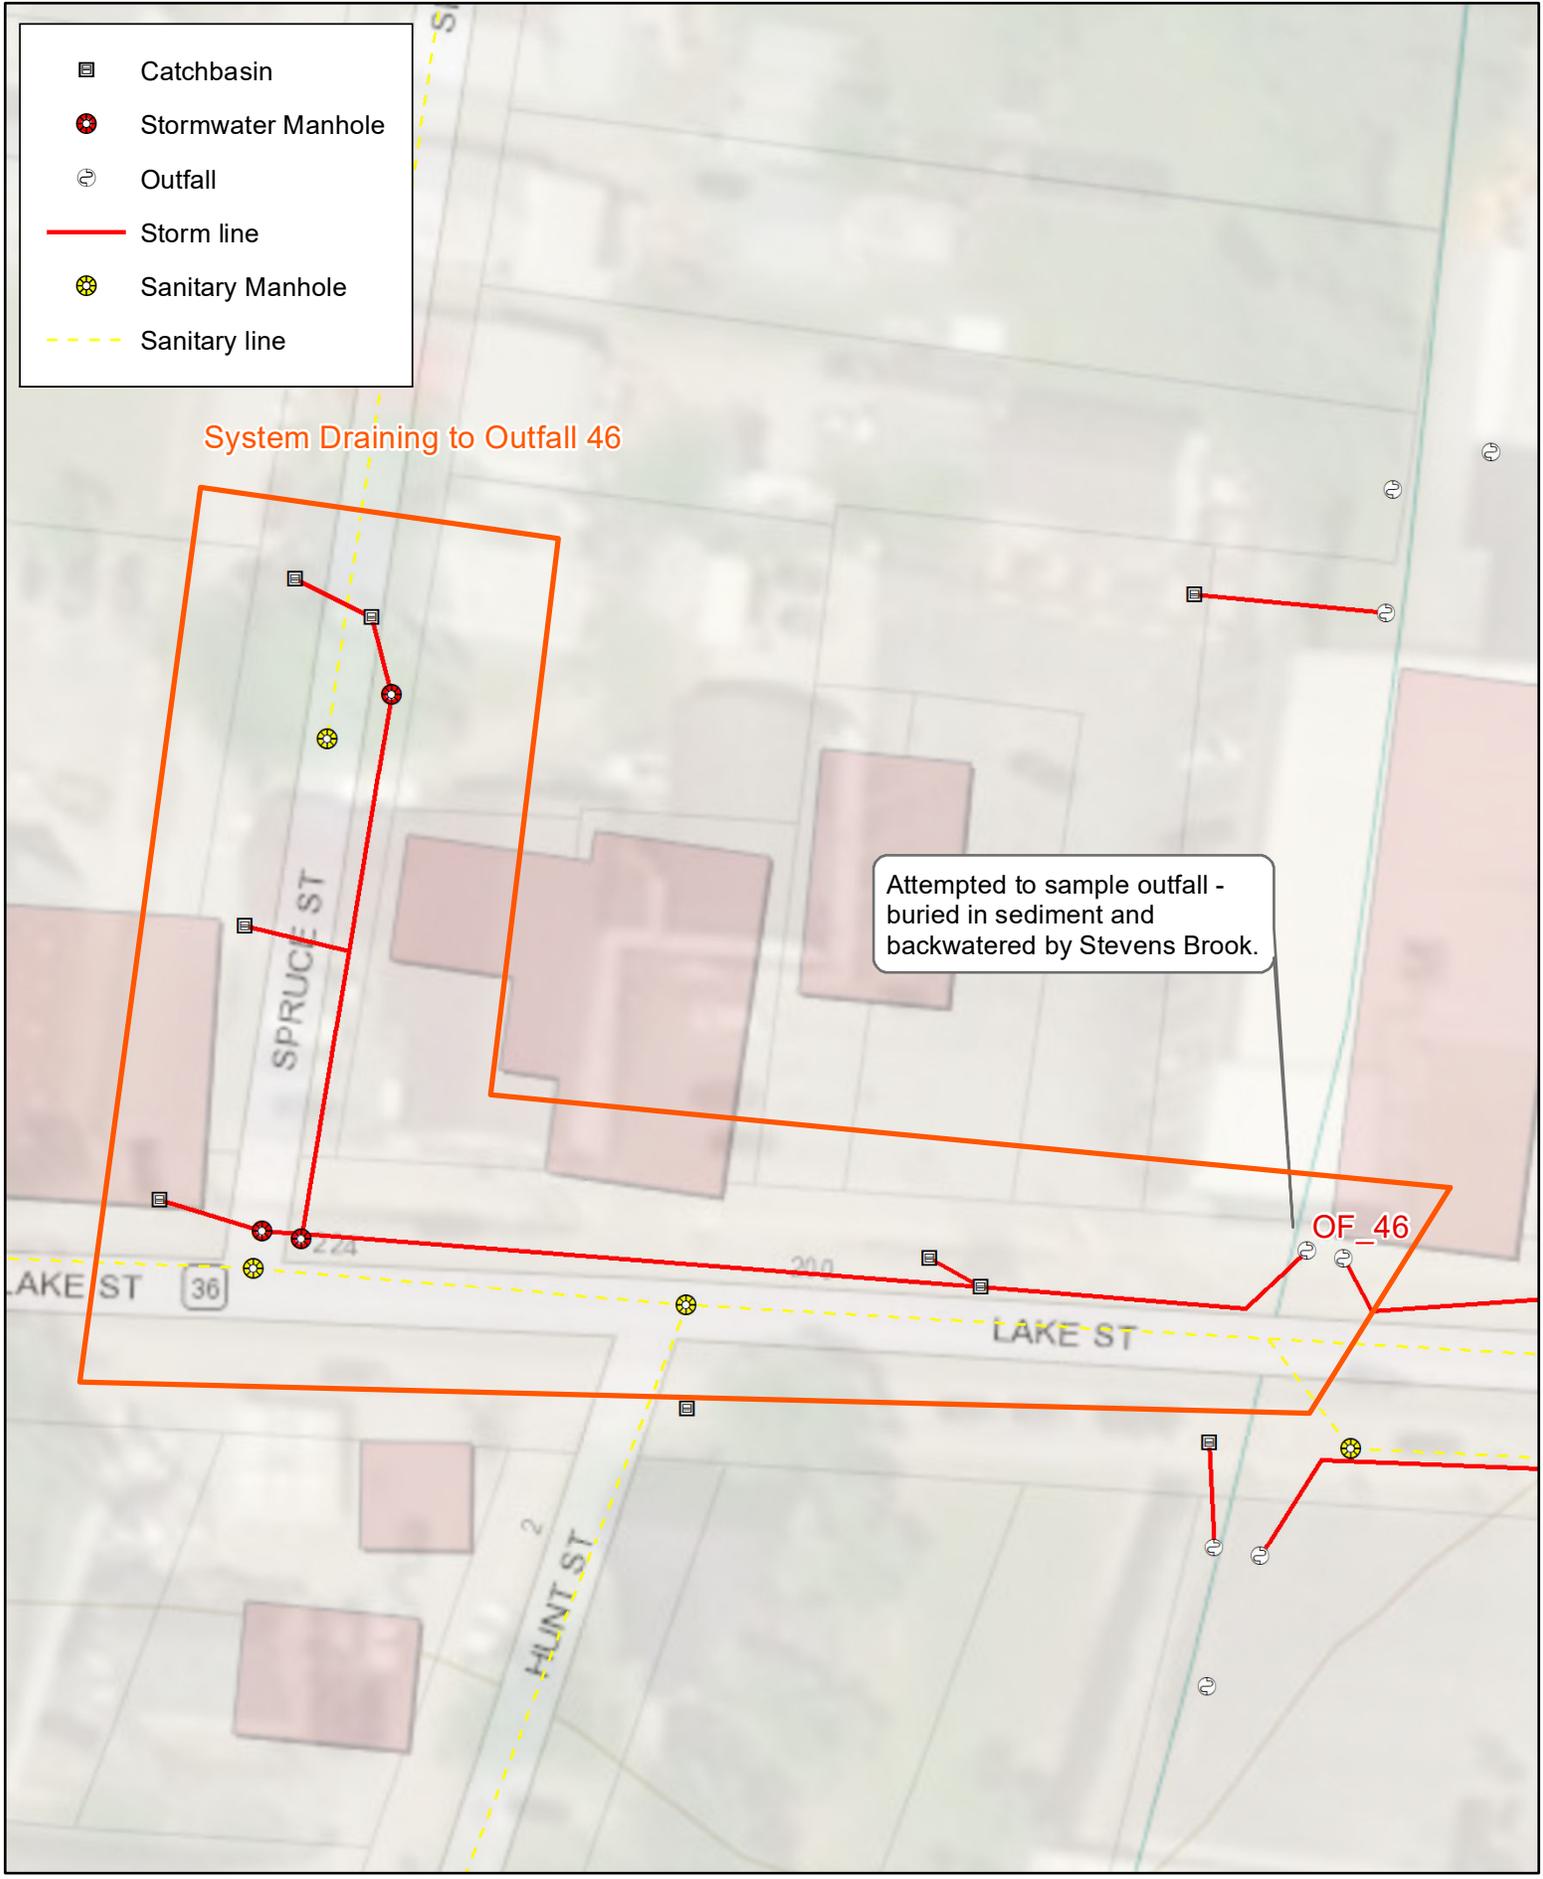
System Draining to Outfall 46

An initial screening of this outfall was conducted in 2018 during an attempt to sample flow from the outfall. However, the outfall is partially buried in sediment and is backwatered by Stevens Brook under the middle of a bridge on Lake Street. Additionally, no flow was seen in the upstream infrastructure. It was therefore decided that smoke testing would be the most efficient means to identify a potential illicit discharge. However, the early onset of wintry conditions prevented this work from occurring. We would recommend that this system be further investigated in 2019 using smoke testing as the primary technique.

Attempted to sample outfall -
buried in sediment and
backwatered by Stevens Brook.
