May 28, 2008

Re: Phase I Environmental Site Assessment
Brickyard Tavern Building
St. Albans, Vermont
JCO #1-1470-15

Phase I Environmental Site Assessment Report
Brickyard Tavern Building
St. Albans, Vermont

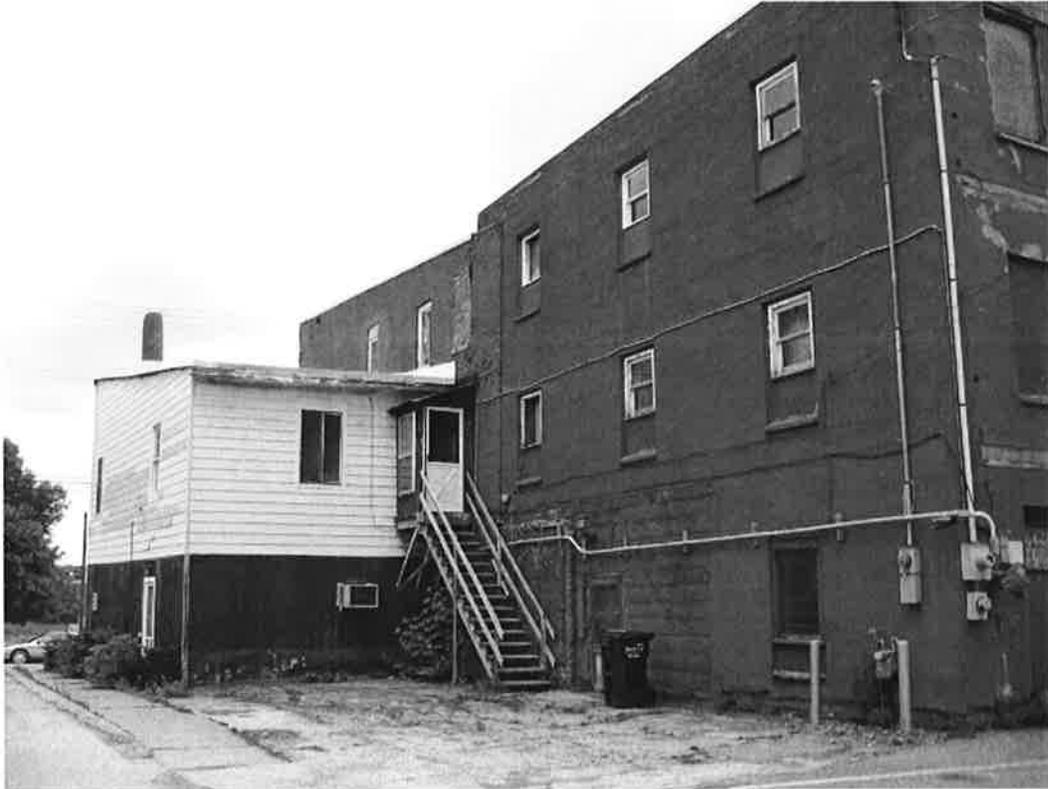
Plate 2. Southern side of building showing exterior staircase on 27-29 building.

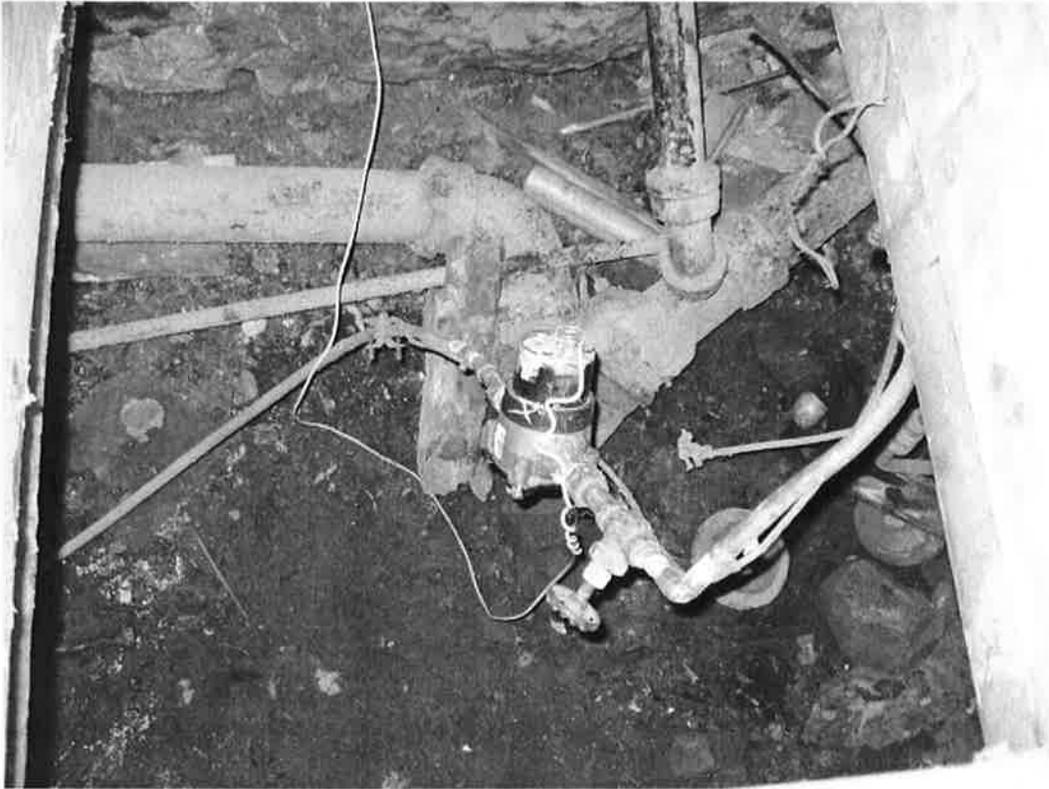
Plate 3. Piping in crawlspace beneath 27-29 building.

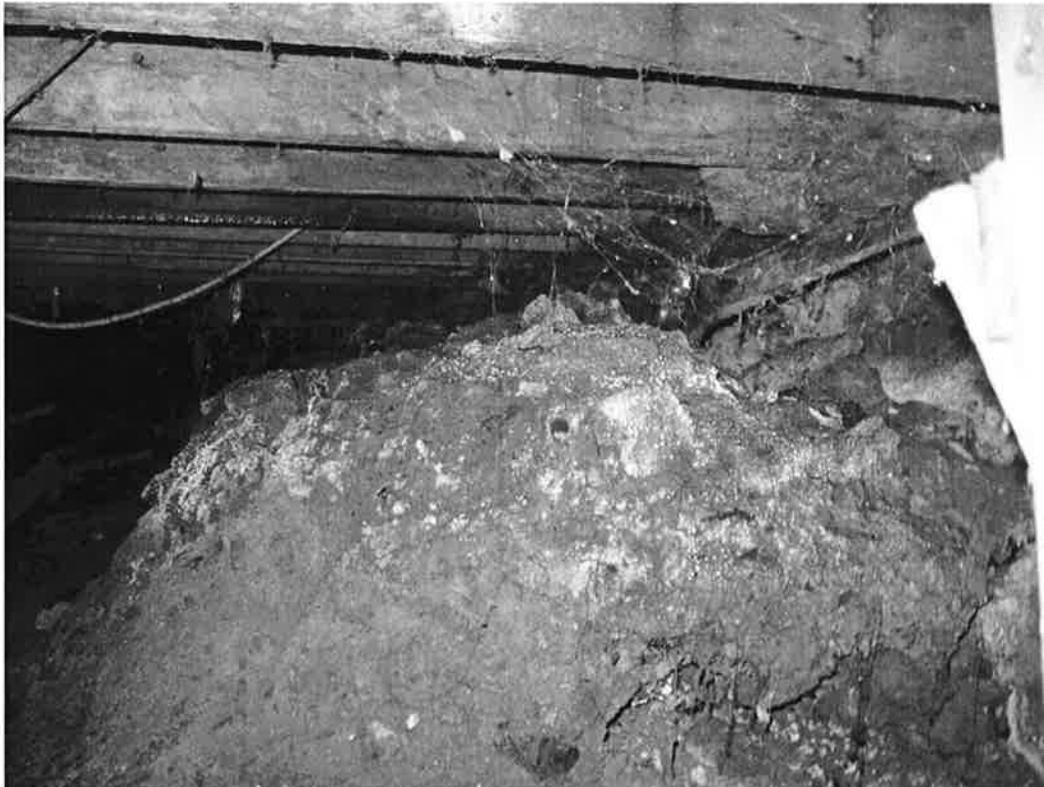
Table 4.5.4 Potential Asbestos Containing Materials	
Floor	Sampling location
Crawl space	There is a built-up pile of material directly under the midline of the first floor in the crawl space. It is possible that this is deteriorated transite removed from another area of the building.
First floor	Kitchen area of tavern: sample the tile flooring. The age of the flooring puts it in a category of potential asbestos floor tile.
	Rear of building, northeast corner: the north wall around the chimney has been refaced with suspect material. CAUTION: this material is friable and needs to be handled as if it is asbestos.
Second floor	The second floor has been somewhat renovated with drywall covering the older construction. Under the drywall there exists a harden board with suspect fibrous content. It is suspected that this may be transite board. Samples of this material should be taken to confirm its composition.

Plate 4. Soil, building debris, possible insulation in crawlspace beneath 31-33 building.
