2018 REPORT – CITY OF ST ALBANS – ILLICIT DISCHARGE DETECTION AND ELIMINATION STUDY

ST ALBANS, VERMONT

Progress Report

Watershed Consulting Associates, LLC

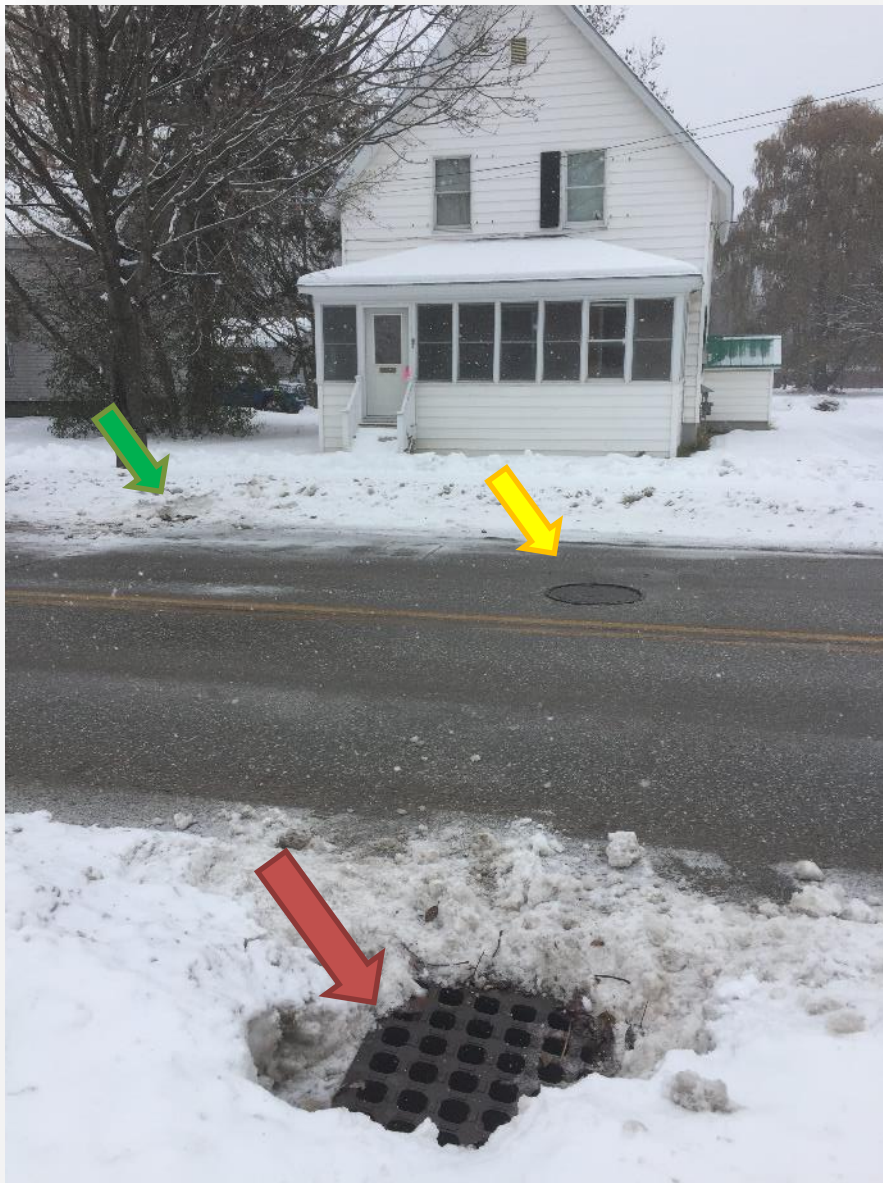
During smoke testing, Watershed found smoke coming from a catch basin opposite 67 North Elm Street while blowing smoke into the sanitary sewer from a manhole on lower Pearl Street (noted on the summary map). Watershed then blew smoke from the sanitary manhole directly adjacent to the catch basin - smoke immediately came out of the catch basin rim from the lower pipe in the catch basin. Watershed then cleared the line of smoke and blew smoke into the stormwater sewer from a nearby catch basin. Smoke came in from the upper pipe in the catch basin. The catch basin opposite 67 North Elm Street is tied to both the sanitary and storm sewer. As the pipe to the storm sewer is considerably higher than the pipe to the sanitary sewer, it would require a surcharge from the sanitary sewer of between 5-5.5' to cause sewage to flow into the stormwater sewer. However, this potential discharge should be eliminated as soon as possible.

Figure 1: Picture taken facing 67 North Elm Street (white house in the background). The catch basin in the foreground (red arrow) is directly connected to both the storm and sanitary sewers. The lower pipe in the catch basin flows directly to the sanitary manhole (yellow arrow). The catch basin in the background (green arrow) is not connected to the sanitary system.

- ❖ The crosstie found near 67 North Elm Street should be fixed as soon as possible. Once fixed, this area should be smoke tested again and the rest of system investigated for other possible illicit discharges.

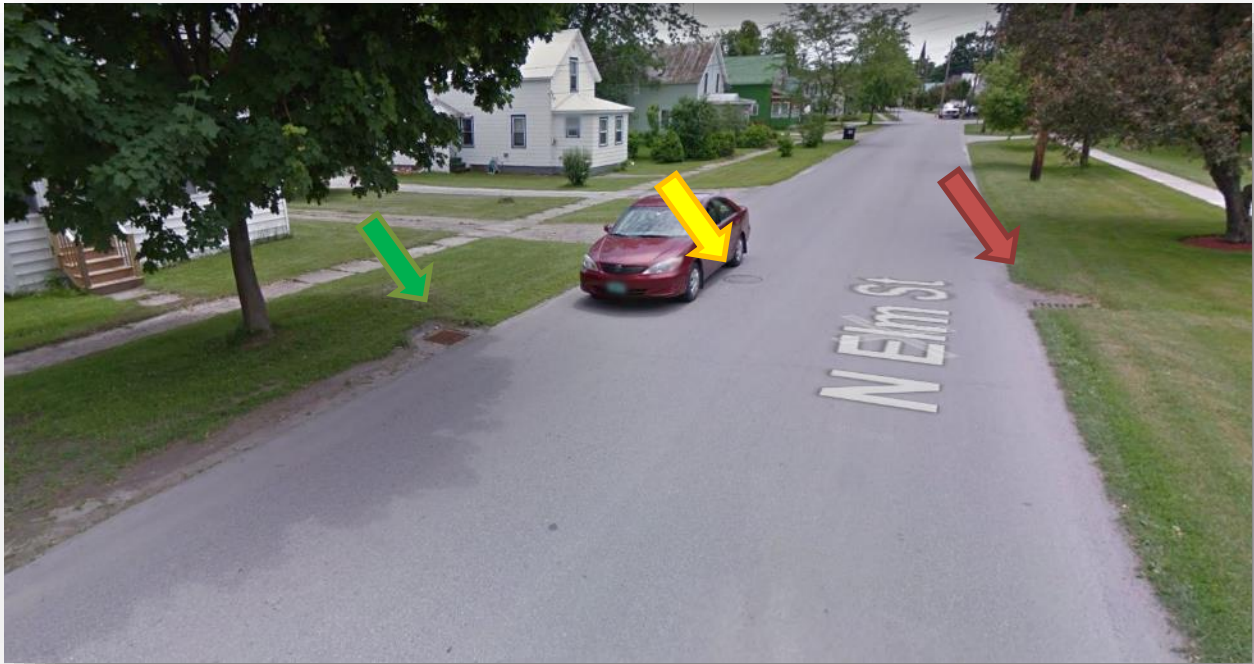
Figure 2: Image from Google StreetView. The red arrow indicates the catch basin connected to both the sanitary and storm sewers. The yellow arrow indicate the sanitary sewer manhole to which the catch basin is connected. The green arrow indicates the catch basin that is not connected to the sanitary sewer.

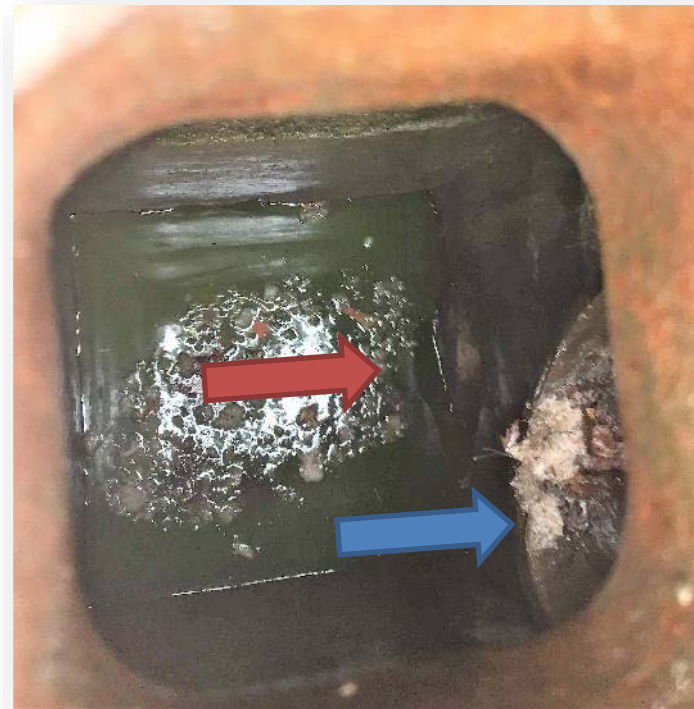
Figure 3: Picture of the catch basin connected to both the sanitary and storm sewers. The red arrow is pointing to the pipe that is directly connected to the sanitary sewer (lower pipe). The blue arrow points to the pipe that leads to the stormwater sewer. In runoff events most runoff would go into the sanitary sewer.
