2019 REPORT – CITY OF ST ALBANS – ILLICIT DISCHARGE DETECTION AND ELIMINATION STUDY

ST ALBANS, VERMONT

Progress Report

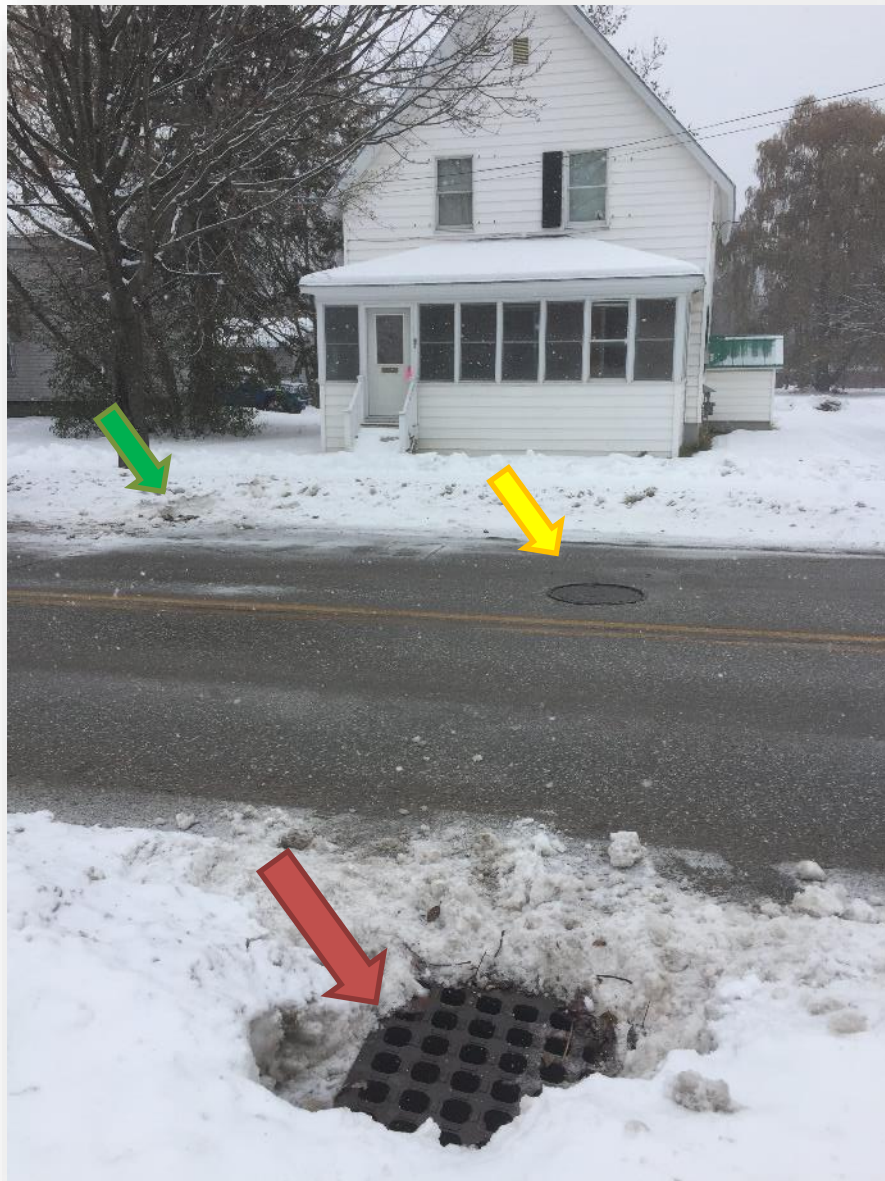
During smoke testing, Watershed found smoke coming from a catch basin opposite 67 North Elm Street while blowing smoke into the sanitary sewer from a manhole on lower Pearl Street (noted on the summary map). Watershed then blew smoke from the sanitary manhole directly adjacent to the catch basin - smoke immediately came out of the catch basin rim from the lower pipe in the catch basin. Watershed then cleared the line of smoke and blew smoke into the stormwater sewer from a nearby catch basin. Smoke came in from the upper pipe in the catch basin. The catch basin opposite 67 North Elm Street is tied to both the sanitary and storm sewer. As the pipe to the storm sewer is considerably higher than the pipe to the sanitary sewer, it would require a surcharge from the sanitary sewer of between 5-5.5' to cause sewage to flow into the stormwater sewer. However, this potential discharge should be eliminated as soon as possible.

Figure 1: Picture taken facing 67 North Elm Street (white house in the background). The catch basin in the foreground (red arrow) is directly connected to both the storm and sanitary sewers. The lower pipe in the catch basin flows directly to the sanitary manhole (yellow arrow). The catch basin in the background (green arrow) is not connected to the sanitary system.

- ❖ The crosstie found near 67 North Elm Street should be fixed as soon as possible. Once fixed, this area should be smoke tested again and the rest of system investigated for other possible illicit discharges.

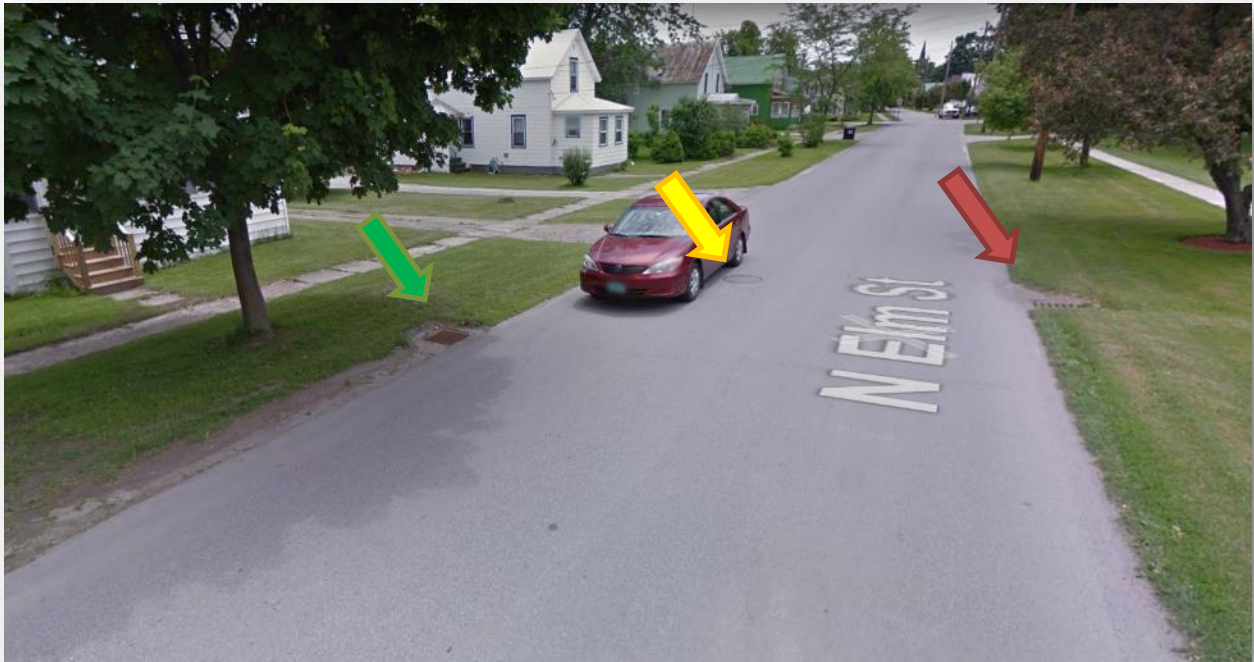
Figure 2: Image from Google StreetView. The red arrow indicates the catch basin connected to both the sanitary and storm sewers. The yellow arrow indicate the sanitary sewer manhole to which the catch basin is connected. The green arrow indicates the catch basin that is not connected to the sanitary sewer.

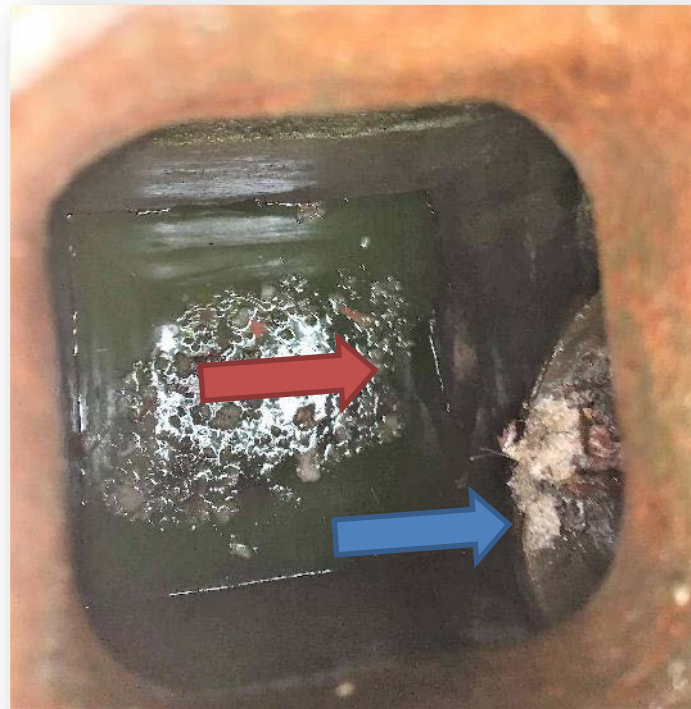
Figure 3: Picture of the catch basin connected to both the sanitary and storm sewers. The red arrow is pointing to the pipe that is directly connected to the sanitary sewer (lower pipe). The blue arrow points to the pipe that leads to the stormwater sewer. In runoff events most runoff would go into the sanitary sewer.
