**Corrective Action Feasibility Investigation
for Remediation of Soil and Building-
Related Contamination**

**Former Fonda Group Facility
St. Albans, Vermont
SMS #2008-3777**

Former Fonda Group Facility Part A
15-21 Lower Newton Street, St. Albans, Vermont

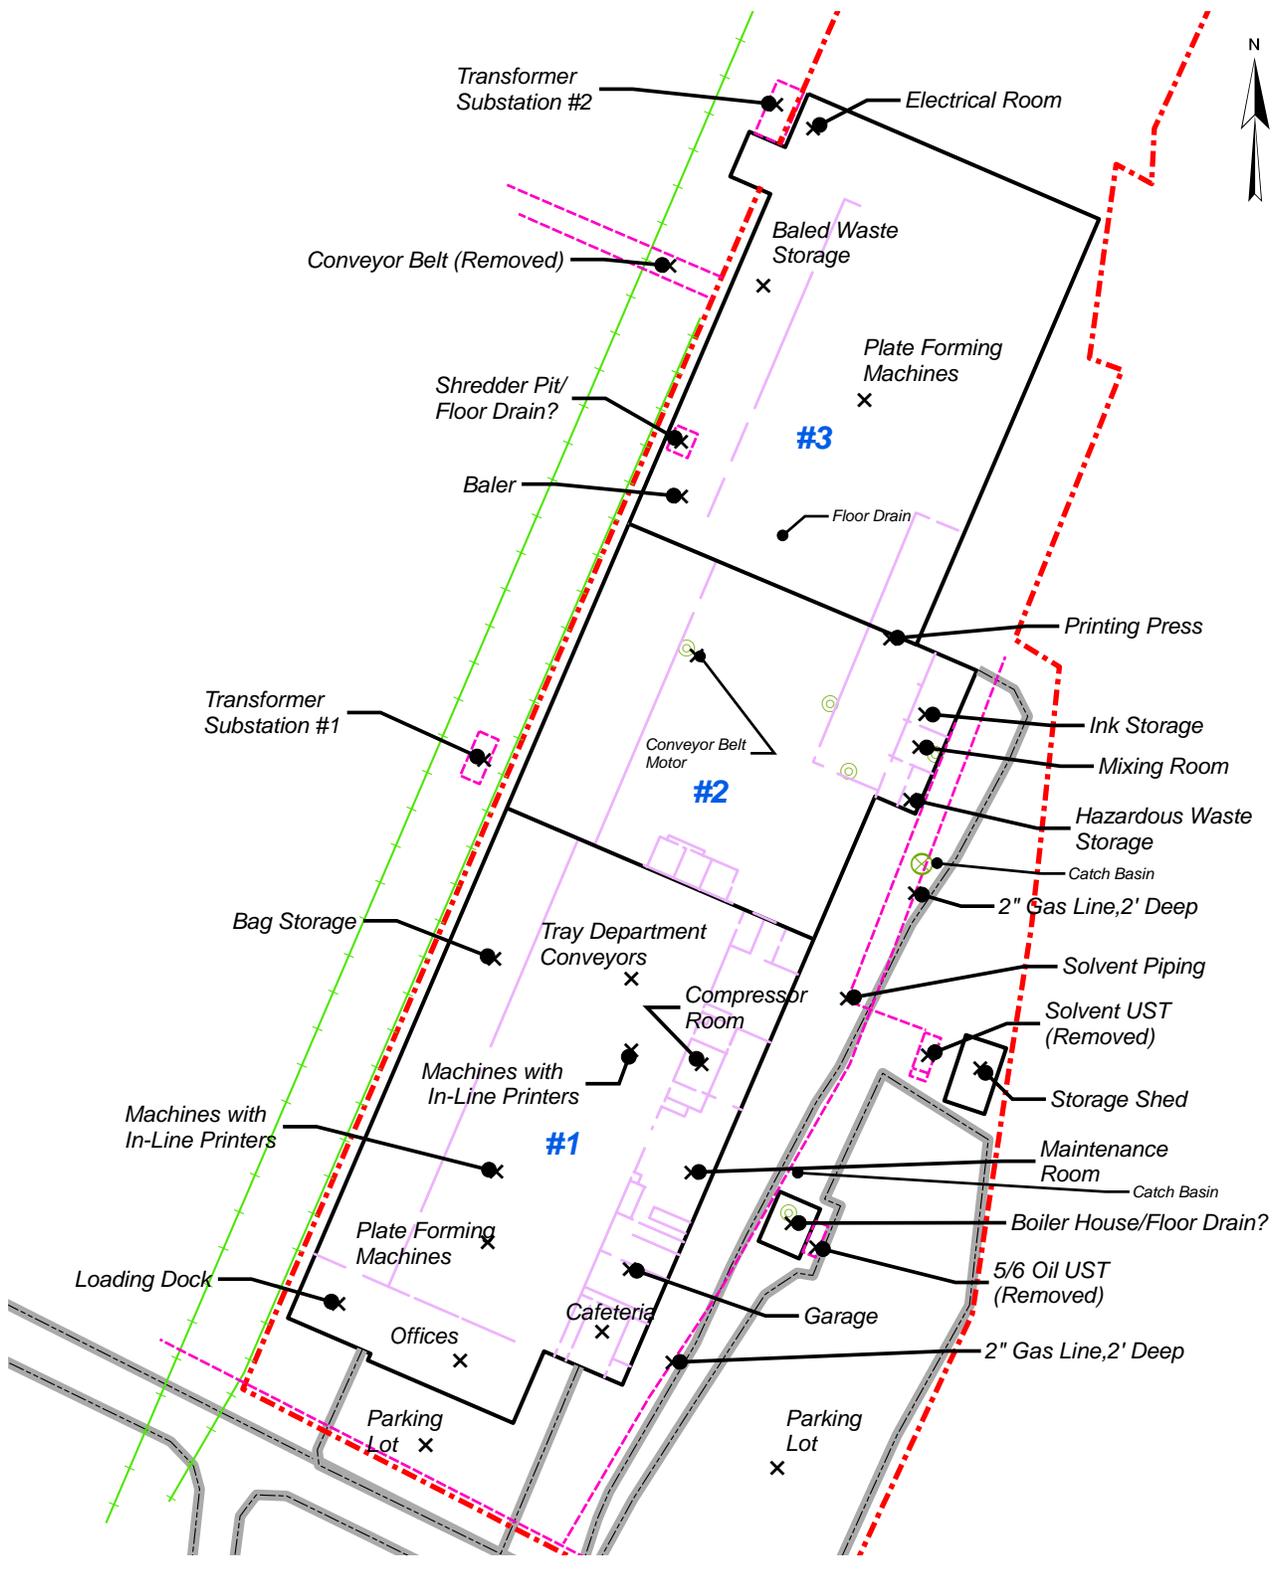
Sources: NAIP 2003 Orthophotograph St. Albans NW (4407316_nw) and "Facility Plan: The Fonda Group, Inc., by New England Air Quality Testing, 3/19/01.

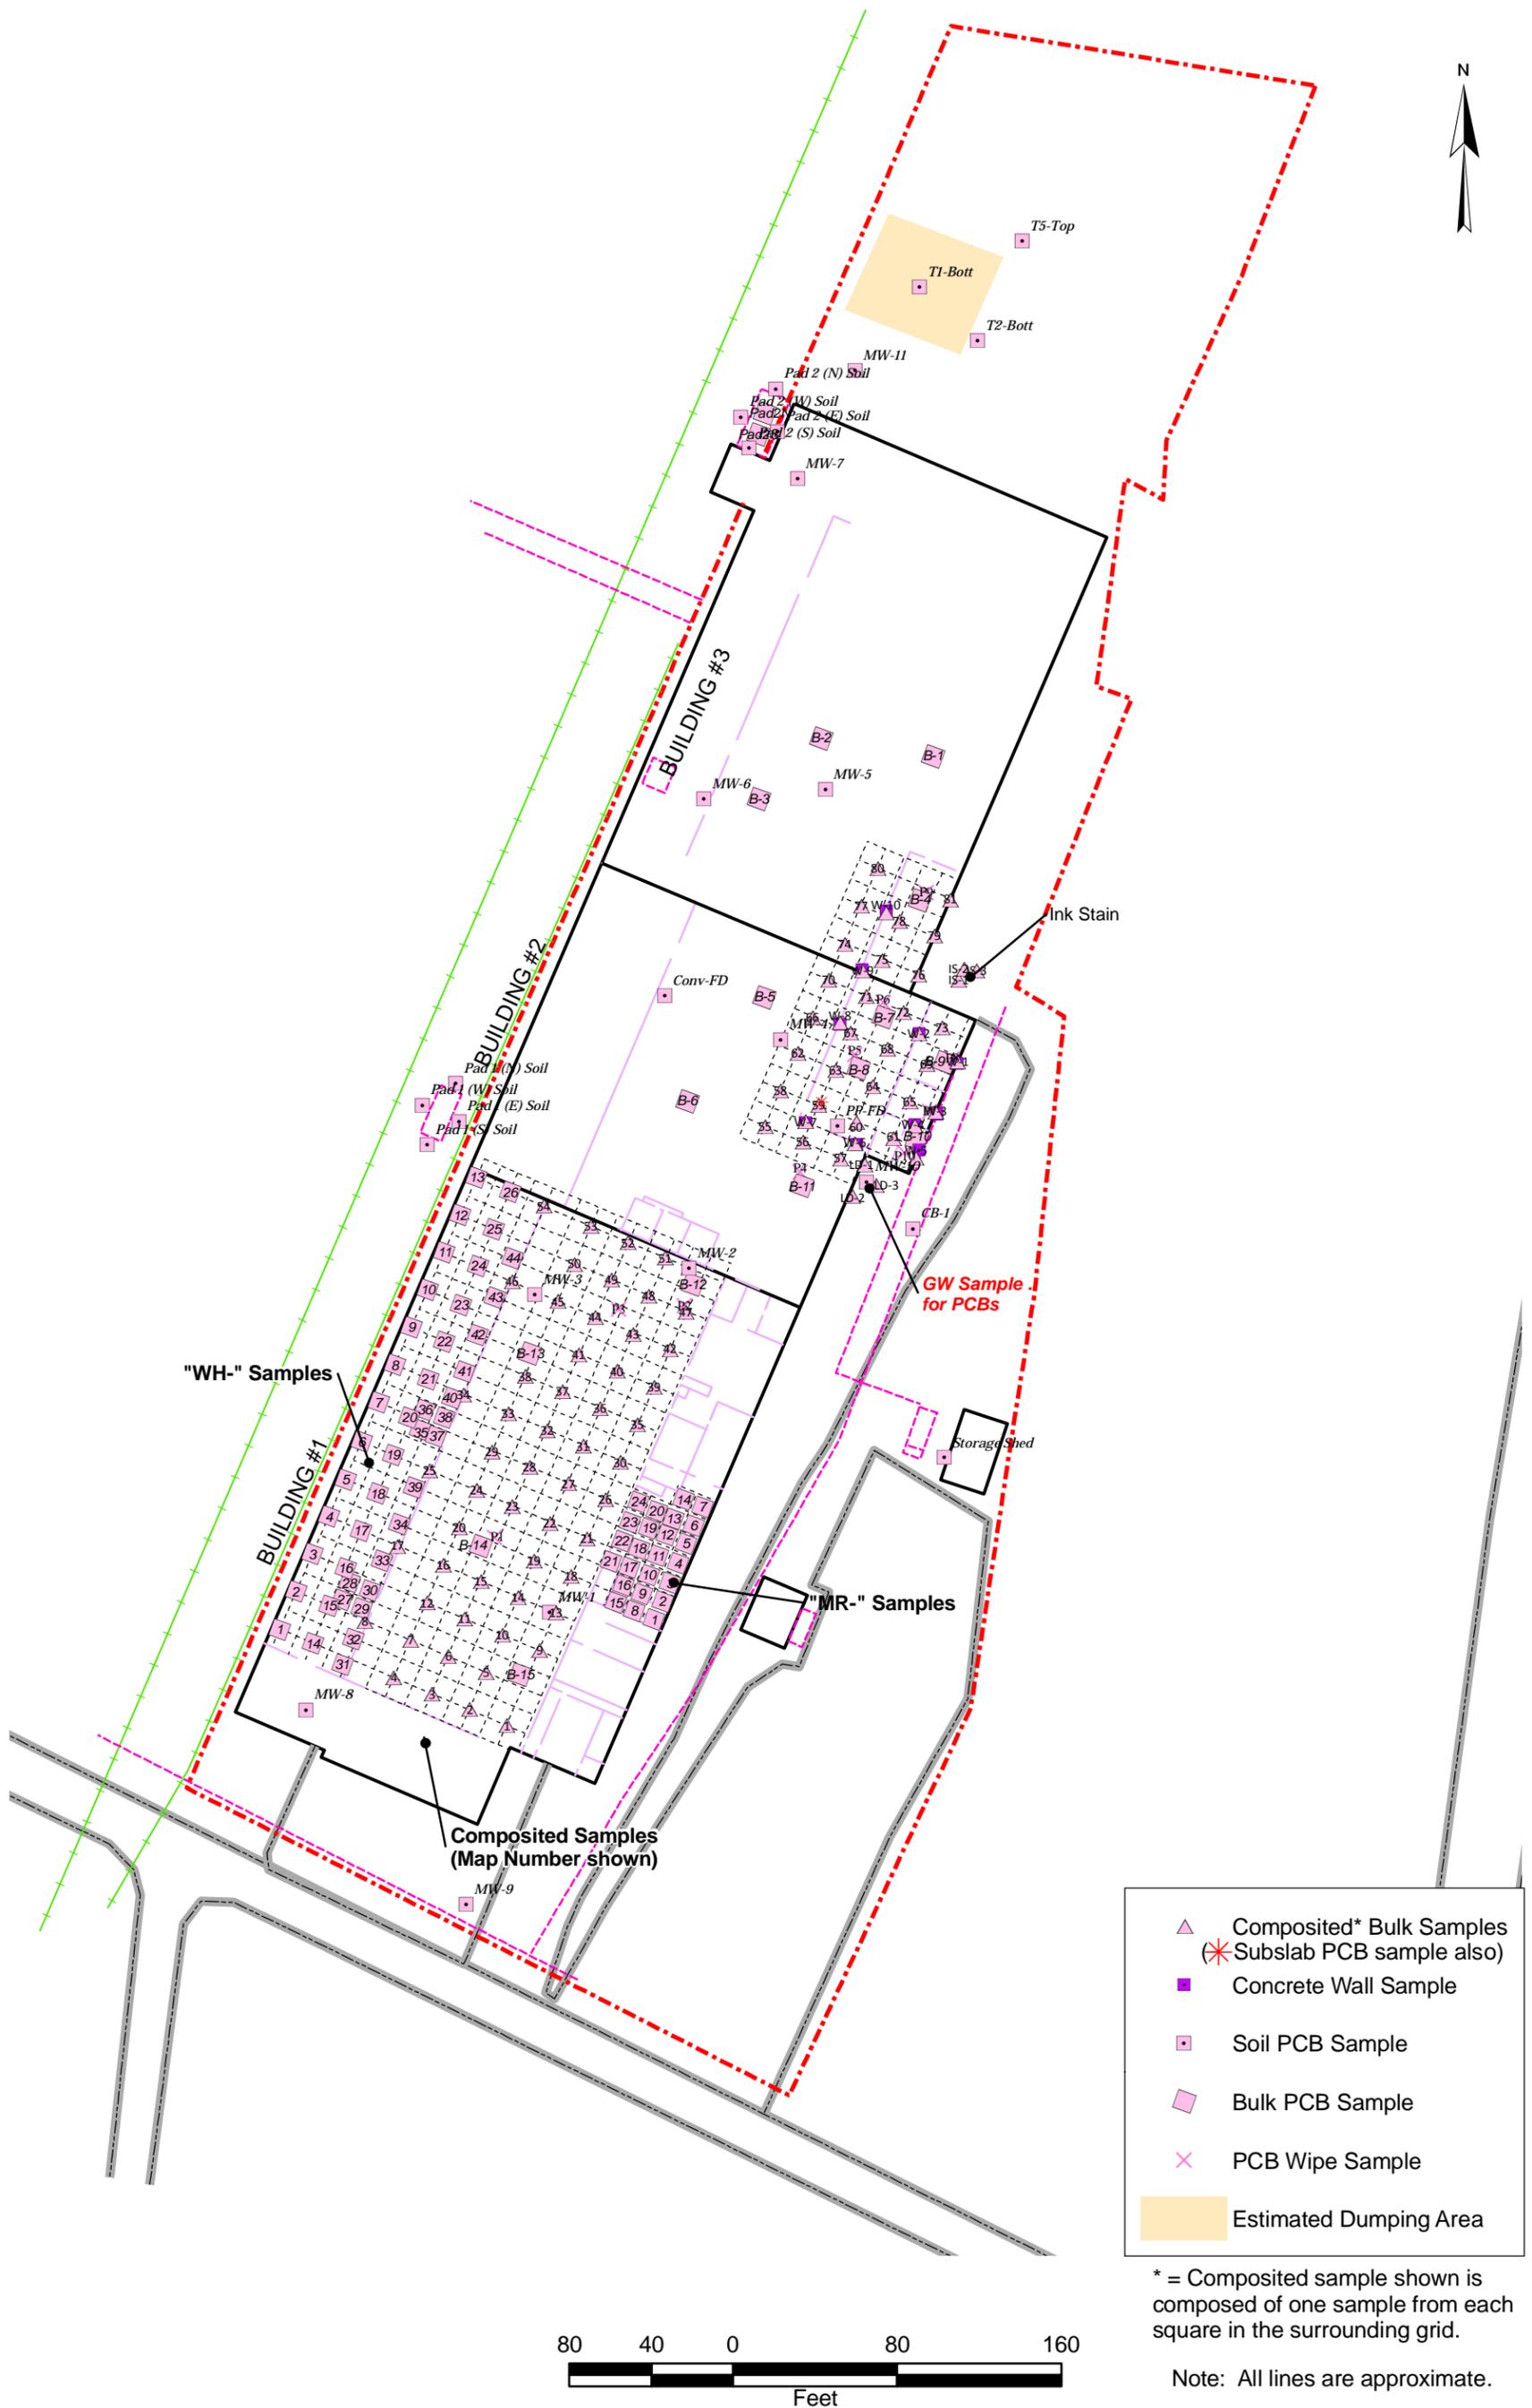
- ▲ Composit^{*} Bulk Samples
(*Subslab PCB sample also)
- Concrete Wall Sample
- Soil PCB Sample
- ◇ Bulk PCB Sample
- × PCB Wipe Sample
- Estimated Dumping Area

* = Composit^{*} sample shown is composed of one sample from each square in the surrounding grid.

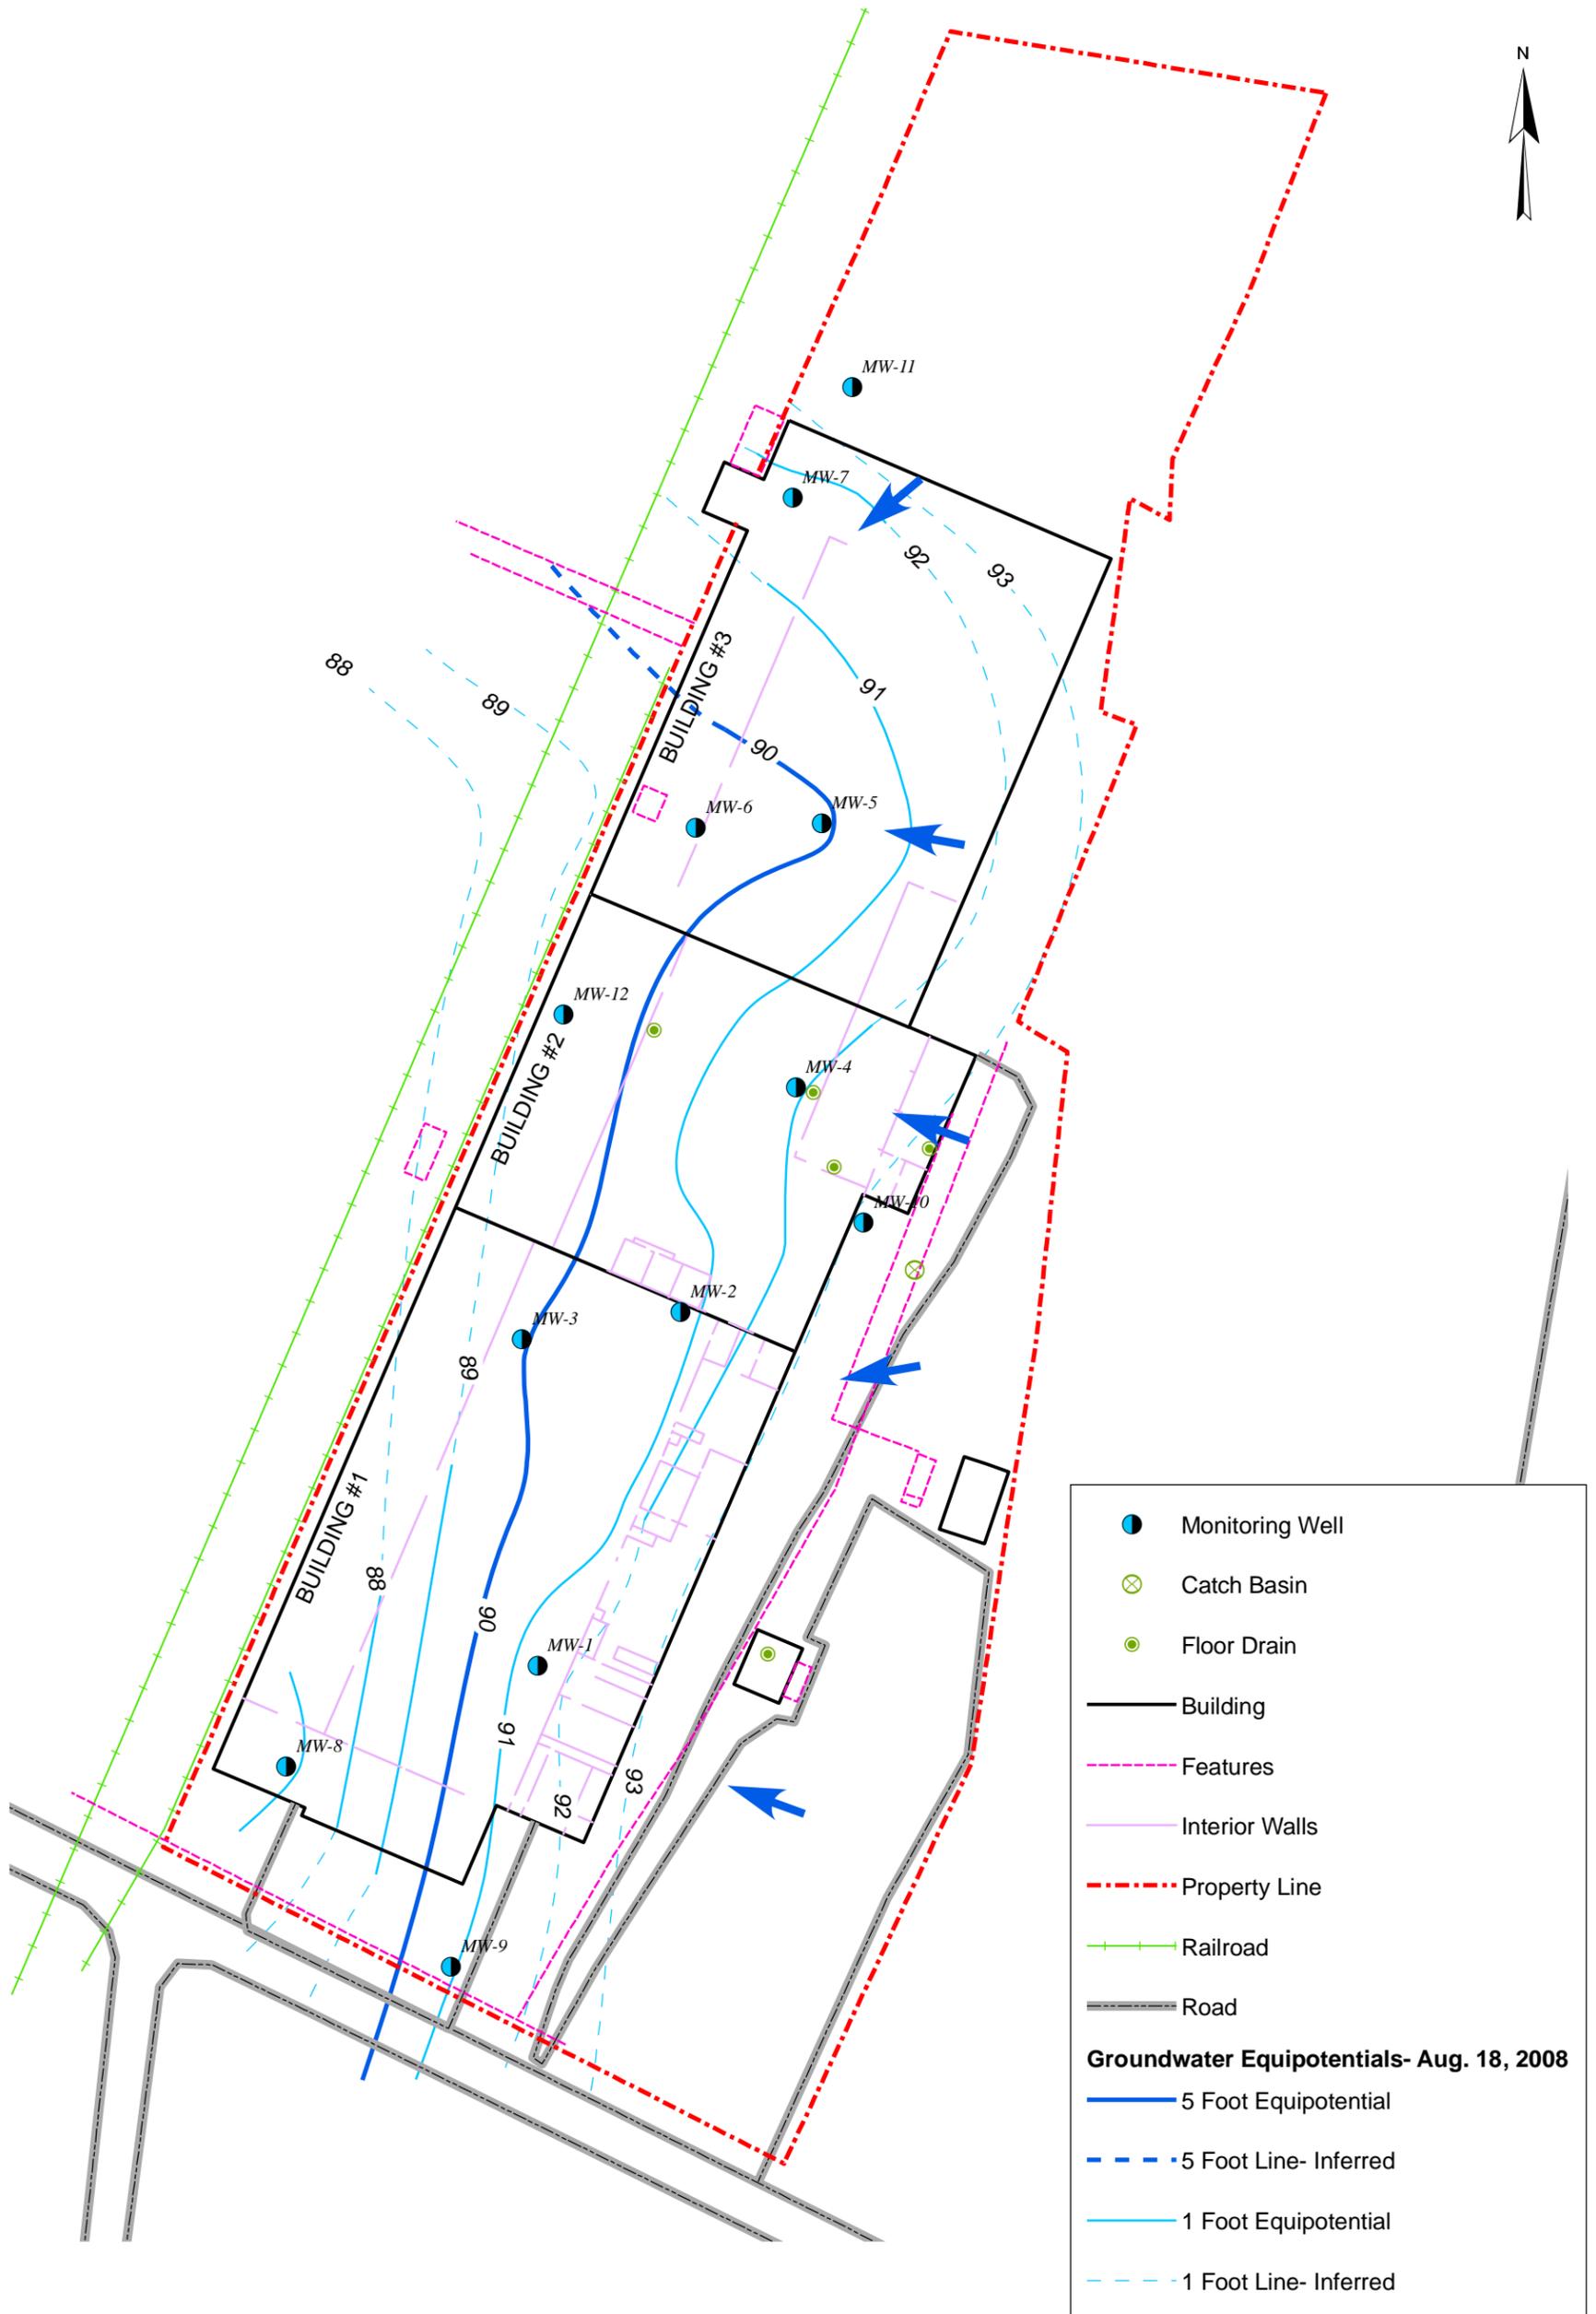
Sources: NAIP 2003 Orthophotograph St. Albans NW (4407316_nw) and "Facility Plan: The Fonda Group, Inc., by New England Air Quality Testing, 3/19/01. Water elevations based on a level survey by The Johnson Company on 02/12/08.

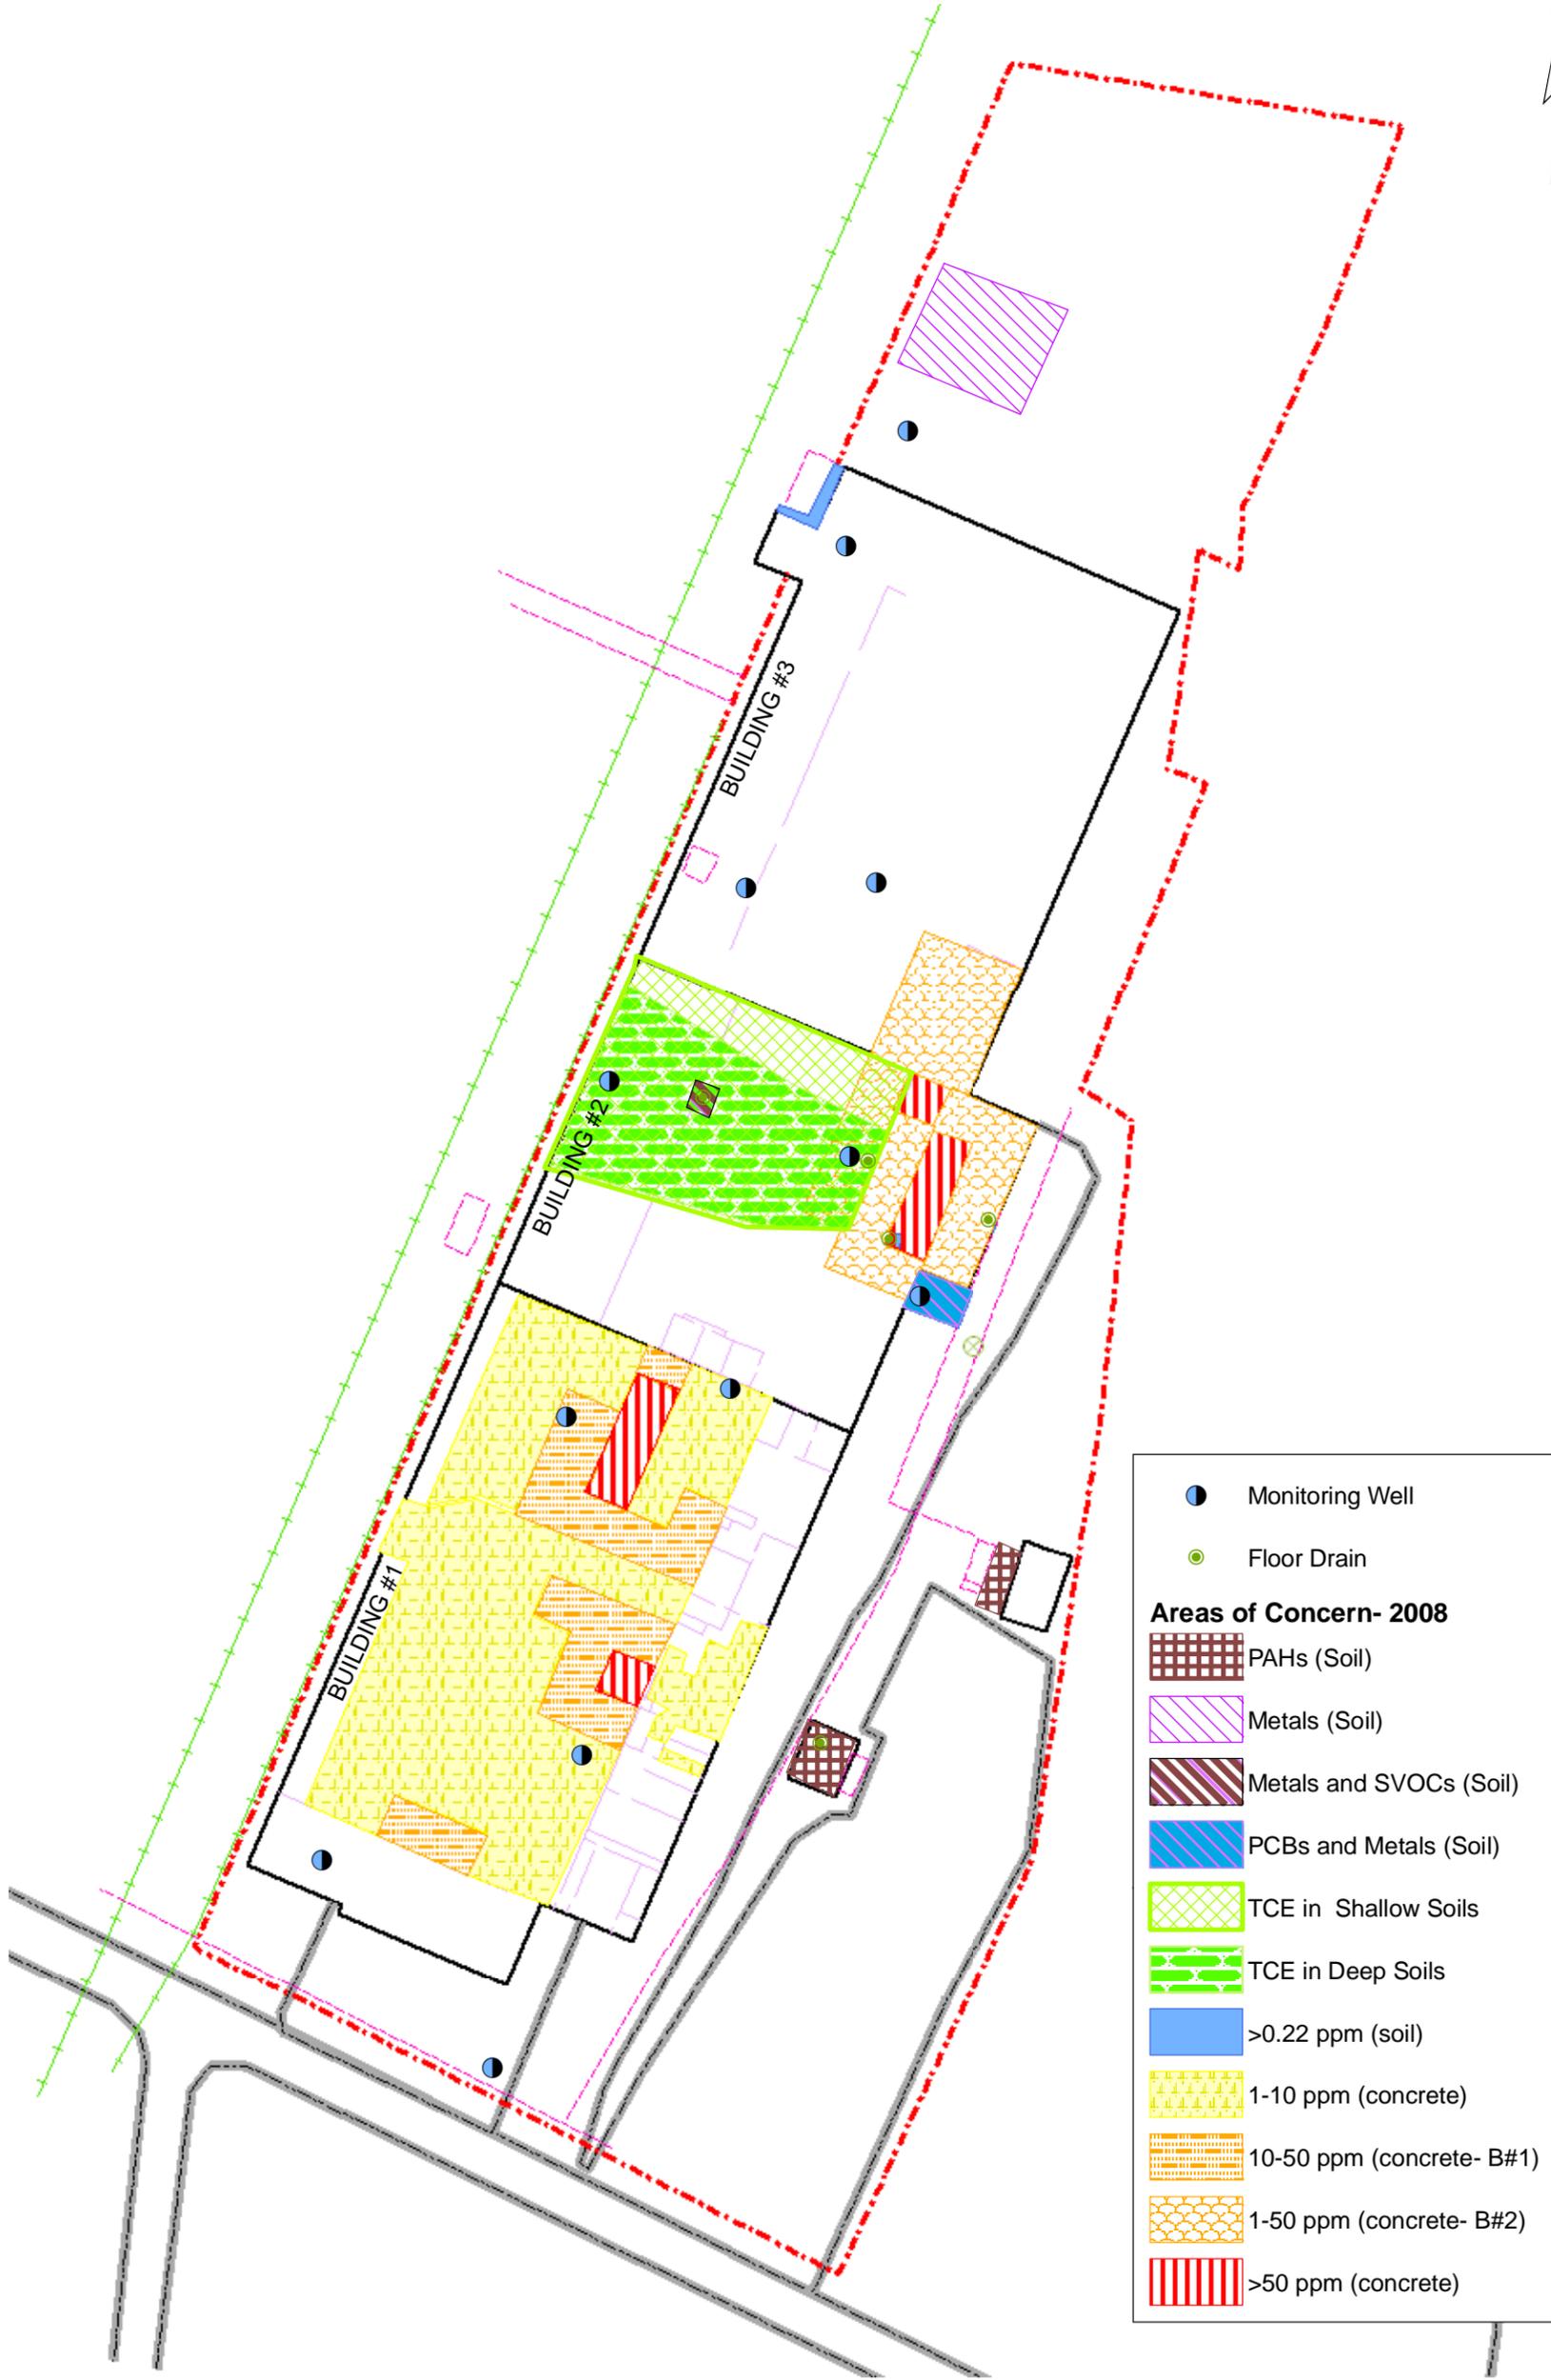
- Monitoring Well
- Floor Drain
- Areas of Concern- 2008**
- PAHs (Soil)
- Metals (Soil)
- Metals and SVOCs (Soil)
- PCBs and Metals (Soil)
- TCE in Shallow Soils
- TCE in Deep Soils
- >0.22 ppm (soil)
- 1-10 ppm (concrete)
- 10-50 ppm (concrete- B#1)
- 1-50 ppm (concrete- B#2)
- >50 ppm (concrete)

Albans, Vermont (the Site). The Site is currently owned by the City of St. Albans and formerly housed a paper products manufacturing and printing facility, but the building is now vacant. NRPC is utilizing United States Environmental Protection Agency (EPA) grant money to assess environmental conditions at the Site and thus assist in its redevelopment. The Phase II ESA (JCO, 2008) followed a Phase I ESA report prepared by The Johnson Company on December 11, 2007. The Phase II Environmental Site Assessment included sampling for metals, PCBs, VOCs, and SVOCs. The results of the investigation are summarized below. The areas of concern are illustrated on Figure 6.
