Memorandum

Re: **MS4 IDDE Outfall Survey Update**

Watershed Consulting is pleased to present this memorandum detailing the work completed to date on the 2025 Illicit Discharge Detection & Elimination Study required by the City’s Municipal Separate Storm Sewer Systems (MS4) permit.

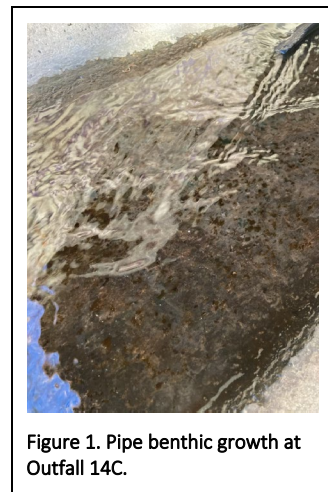
Outfall 14C is a large stormwater outfall located beneath Lincoln Avenue, where extensive advanced investigation (AI) was previously completed. Substantial flow was noted, though no flow-only indicators were present. Brown pipe benthic growth was noted (Figure 1). The anionic surfactant and chlorine concentrations were both elevated above their respective thresholds. The previous AI was completed due to high ammonia and anionic surfactant concentrations, and subsequent *E. coli* readings, however no ammonia was detected during this field visit. The previous round of AI included smoke and dye testing, camera work, and microbial source tracking (MST). While racoons were observed in the pipe previously, human fecal contamination was also confirmed via MST. The previously identified recommendations included:

Figure 1. Pipe benthic growth at Outfall 14C.

- Completing additional *E. coli* sampling at key points along the stormline, especially upstream of the manhole at Lincoln Ave/Rugg St intersection and closer to the intersection with Fairfield Street.
- Clean the stormline and vector catchbasins along Lincoln Ave.
- Conducting additional camera work after the stormline has been cleaned to identify additional unknown connections or breaks.
- Sealing the sewer/stormline connection discovered at the catchbasin in front of 70 Lincoln Ave.
- Upon further *E. coli* sampling, consider additional MST sampling, dye testing, and smoke testing at key locations in the storm and sewer system.

The results found during the most recent round of sampling support these recommendations.

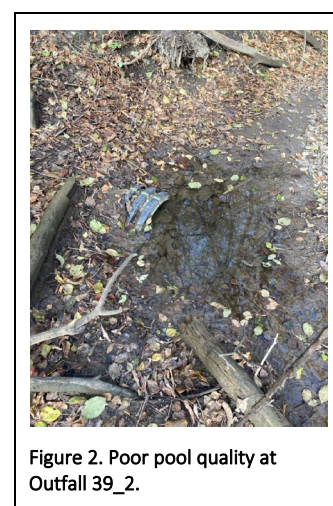
Outfall 39_2 is located east of the Department of Public Works and has previously been the subject of AI throughout the Public Works yard. The outfall is approximately 90% submerged and was noted to have poor pool quality, including staining of leaves and the pool bottom around the outfall (Figure 2). The conductivity measurement, ammonia, anionic surfactants, and chlorine concentrations were all above their respective threshold values. Due to the elevated ammonia reading, a laboratory sample was also collected and brought to Endyne Laboratories (Williston, VT) to measure *E. coli*. The Endyne analysis yielded a result of 2 MPN, indicating that *E. coli* contamination is very minimal. While AI has been completed at this outfall previously, it is clear that additional AI is still required, as well as general outfall remediation.

Figure 2. Poor pool quality at Outfall 39_2.

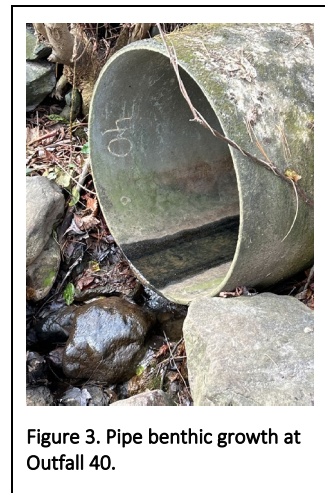
Outfall 40 is located behind the Four Winds subdivision located off North Elm Street. The outfall had flow present, though no flow-only indicators were noted. Orange benthic growth was noted in the bottom of the pipe (Figure 3). Anionic surfactant and chlorine concentrations both exceeded their thresholds. These findings indicate that AI is needed to locate the source of these elevated readings. AI was previously completed for this outfall in the Four Winds subdivision with no illicit discharges detected; it was determined at that time that further investigation of the stormline from Finn Ave was necessary. Catchbasin sampling in the Finn Ave section of the contributing storm system should be completed.

Figure 3. Pipe benthic growth at Outfall 40.

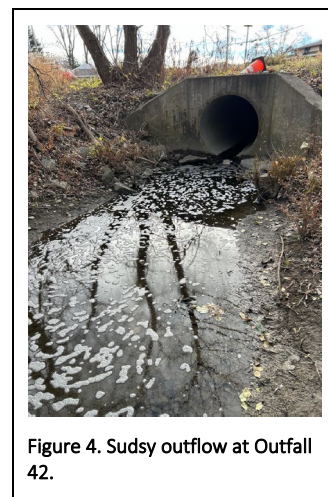
Outfall 42 is located where Lower Newton Street crosses Stevens Brook. The outflow from this outfall had a high degree of floatables (Figure 4). Brown pipe benthic growth was also noted in the bottom of the concrete pipe. All parameters measured within the normal range except for the anionic surfactant concentration, which was substantially elevated. The pH was also slightly elevated. AI may be necessary to determine the source of the elevated anionic surfactant reading and sudsy floatables.

Figure 4. Sudsy outflow at Outfall 42.
