**85-87 NORTH MAIN STREET  
ST. ALBANS, VERMONT**

**HISTORIC DOCUMENTATION**

***I. INTRODUCTION***

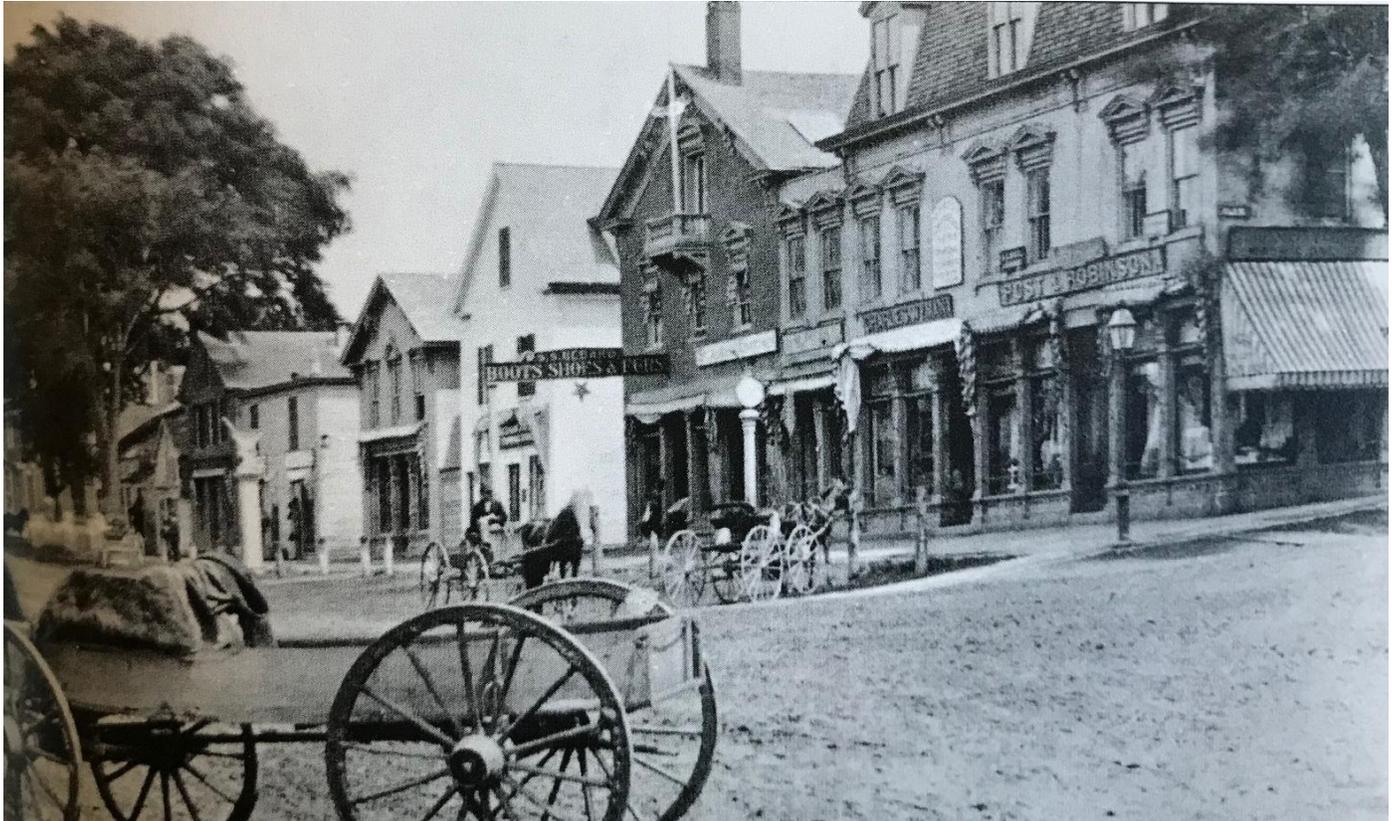
North Main Street c. 1880. The building at 85-87 is the flat roofed building on the left side of the photograph. It and a nearby building both have had their roofs raised and the roofline altered. Other buildings have been updated with Italianate trim and windows replacing Federal style windows. *Courtesy: Images of America- St. Albans, page 123.*

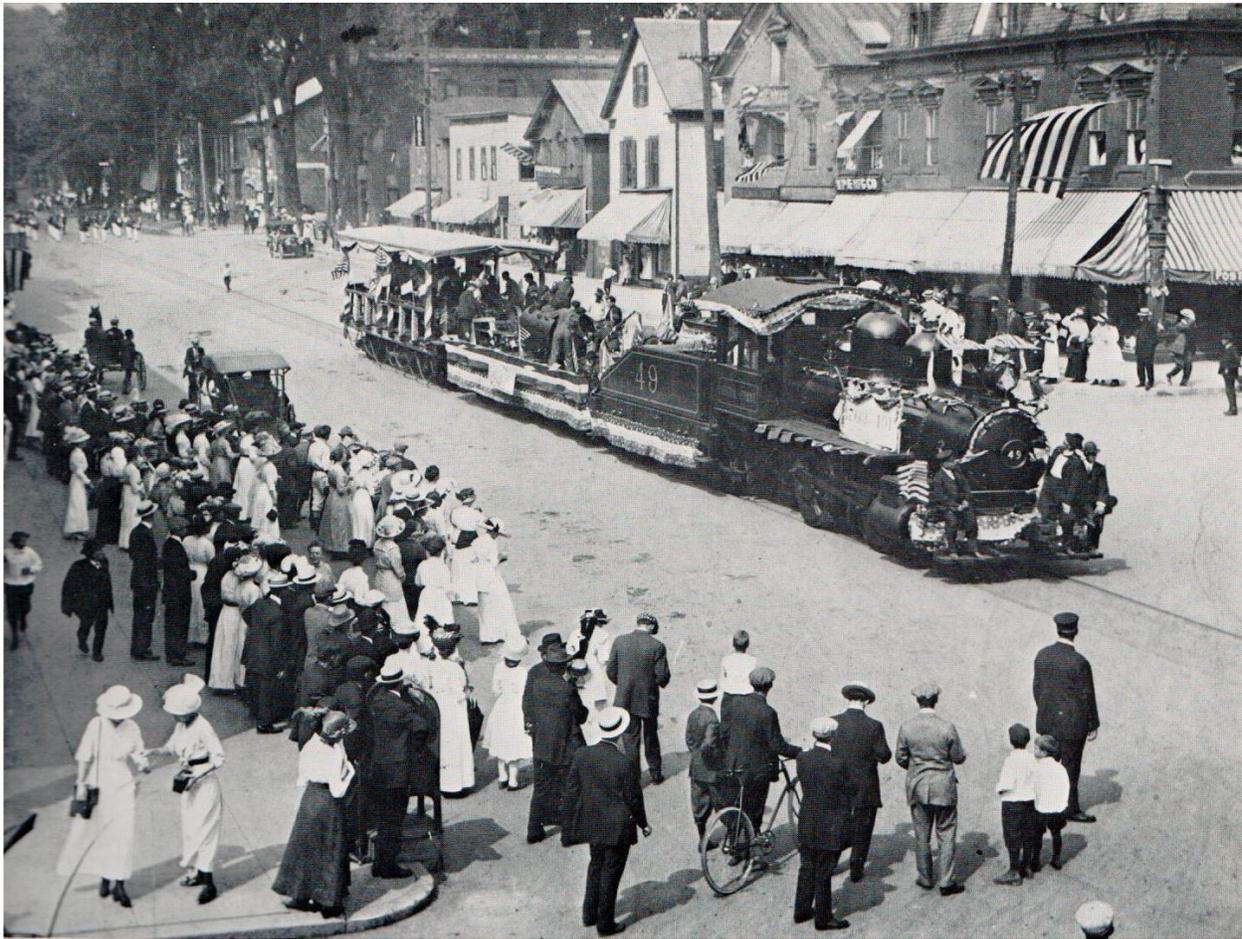
Photo taken in 1914 during a big celebration to celebrate 100 years of peace between the United States and Canada. The train is proceeding on streetcar tracks. 85 North Main is the flat roofed building in the center of the image. *Courtesy of The Central Vermont Railway, Volume 3, 1911-1917, page 55.*

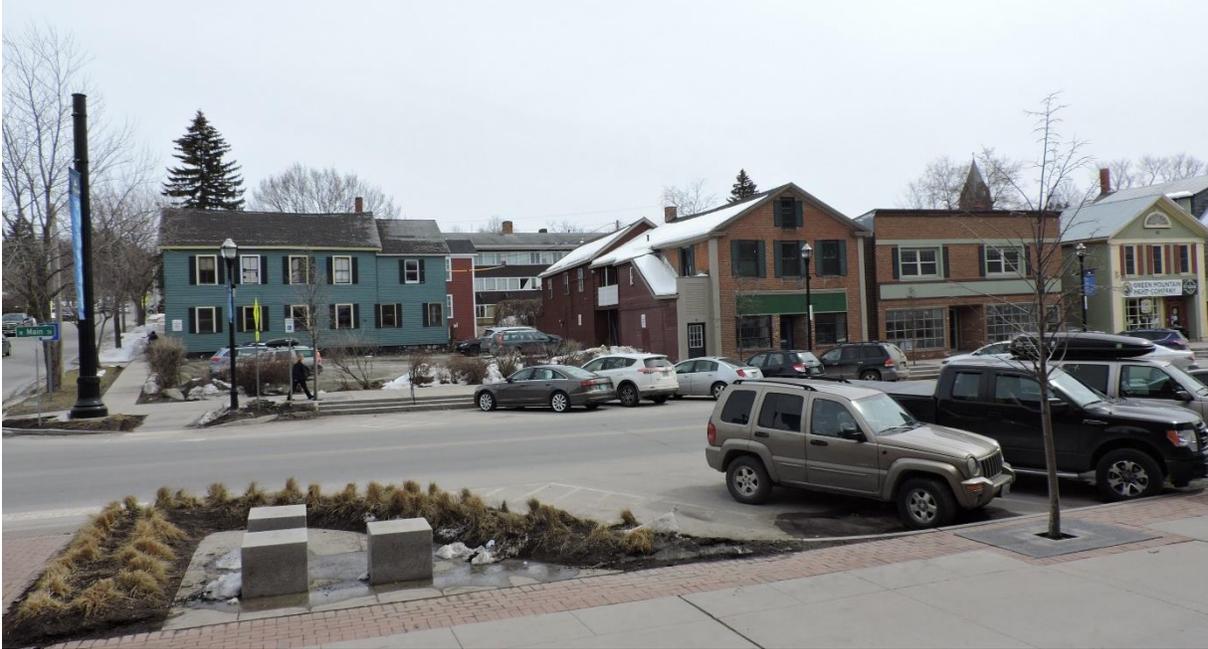
1. View east across North Main Street. #85-87 second from right.

- 1.** View east across North Main Street. #85-87 second from right.
- 2.** View south on North Main Street. #85-87 second from left.
- 3.** View east across North Main Street. 85-87 on right.

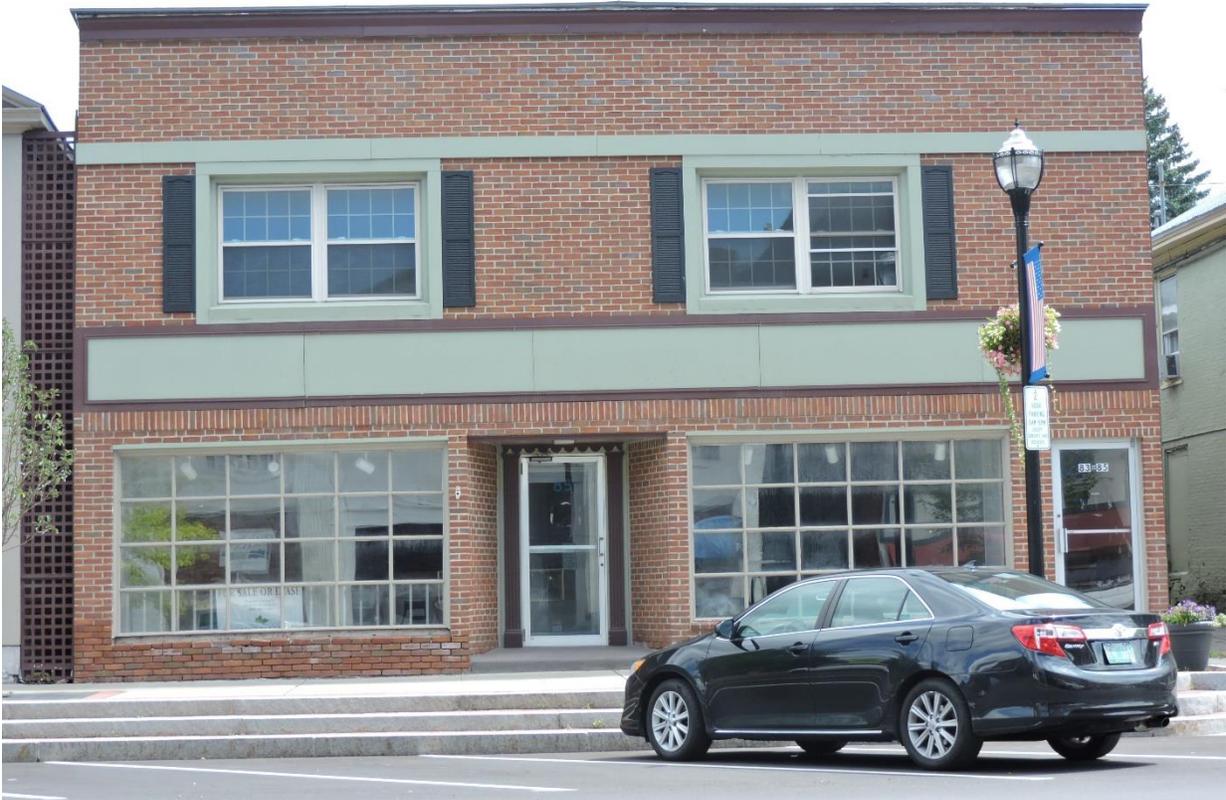
4. View east at front of building.

The front (west) elevation facing North Main Street has a recessed plate glass door offset to the north entering into the storefront area. The door has a surround of fluted pilasters and a narrow molded scalloped cornice. A plate glass door with a row of header bricks above it, enters into the building at the southern end of the front elevation accessing stairs to the second floor. Flanking the central door are angled brick walls and very large 24 pane fixed glass display windows with brick sills. A band of vertically set bricks runs almost the full width of the building above the first floor windows and doors. Above this, a broad wood signboard spans the front of the building separating the first floor from the second. On the second floor are two pairs of modern eight-over-eight windows (8/8) that are slightly recessed and have flat wood trim and modern shutters. A simple wood belt course runs above the windows. There is a two-part cornice band at the eave.

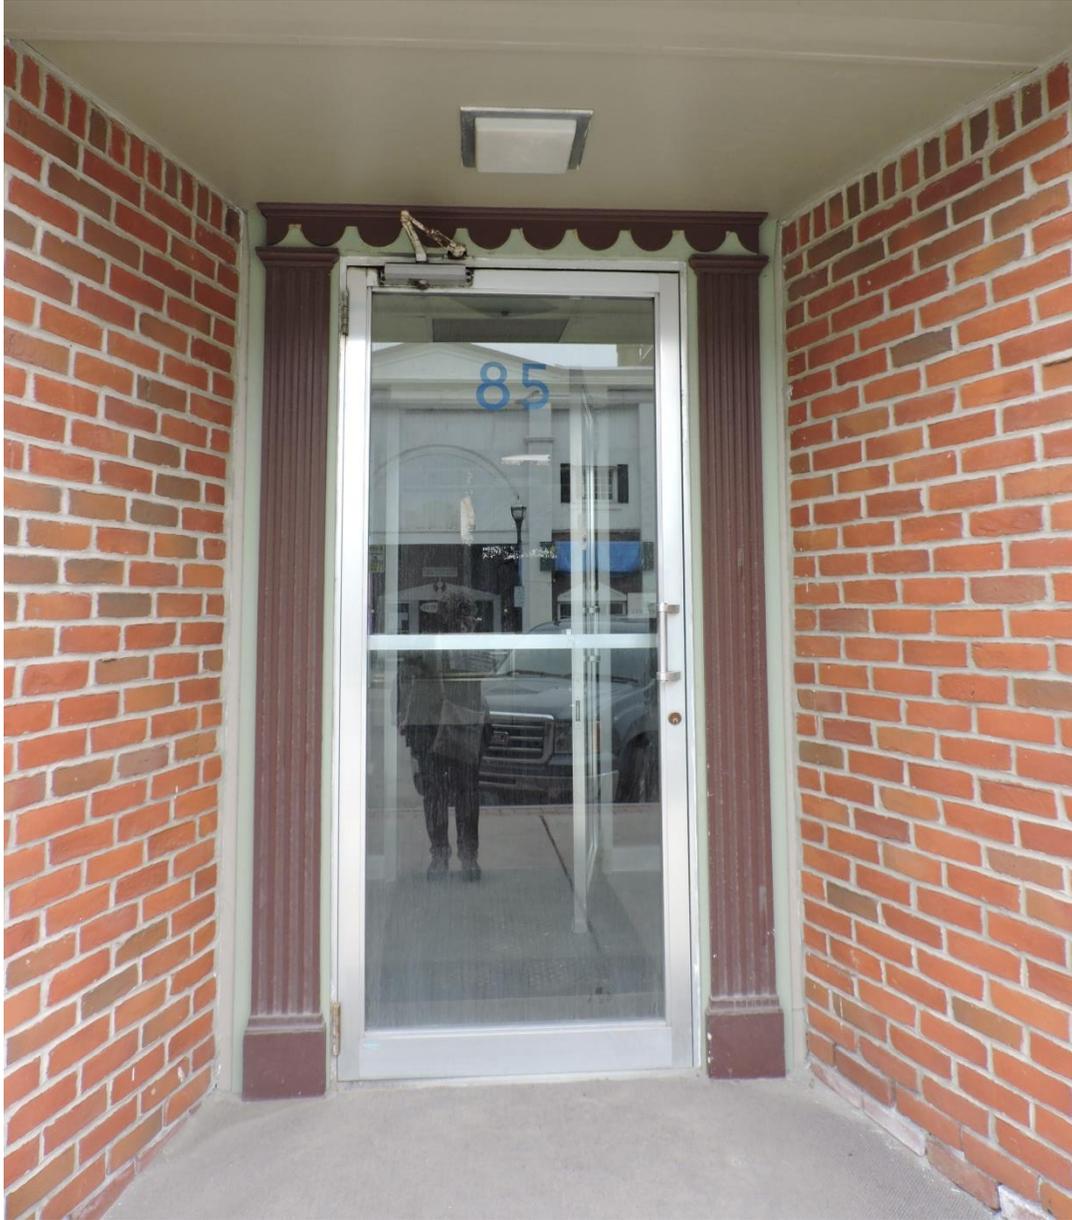
5. View east at center front door to commercial space.

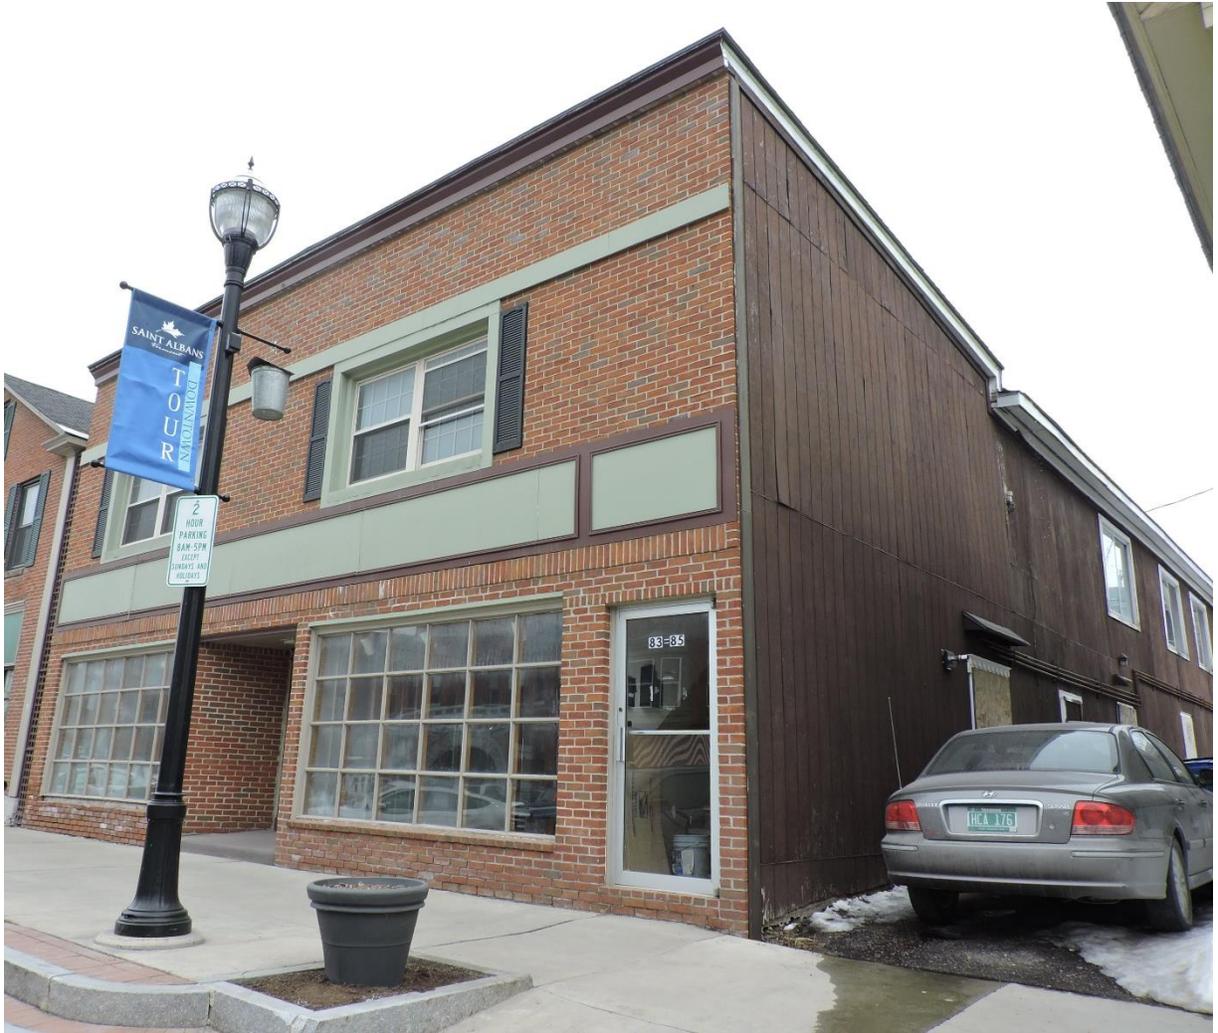
6. View northeast at front (west) and south sides.

The south side of the main block is covered with T1-11 siding and has no windows and a single door on the first floor that is covered with plywood. The door has a molded scalloped cornice similar to that on the front elevation. A narrow pent hood shelters the door. The north side of the main block has corrugated vertical metal siding.

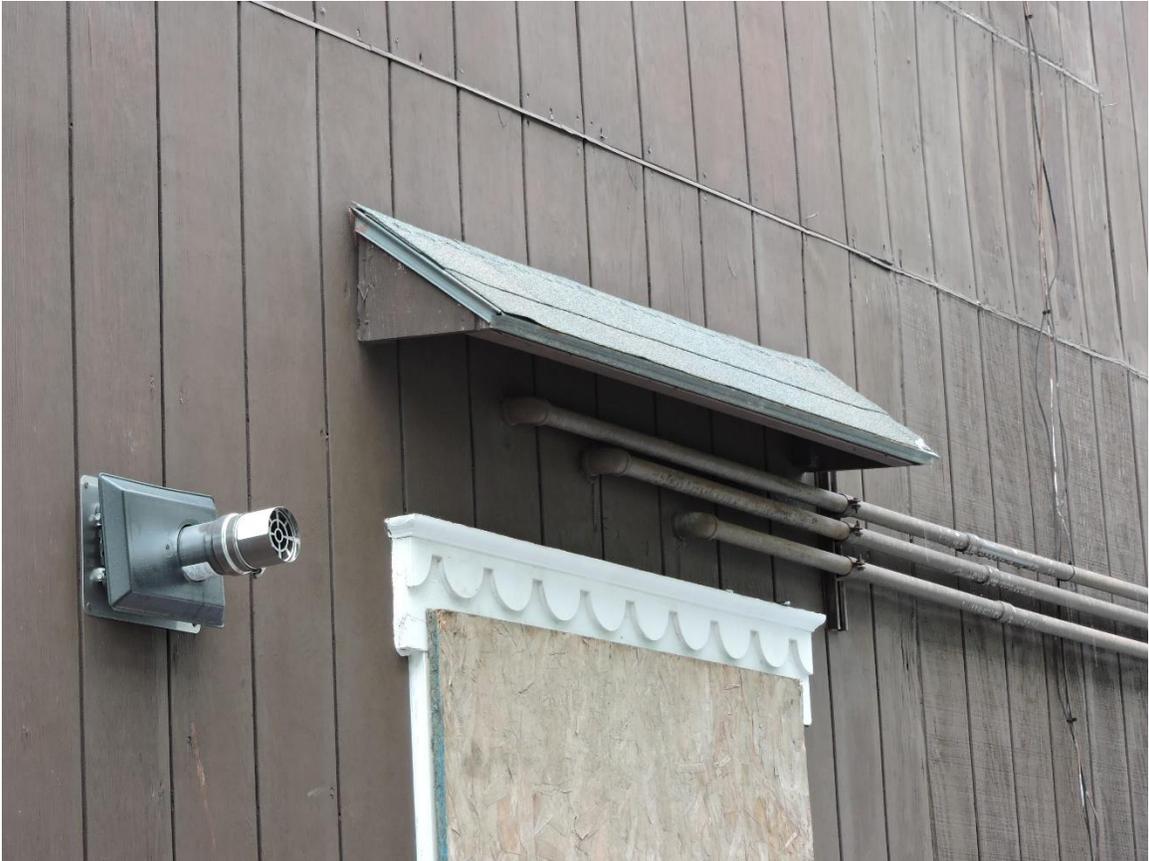
7. View northeast at boarded up door on south side of main block with molded scalloped cornice.

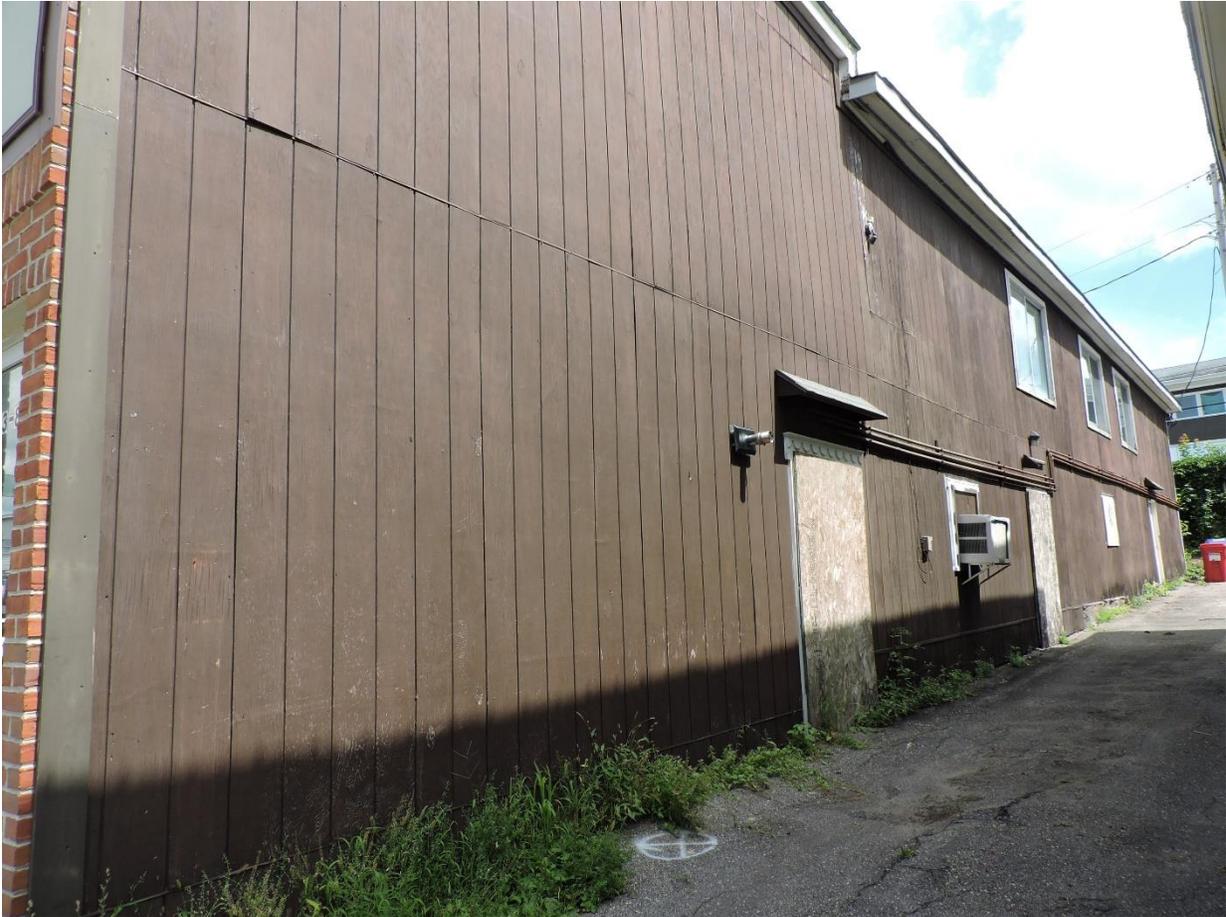
8. View northeast at south side of main block and rear addition.

The rear addition has T1-11 siding and flat wood corner boards, window trim and a boxed cornice with broad eaves. The south side of the rear addition has five bays on the first floor alternating doors and 1/1 windows. There are three sliding windows on the second floor which are typical of second floor windows throughout the addition. Doors have been covered with plywood and have small pent hoods. The back (east) side has no windows on the first floor and two sliding windows on the second floor. The north side is obscured by the adjacent building at 89 North Main Street..

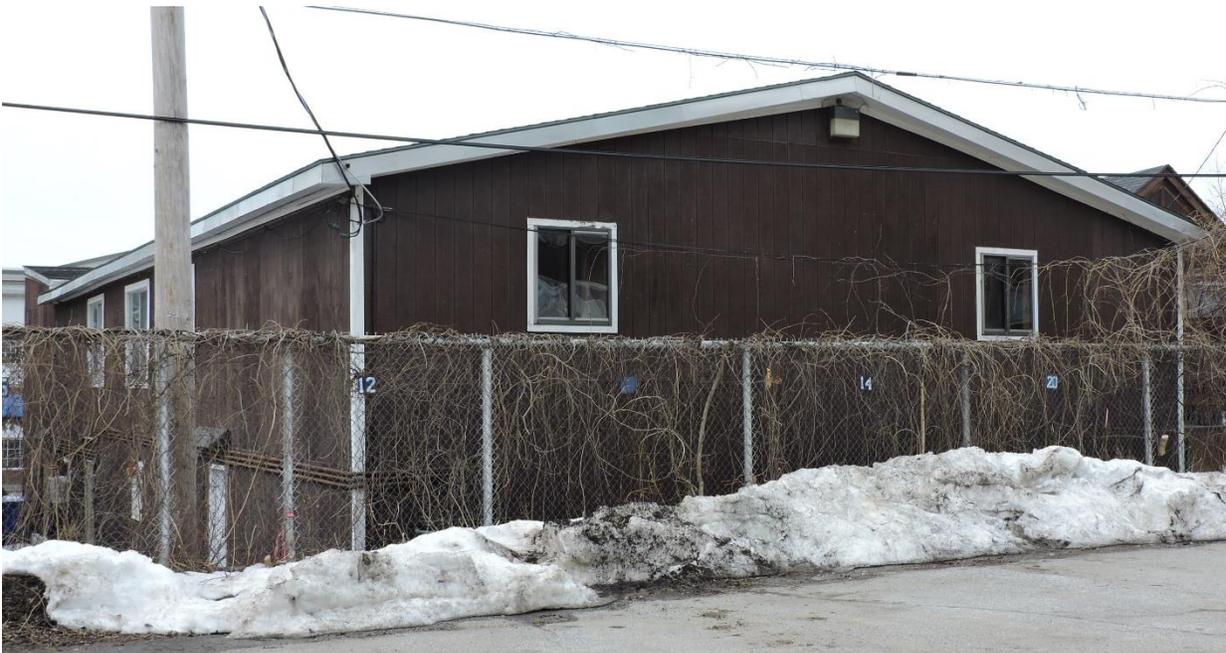
9. View west at addition's south and rear (east) sides.

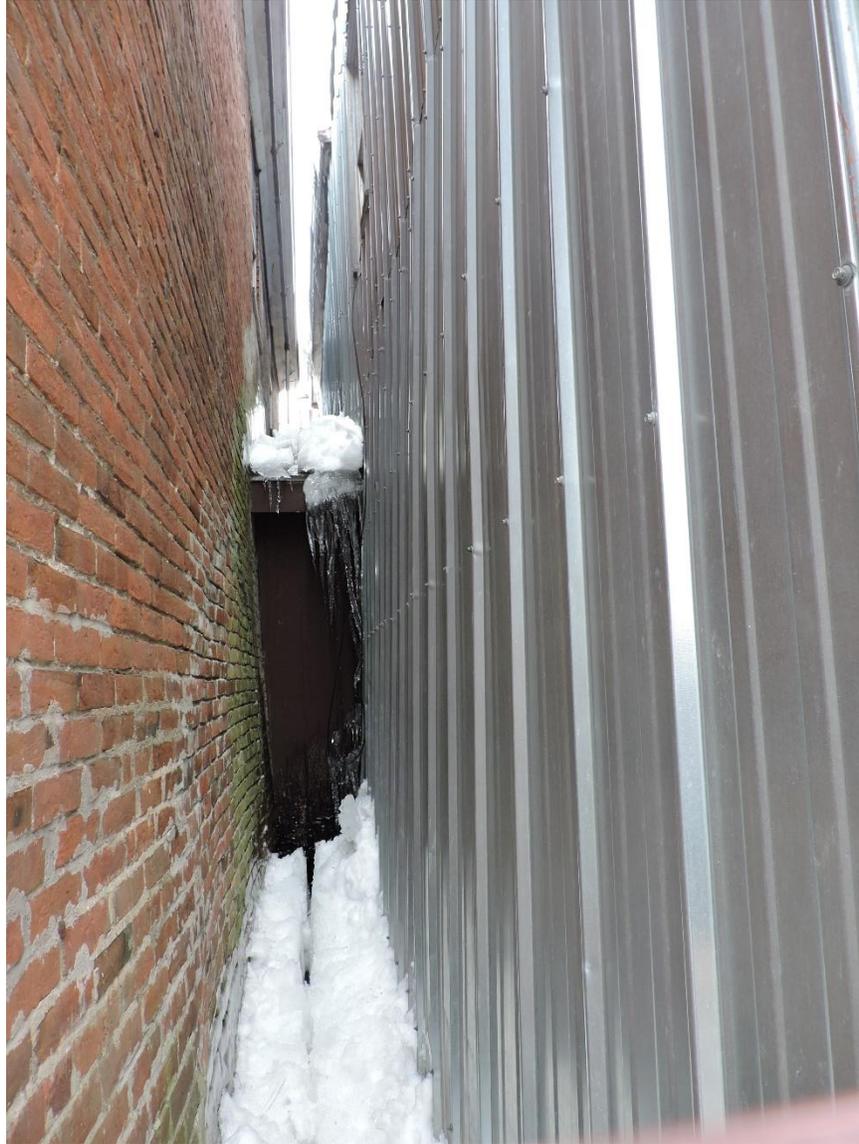
10. View east at north side of building on right. Wall of 89-91 on left.

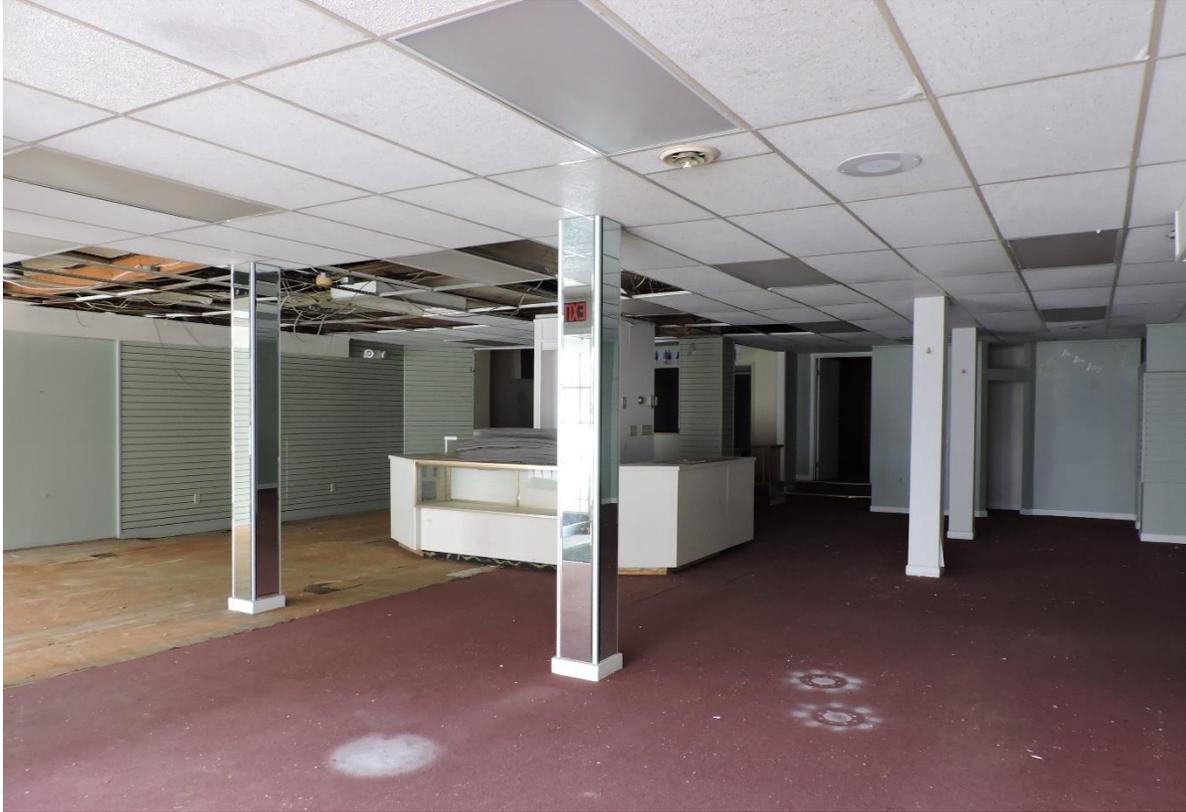
11. View east in first floor storefront.

The first floor of the main block contains a single open commercial space with modern finishes. The floor is carpeted, walls are sheetrock or paneling with clamshell trim, the ceiling has fiberboard tiles on a metal grid. Square posts with mirrors are scattered throughout. The first floor of the addition has a mix of living spaces and storage areas all with modern materials. In living units, floors are carpeted or sheet vinyl, walls are sheetrock or sheet paneling with clamshell or flat stock trim and ceilings are sheetrock or fiberboard tile on a metal grid. Storage portions of the rear addition have painted pine board flooring, vertical panel wood doors that open into storage rooms with roughly constructed plywood walls and ceilings. Exposed framing in the rear addition of the building is all dimensional lumber which is consistent with its construction in the 19-teens.

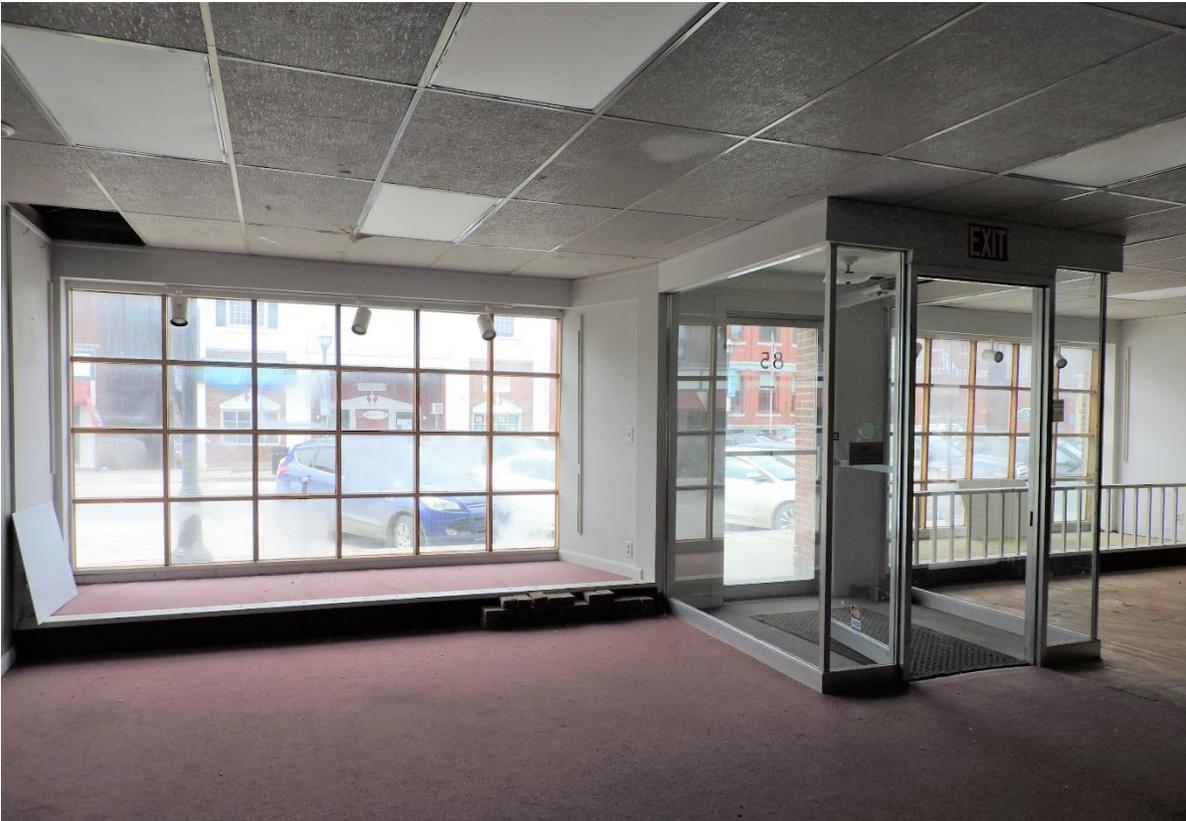
12. View west in first floor storefront.

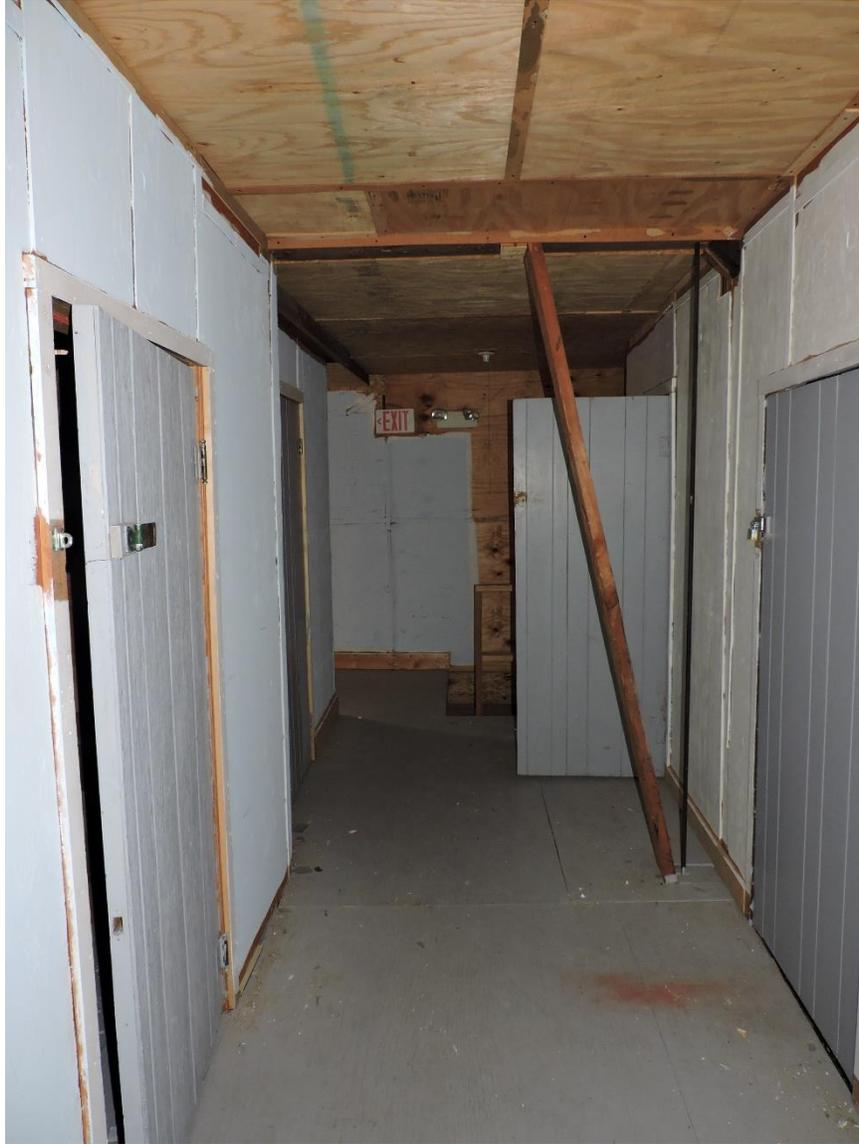
13. View east in first floor storage areas in rear addition.

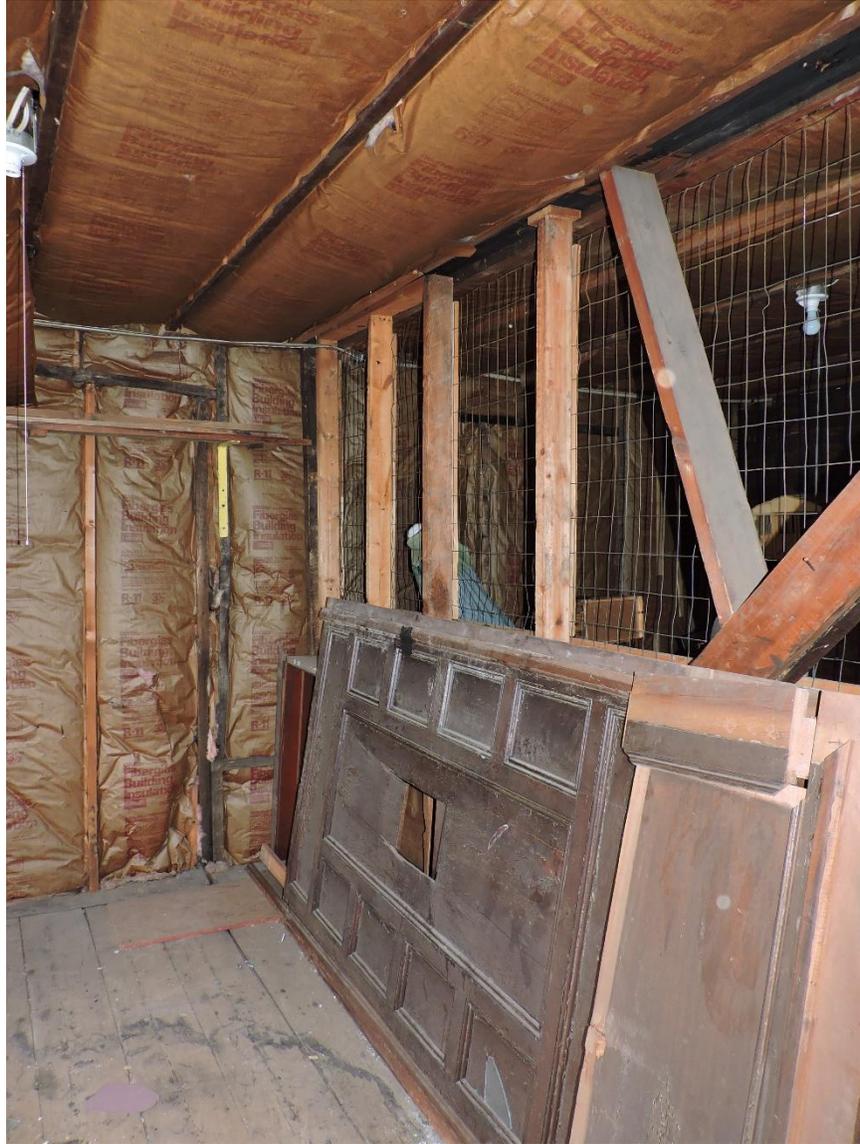
14. View south in unfinished first floor storage areas in rear addition.

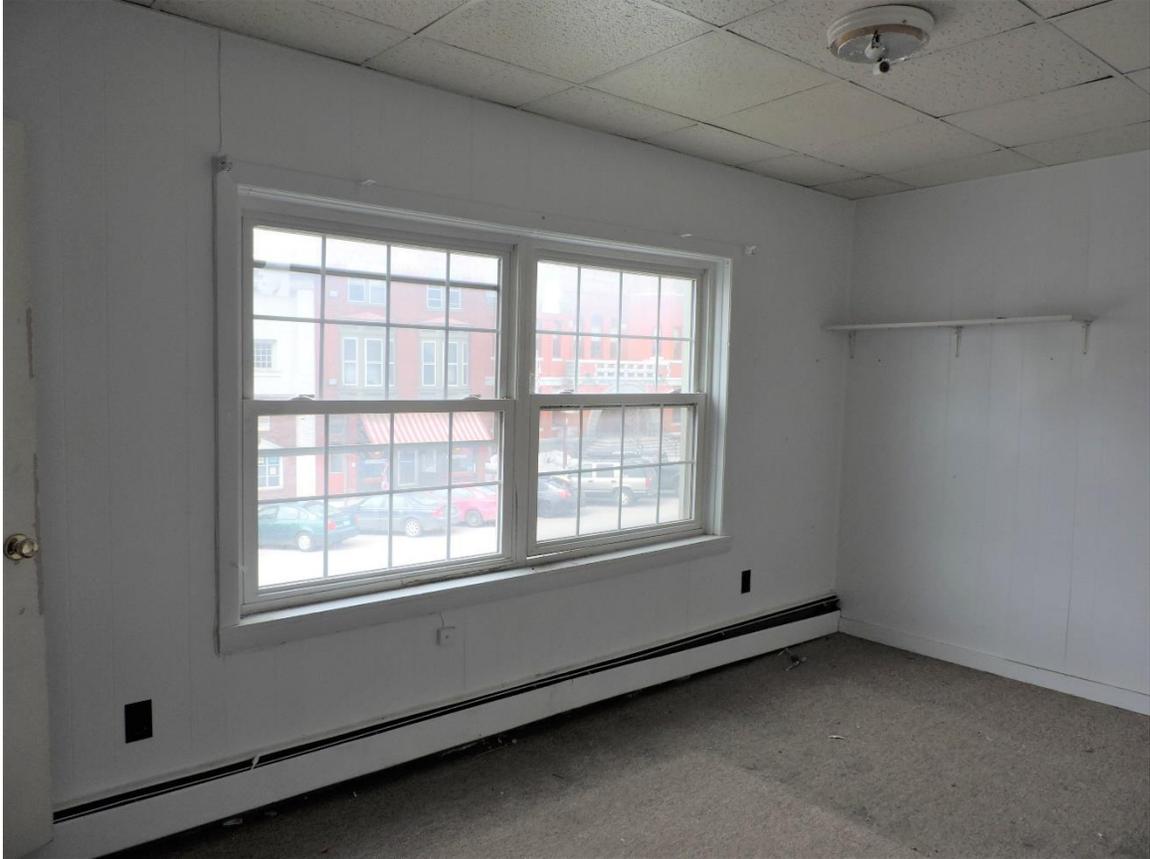
15. View west on second floor at west side front windows.

The second floors of both the main block and addition contain living units with modern finishes. Floors are carpeted or sheet vinyl, walls are sheetrock or paneling with clamshell or flat stock trim, ceilings are sheetrock or fiberboard tile on a metal grid and doors are flush wood.

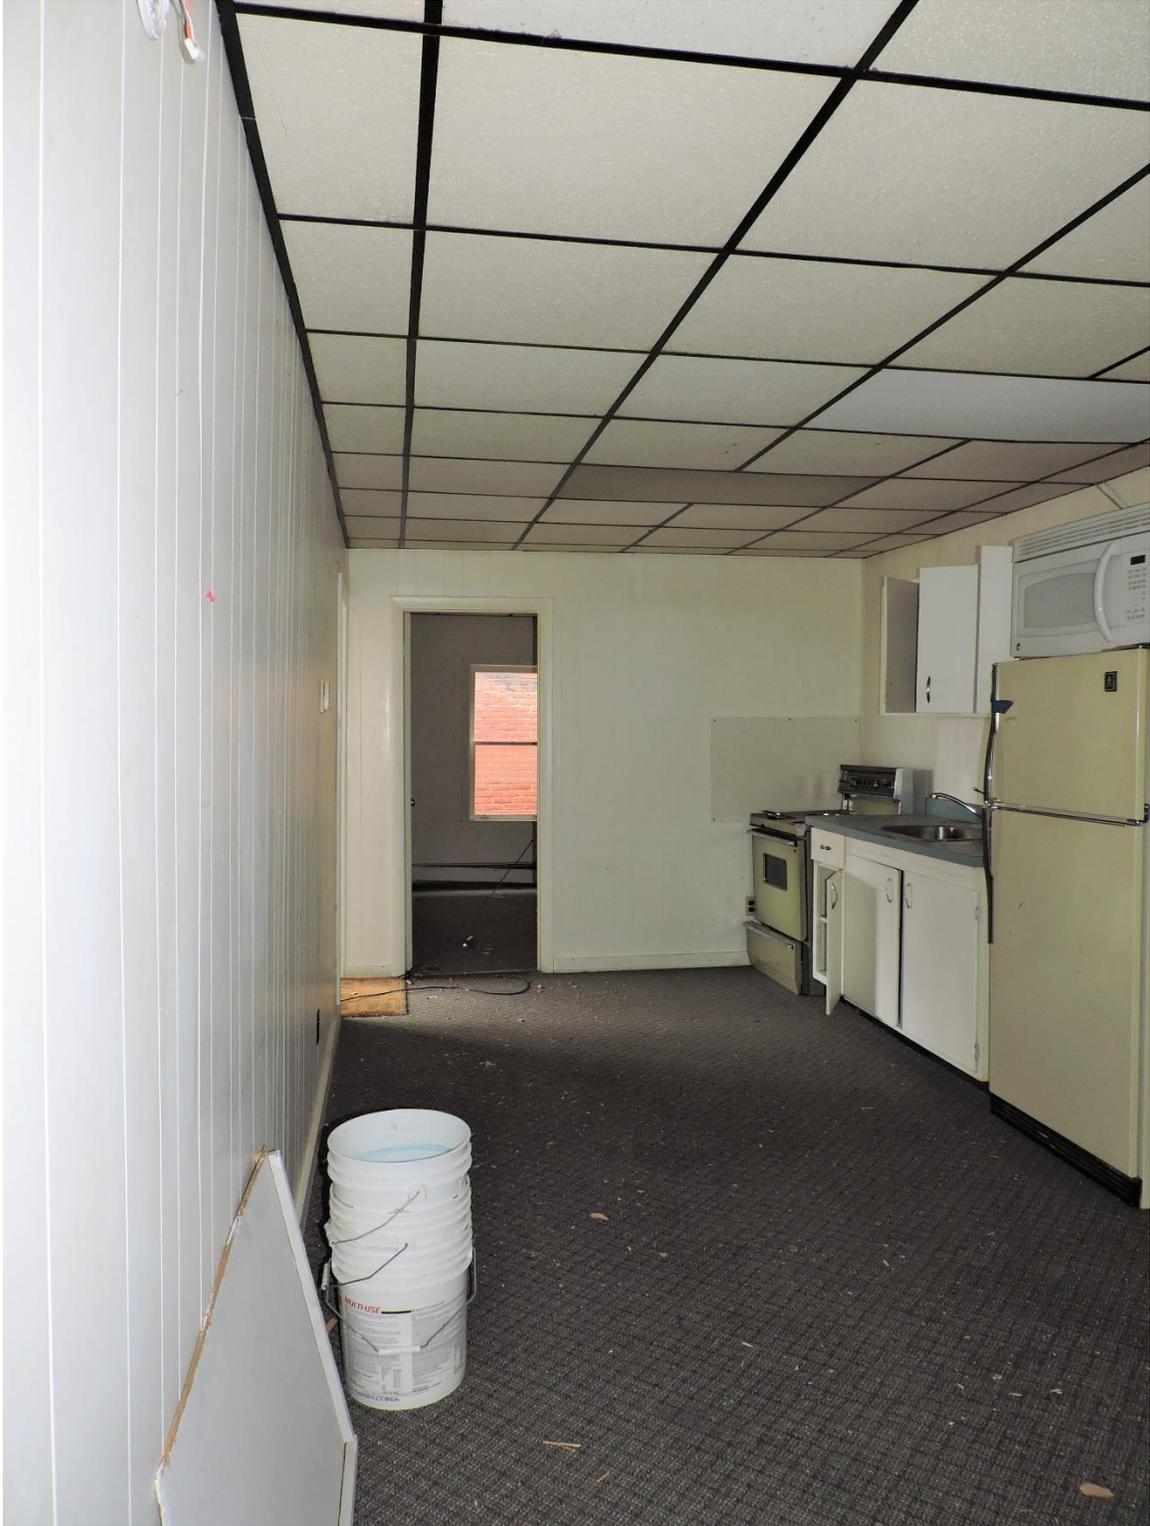
16. View north in second floor living unit.

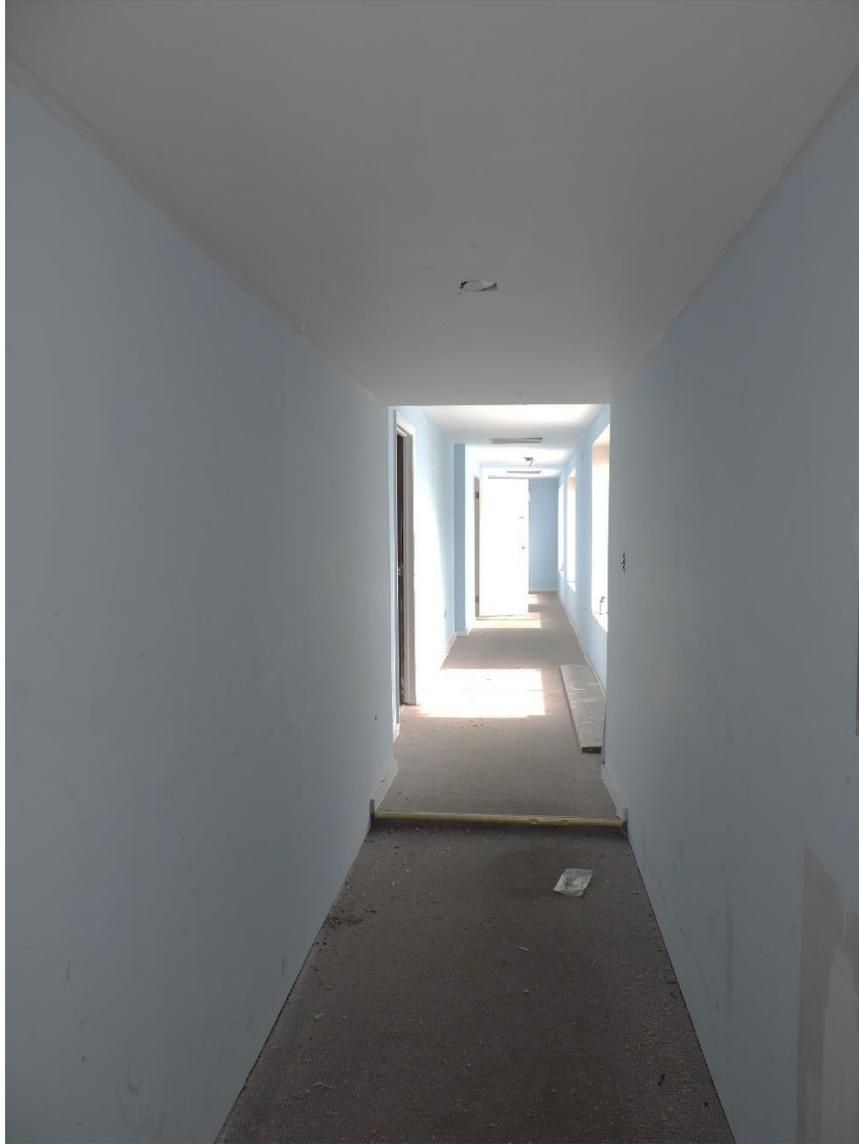
17. View east in second floor hallway in rear addition.
