A. Permittee Information	
1. Name of MS4:	
2. Permit Number: - 9014	
B. Minimum Control Measures	
1. Public Education and Outreach	
1.1 Website address:	
1.2 Participation in Regional Outreach Strategy <input type="checkbox"/> No <input type="checkbox"/> Yes, summary of activities attached

2018 REPORT – CITY OF ST ALBANS – ILLICIT DISCHARGE DETECTION AND ELIMINATION STUDY

ST ALBANS, VERMONT

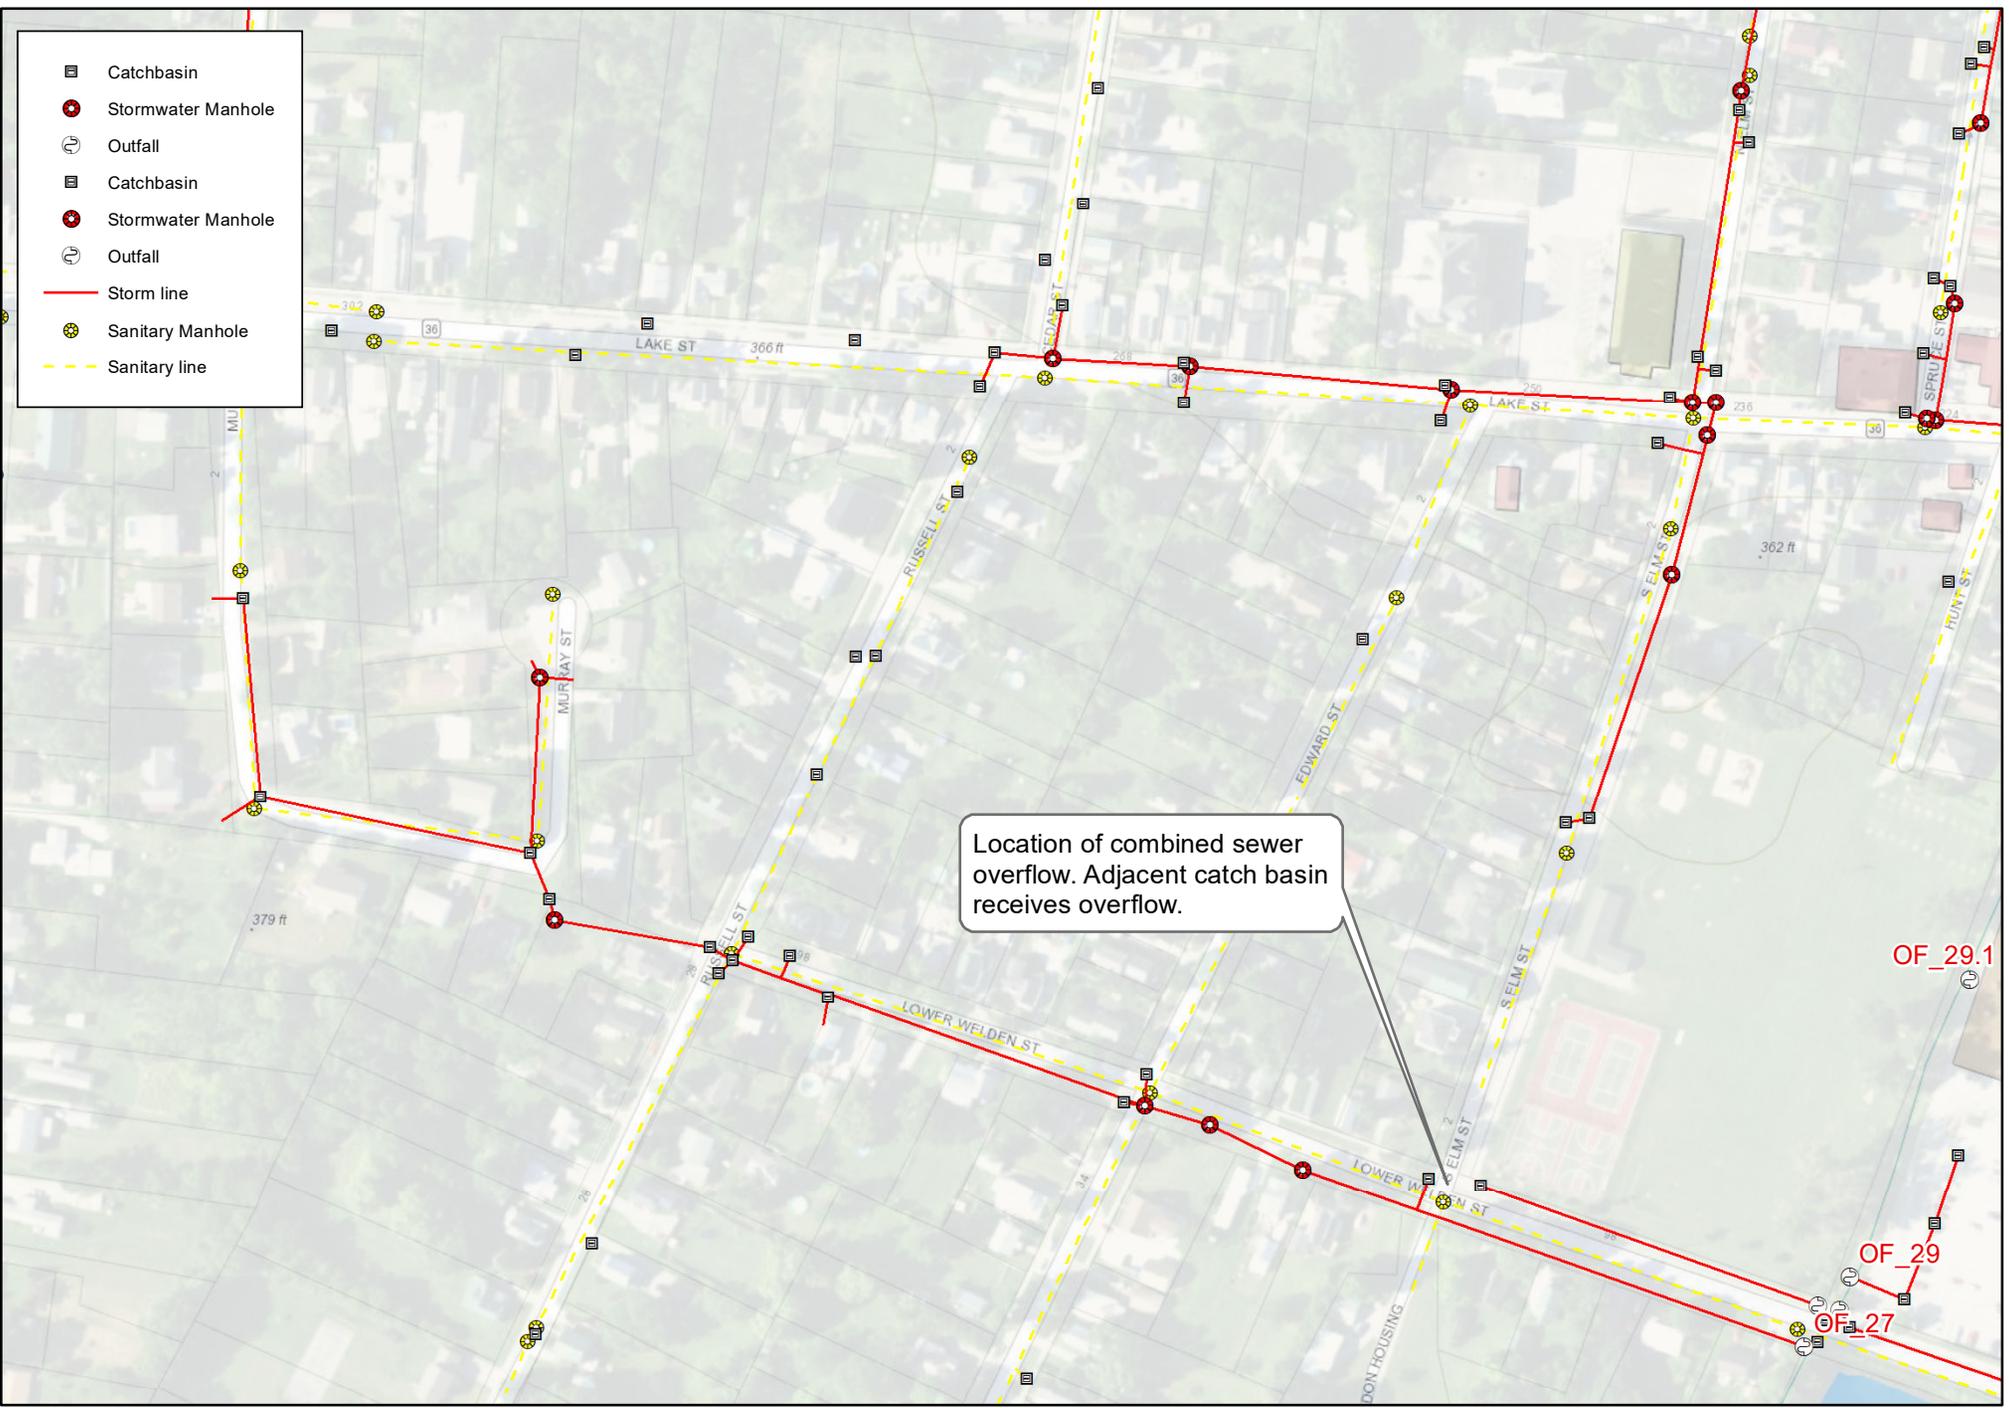
St. Albans IDDE AI - Summary Map
Outfall 26

Location of combined sewer overflow. Adjacent catch basin receives overflow.

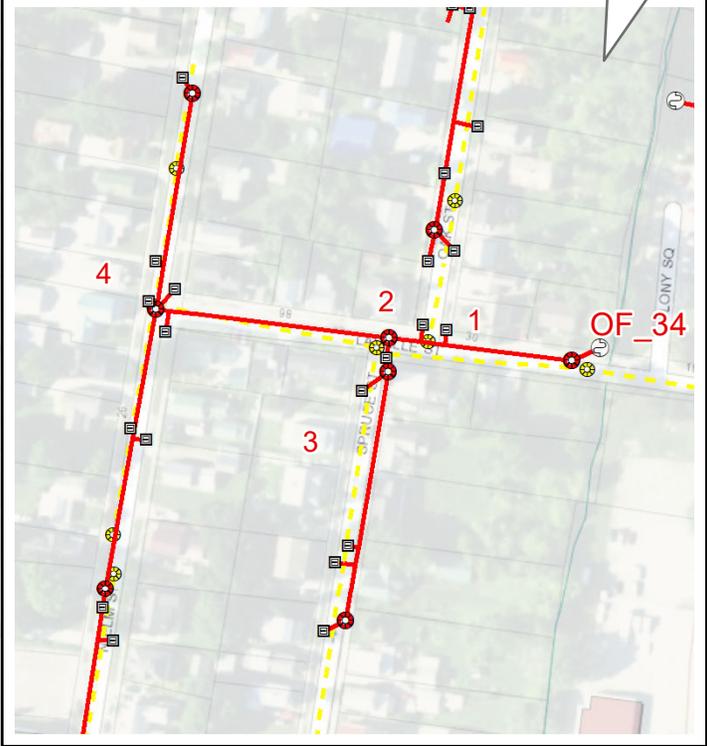
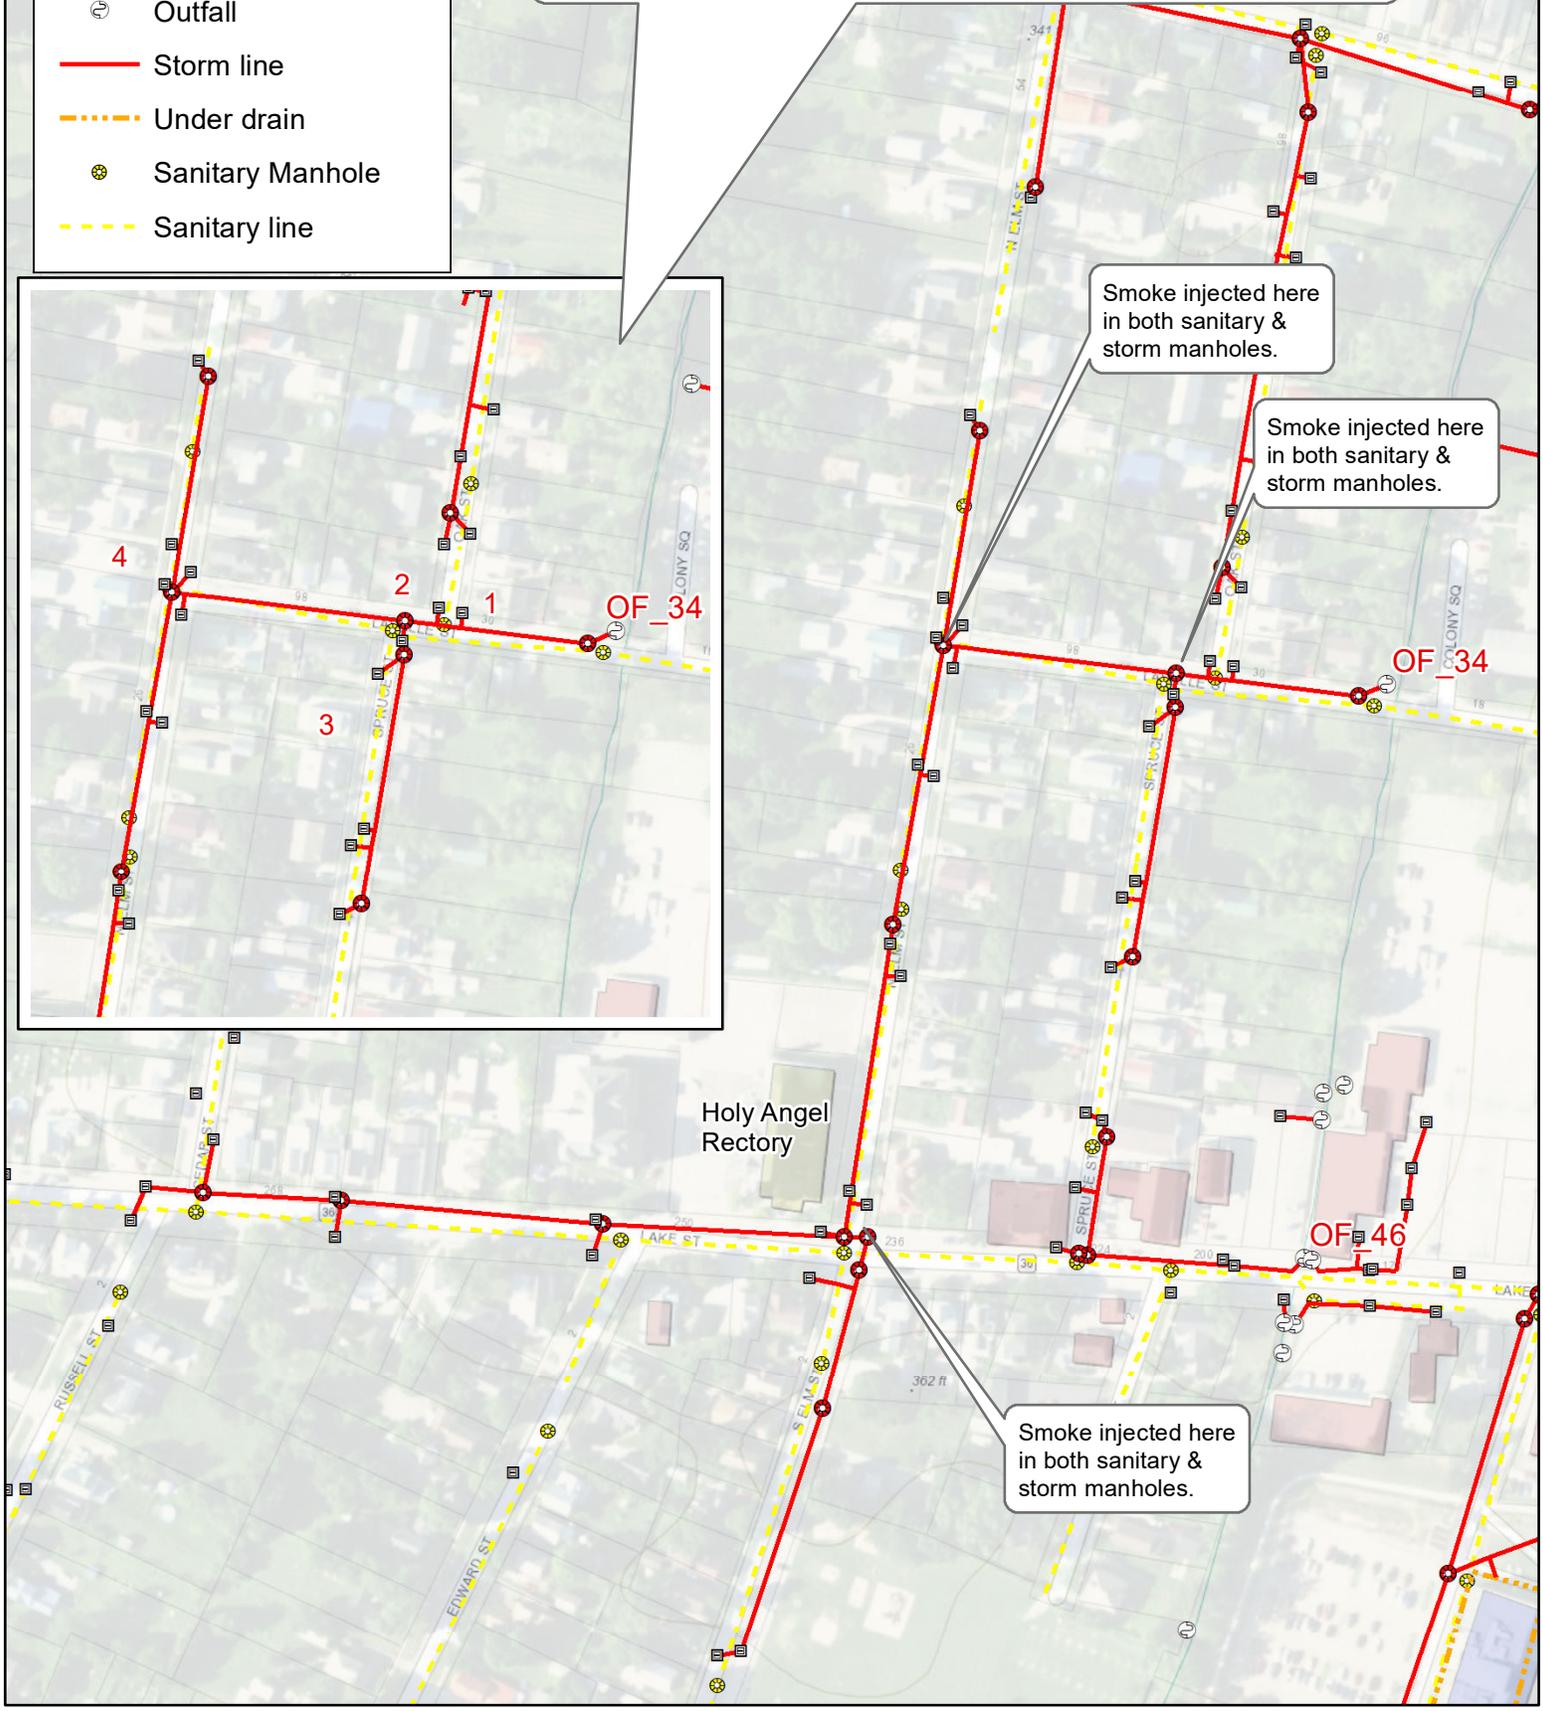
- 1: Sewer gas leak from near washer/dryer in rental house
- 2: Sewer gas leak from cracked pipe in basement (referred to plumber)
- 3: Sewer gas leak from corner of foundation in basement (referred to plumber)
- 4: Sewer gas leak in house from improperly capped pipe. Homeowner to repair.

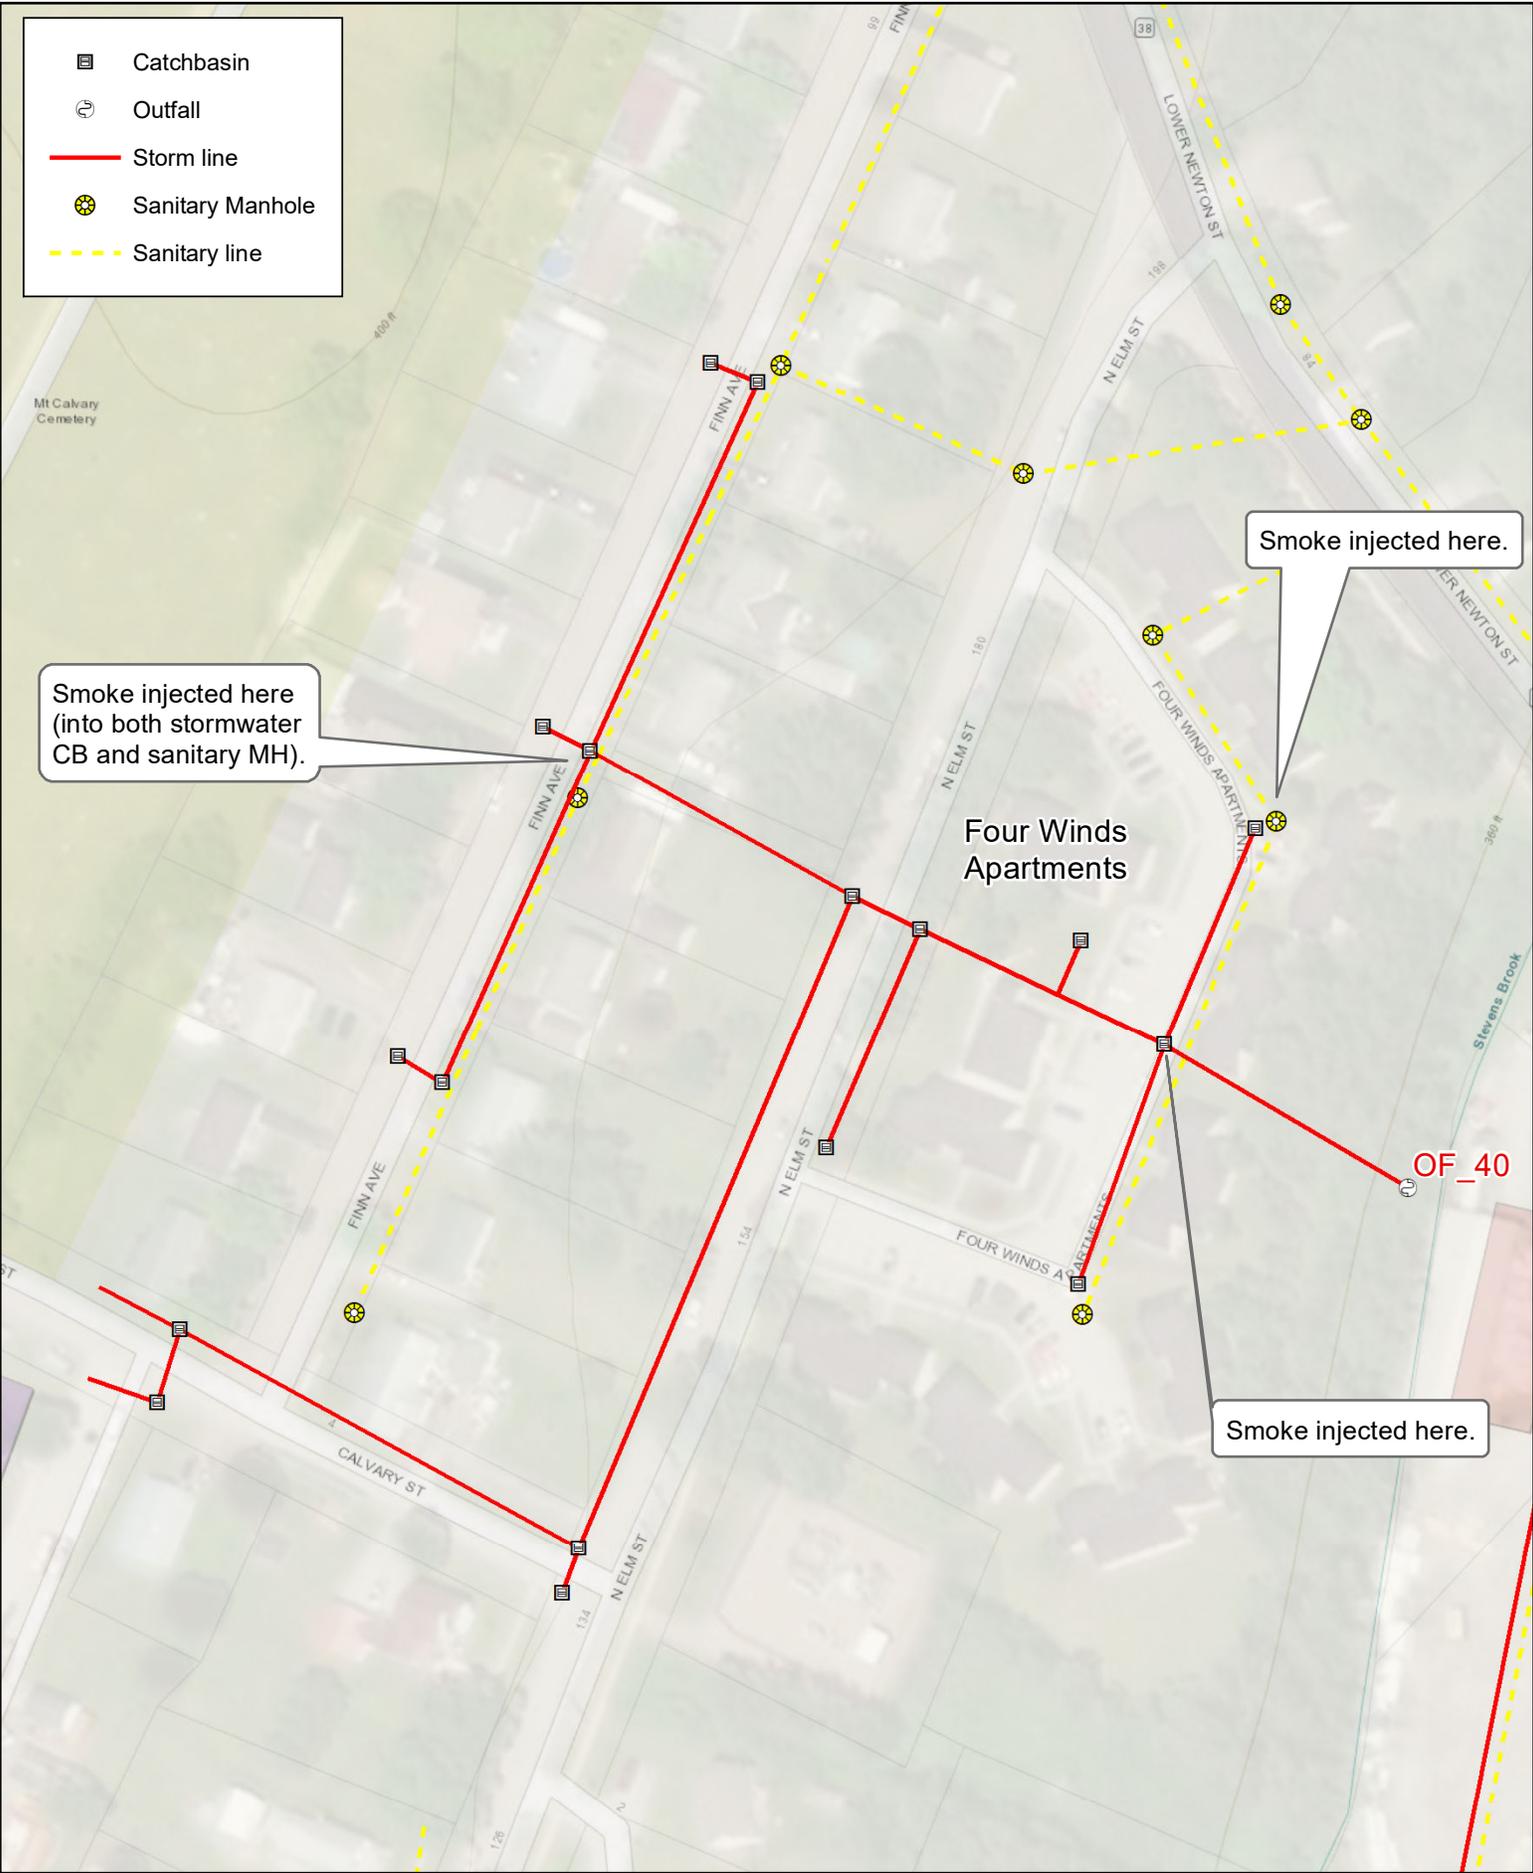
Smoke injected here
(into both stormwater
CB and sanitary MH).

Smoke injected here.

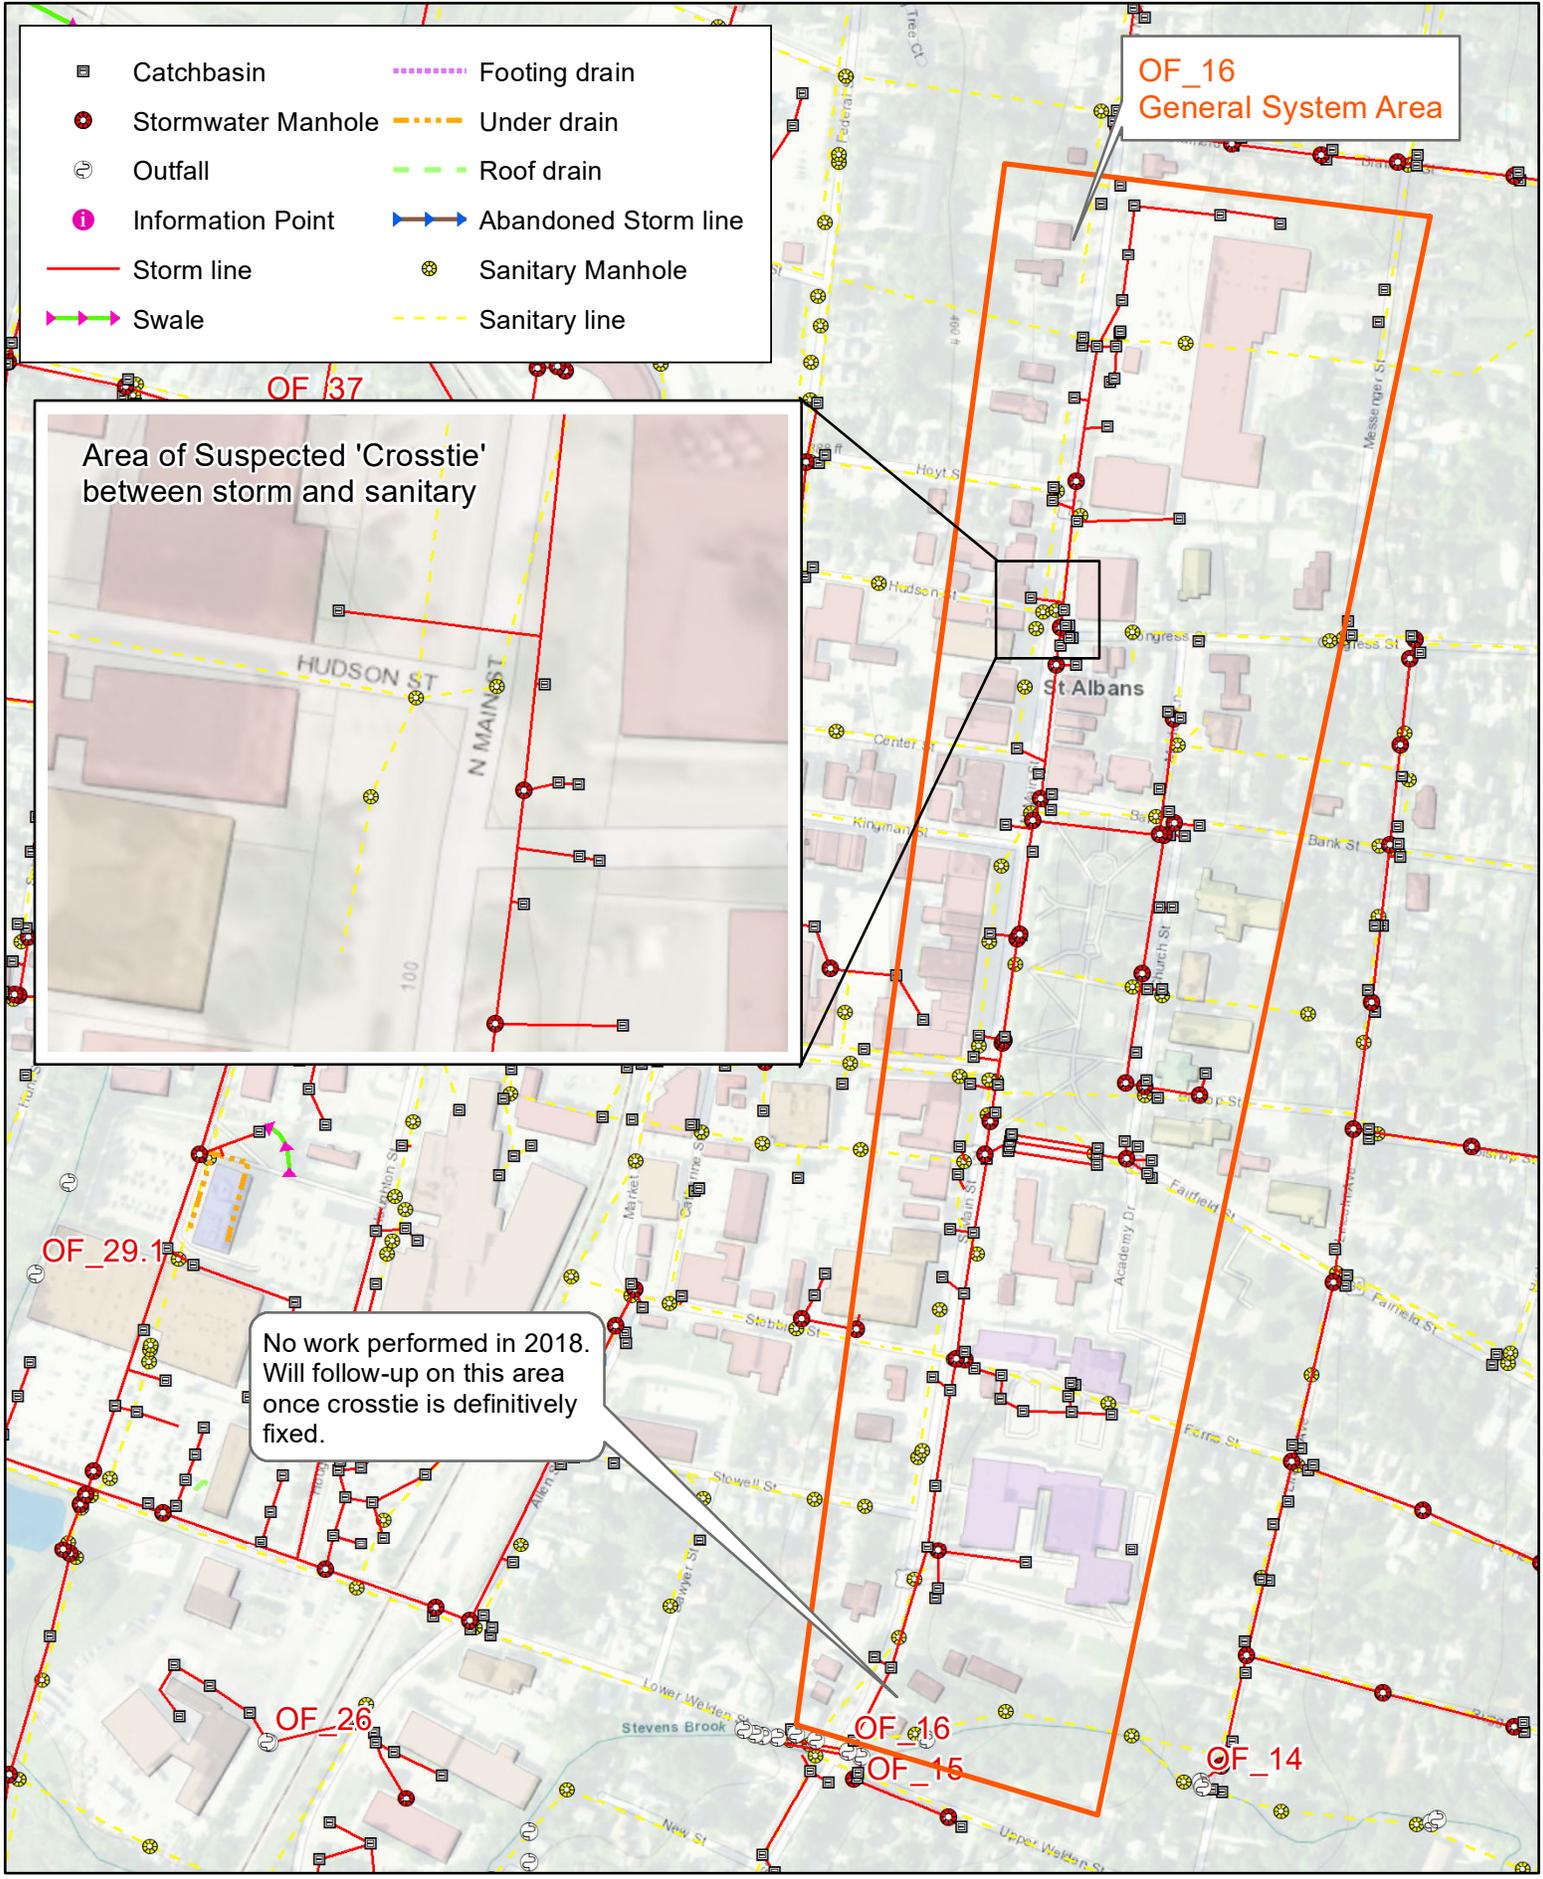
No work performed in 2018.
Will follow-up on this area
once crosstie is definitively
fixed.
