St. Albans Historic District

ST. ALBANS, VT

Natl Register listed
in 1979

RE: St. Albans Historic District

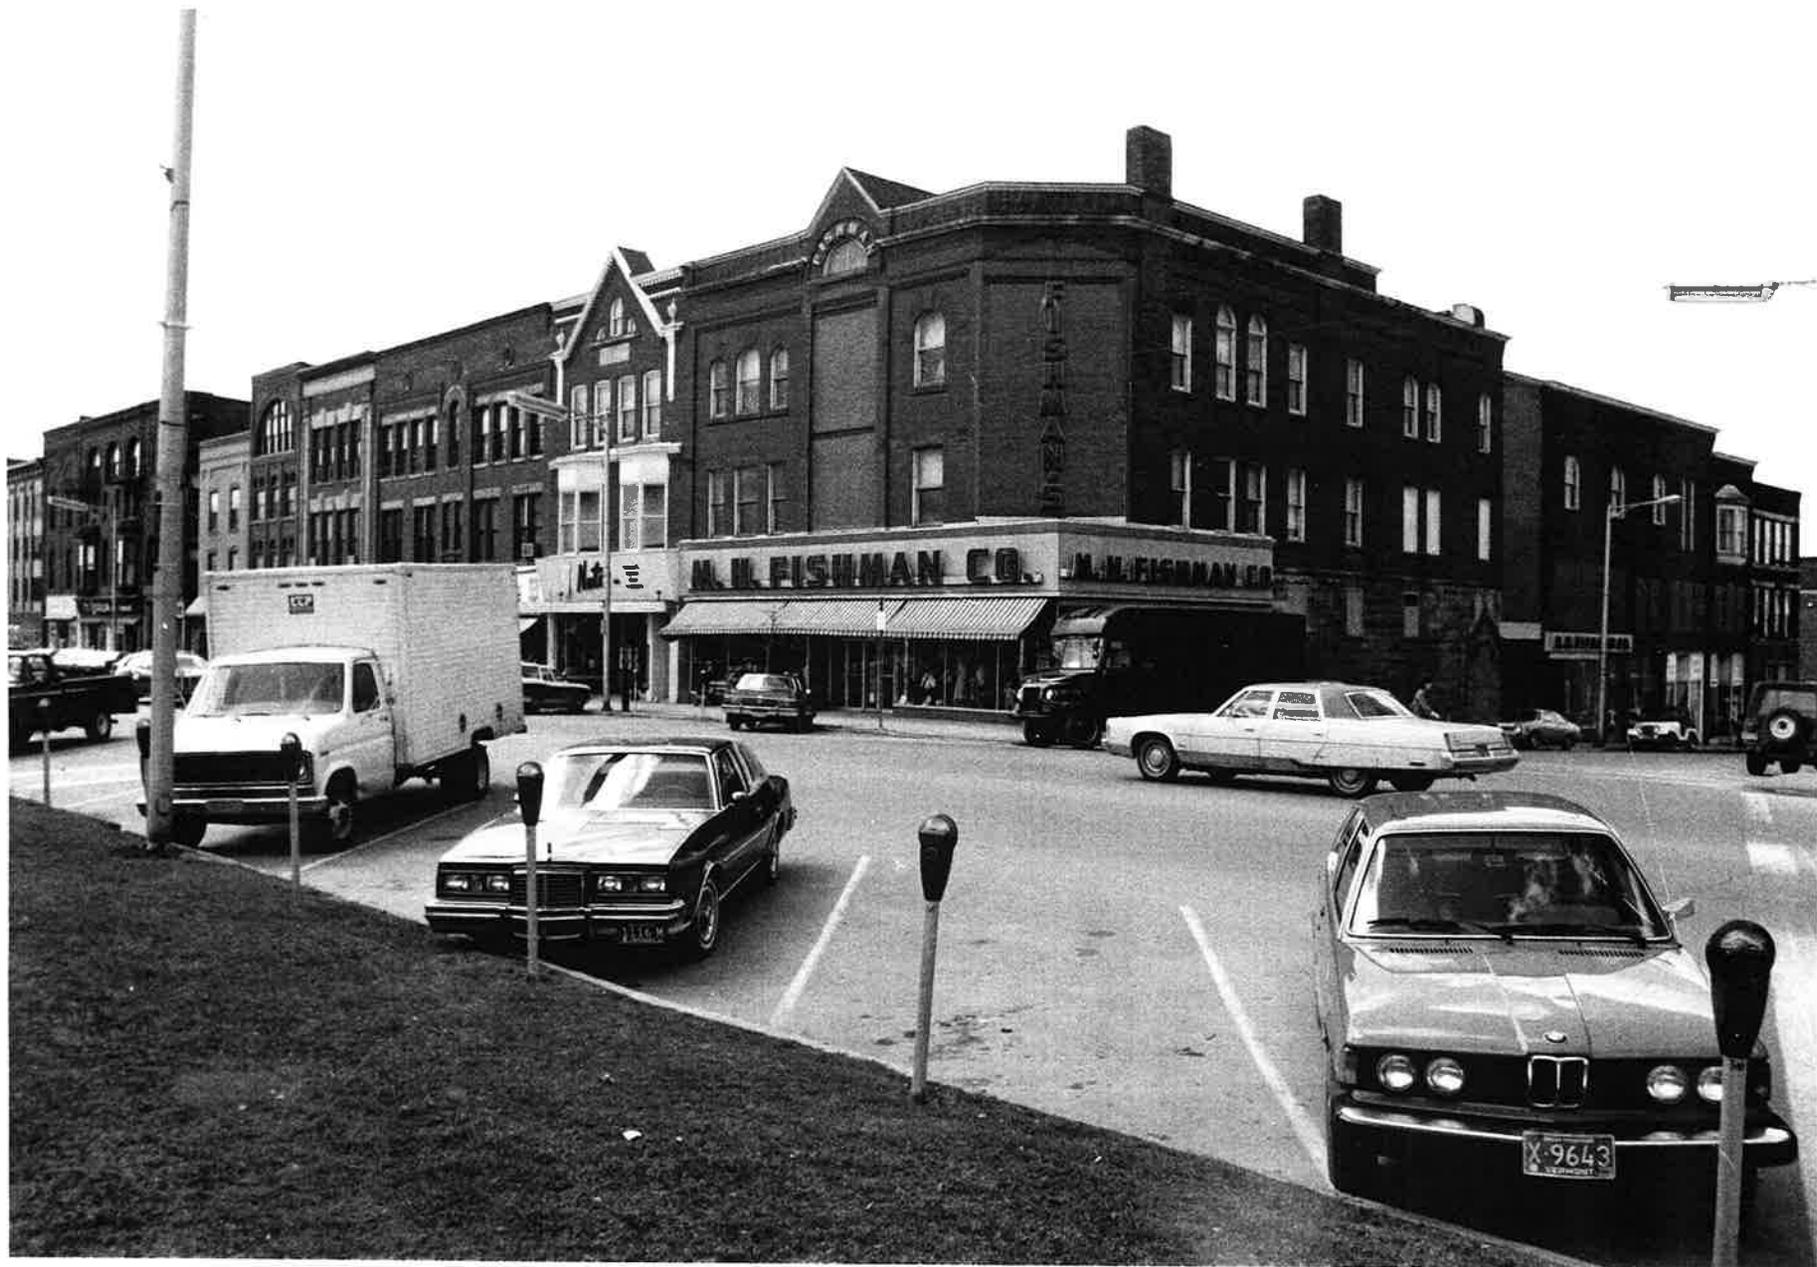
79-A-43

St. Albans Historic District
St. Albans, Vermont
Credit: Margaret DeLaittre
Date: November, 1979
Negative filed at Vermont Division for
Historic Preservation
Description: West side of Main Street,
South of Kingman Street; View looking
Southwest
Photograph 3

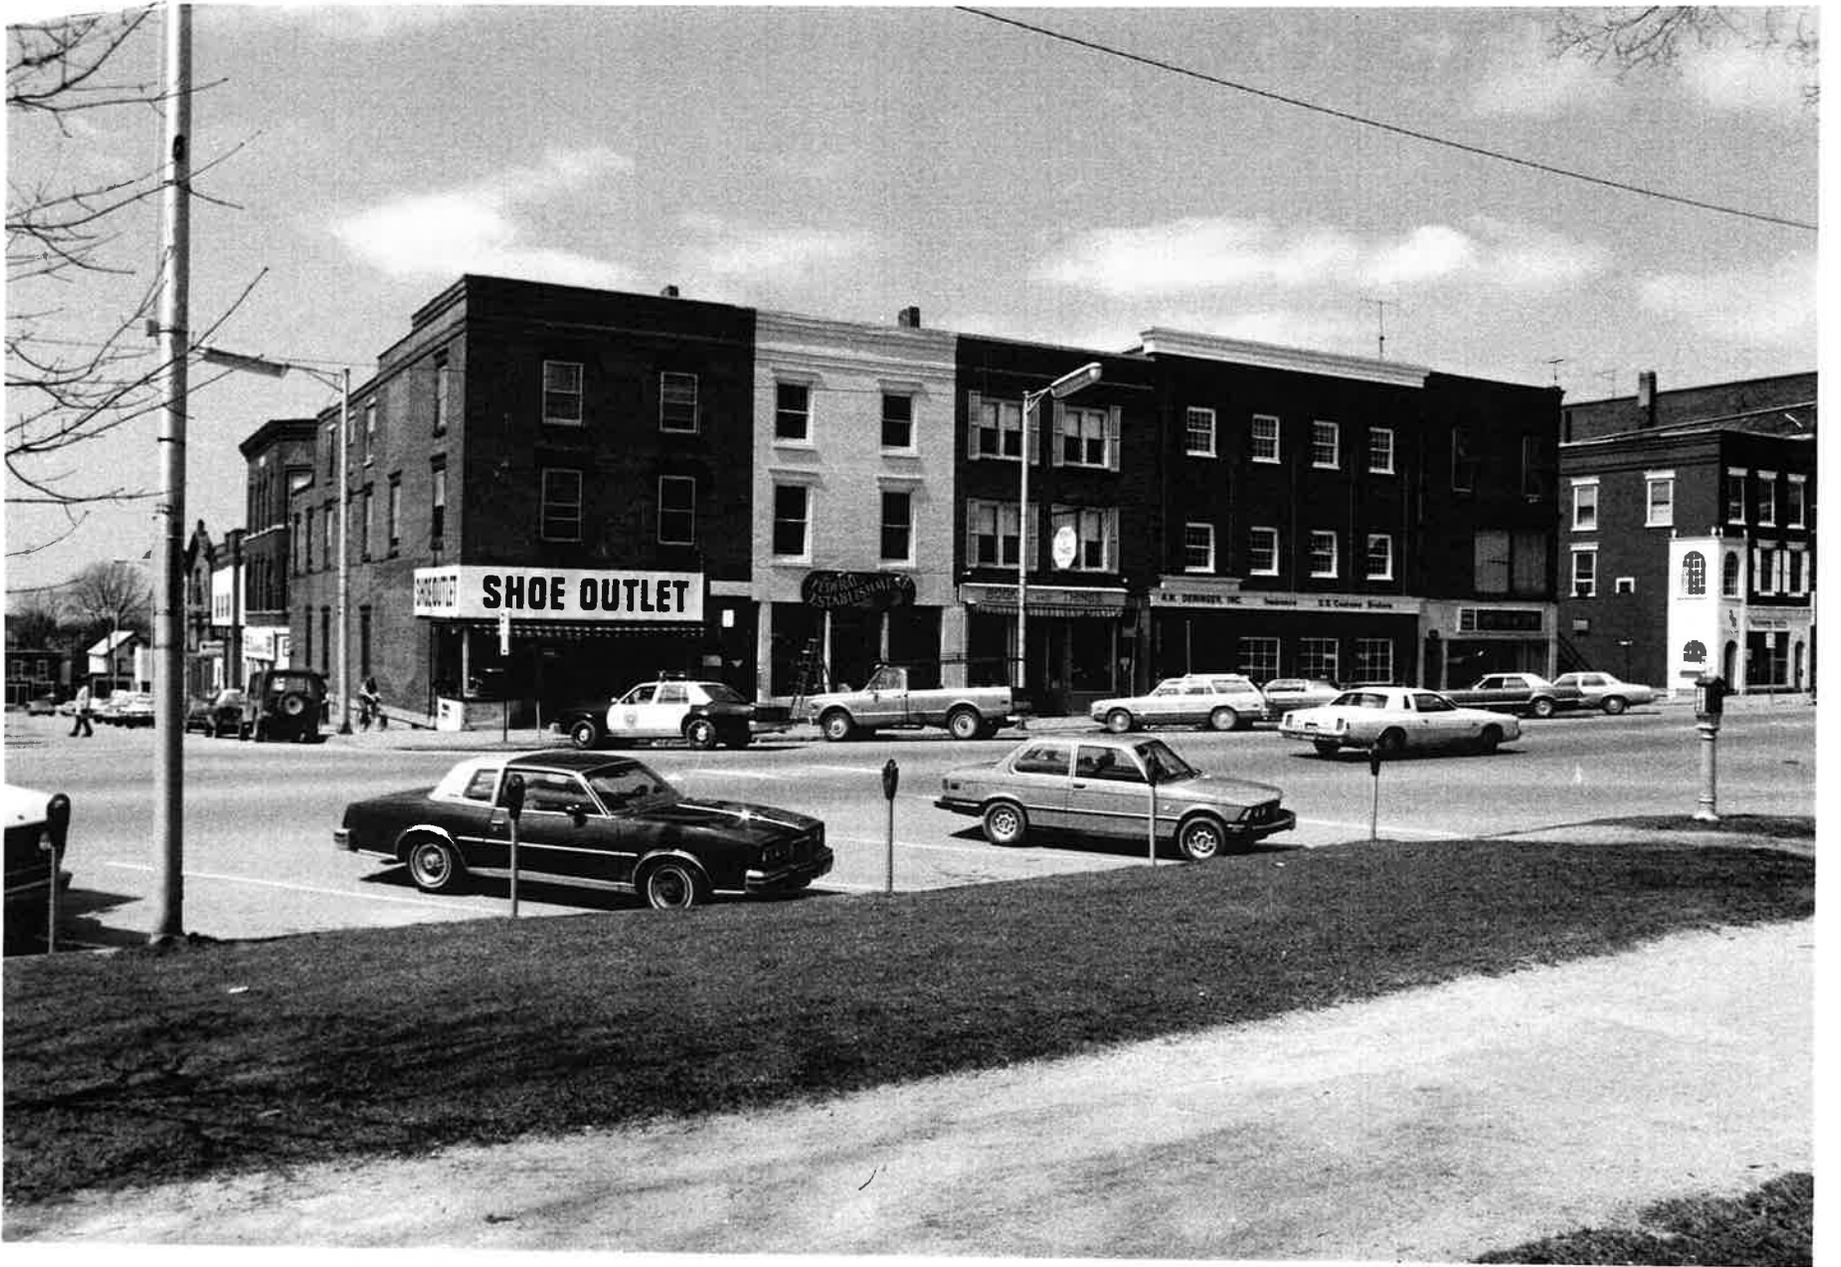
79-A-44

St. Albans Historic District
St. Albans, Vermont
Credit: C. Richard Morsbach
Date: Spring 1979
Negative filed at Vermont Division for
Historic Preservation
Description: Bldgs. #48, 47, 46, 45, 44,
W. side of Main Street between Kingman
and Center Streets. View NW
Photograph 17

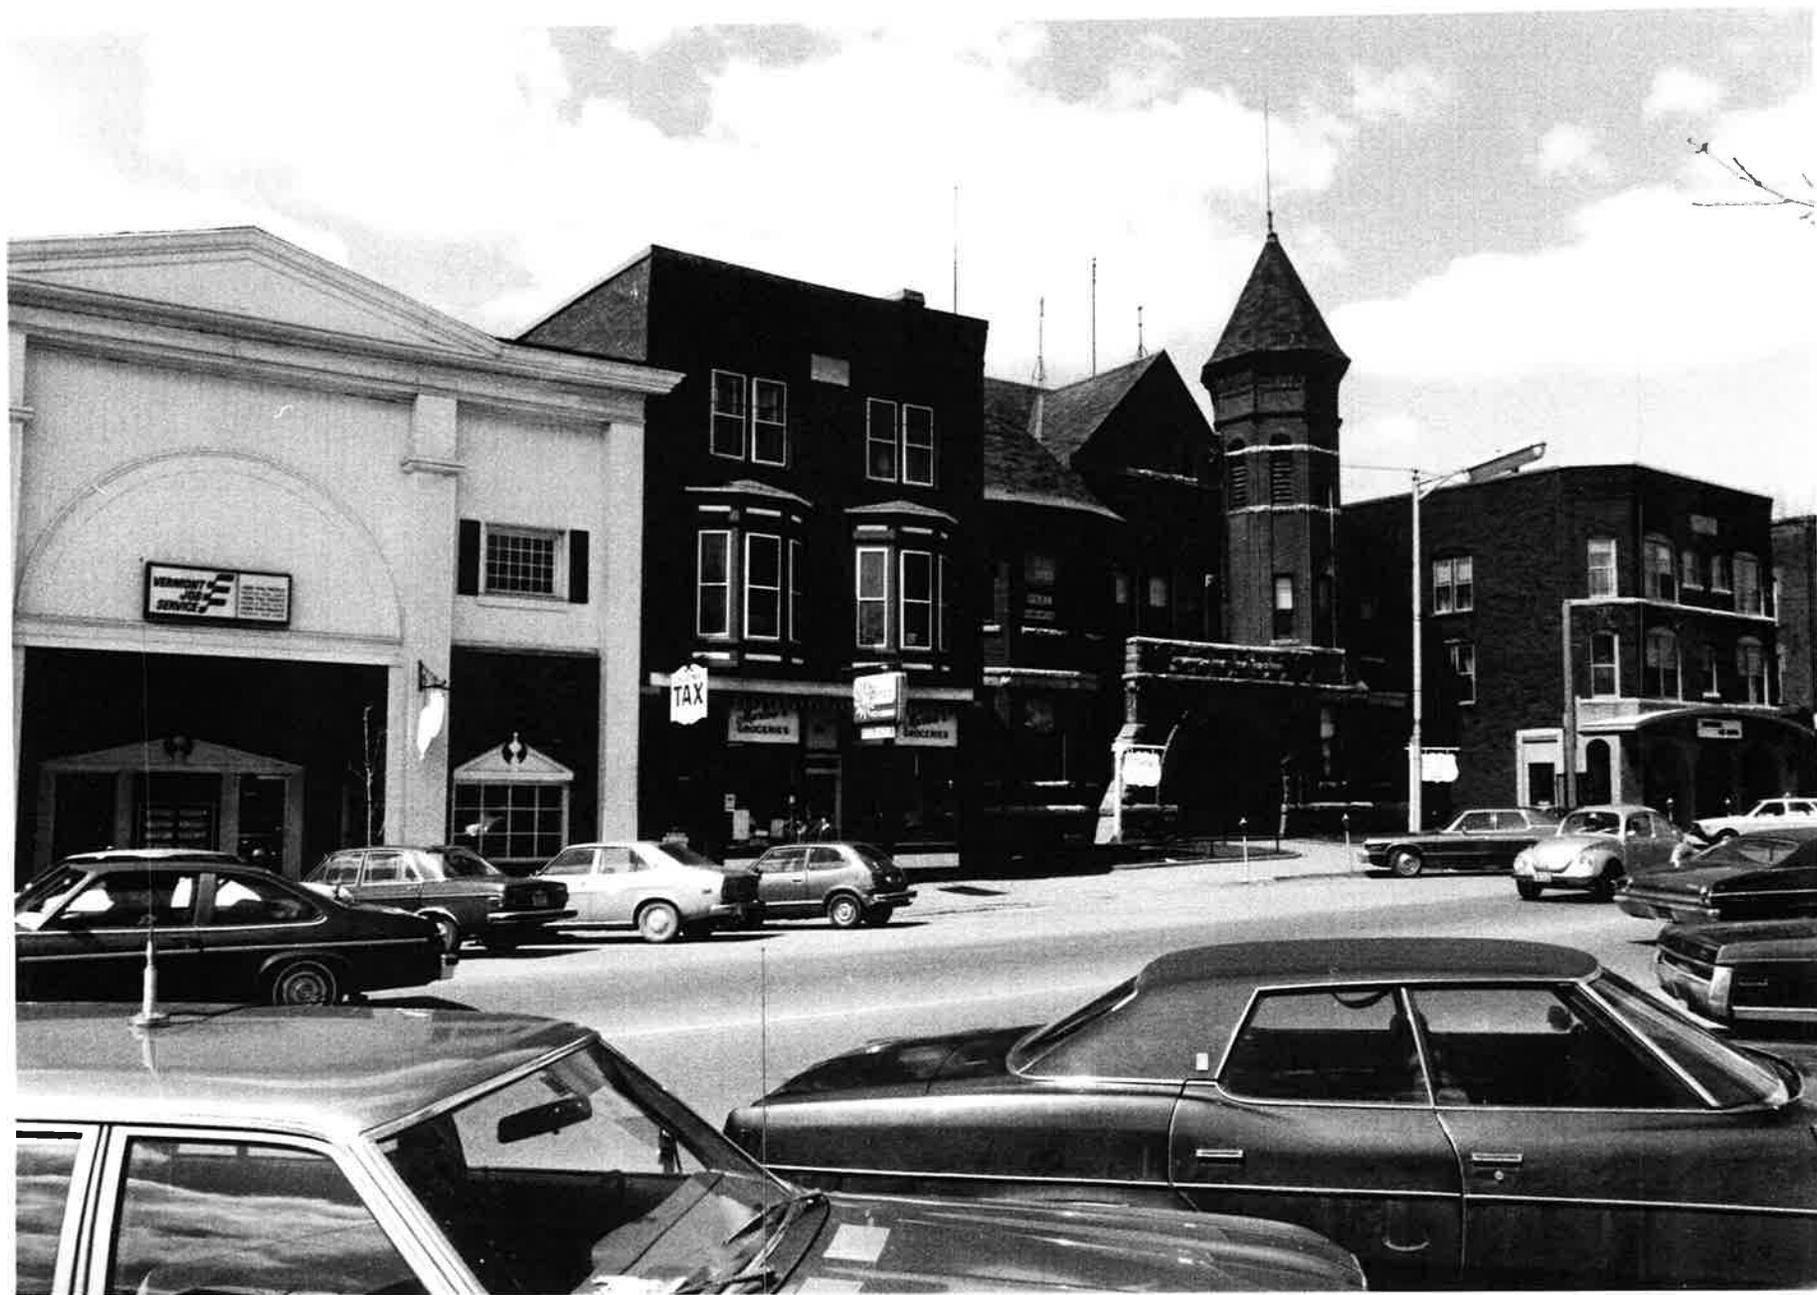
79-1143

Description: North side of Lake Street show-
ing building #s 68, 67, 66, 65; View facing
Northeast.

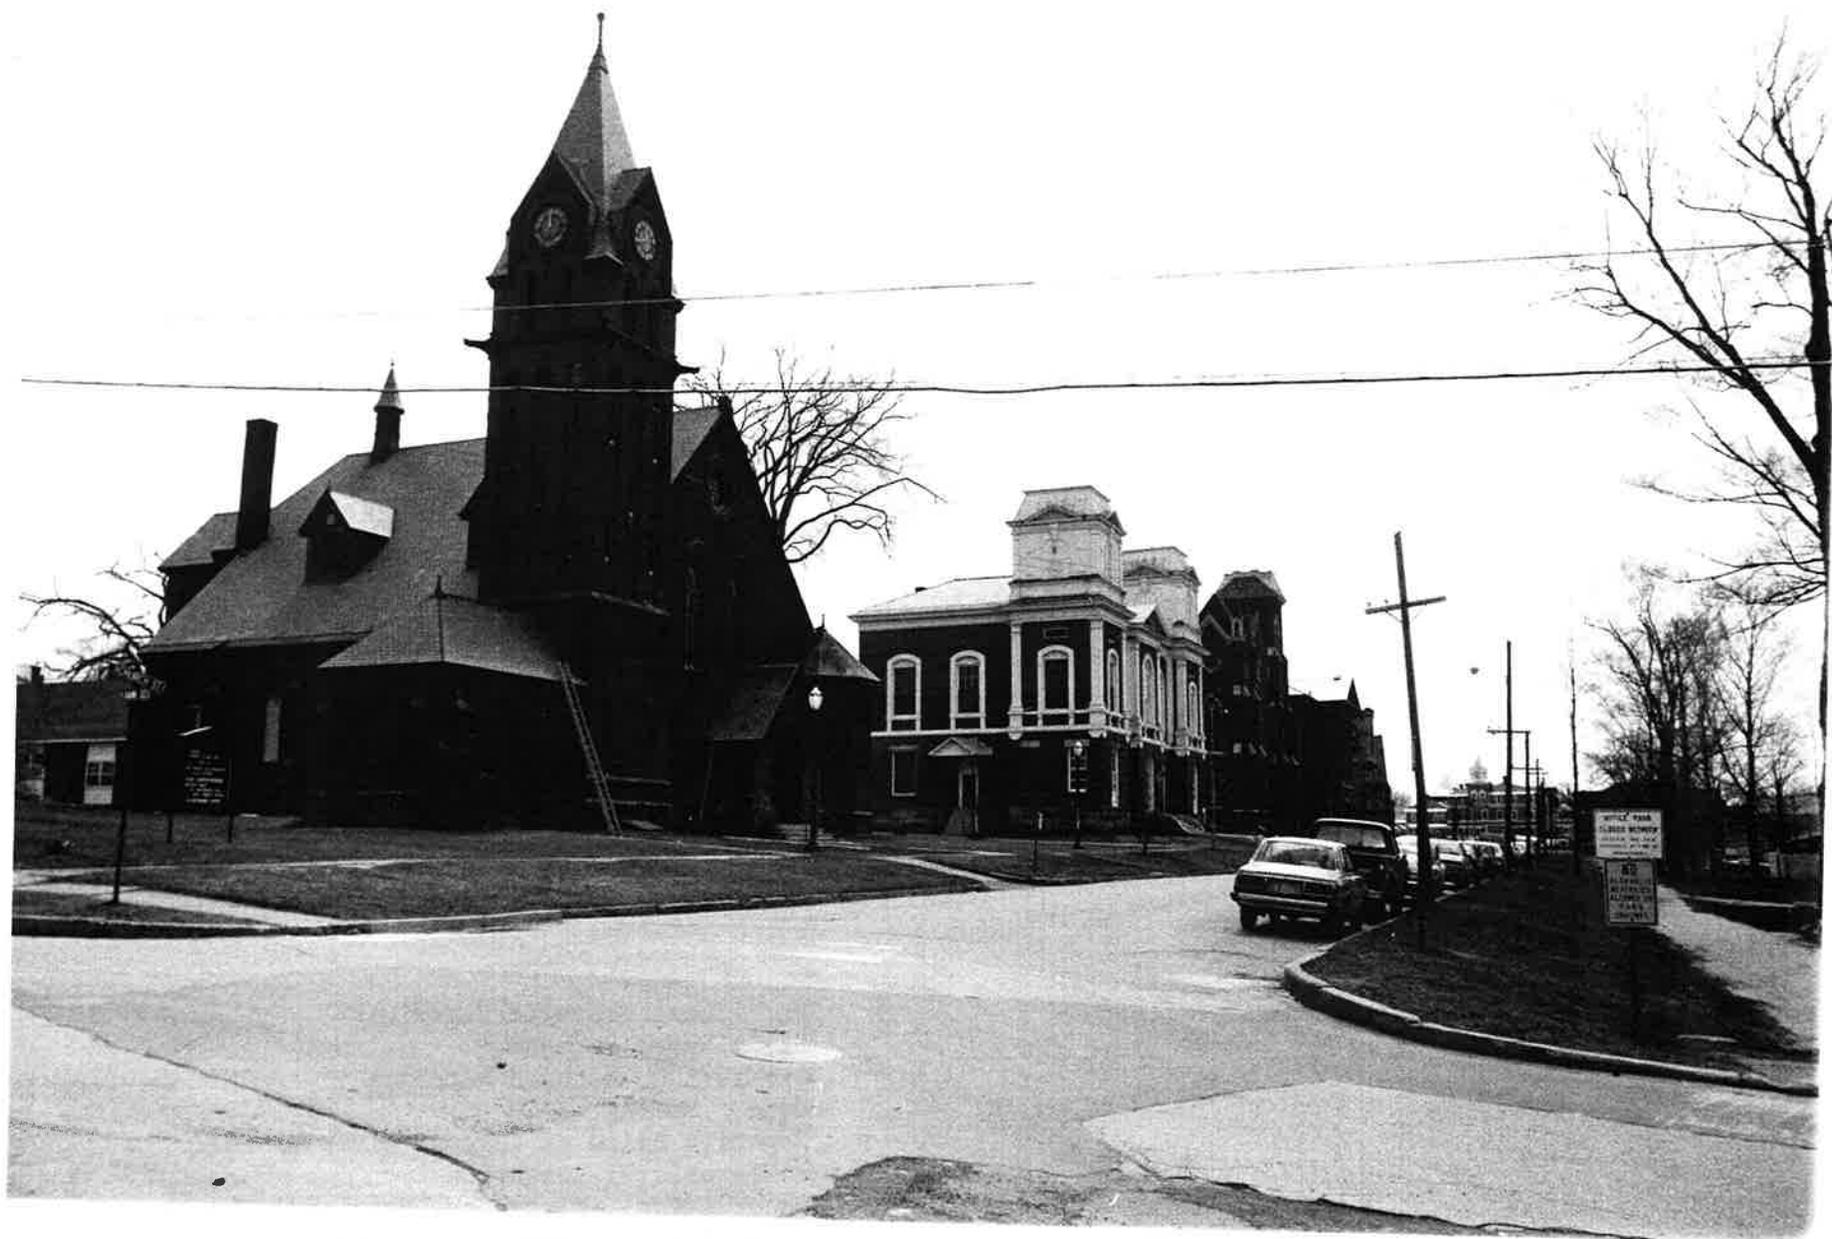
79-A-44

St. Albans Historic District
St. Albans, Vermont
Credit: C. Richard Morsback
Date: Spring, 1979
Negative Filed at Vermont Division for
Historic Preservation
Description: First Congregational Church (#8)
and Franklin County Courthouse (#7) on
Church Street; View Southeast
Photograph 6

7. Franklin County Courthouse (17 Church Street). This Renaissance Revival style Courthouse was built in 1874 for a cost of \$75,000. It has 5 x 3 bays and is a two-story rectangular block mass brick building rising from an ashlar, rock-faced granite base. The granite blocks have tooled margins. Symmetry is provided by corner towers (whose third level is wood) and the 2-story center frontispiece. The first-story is rusticated brick terminating in belt course. Granite steps rise to a segmental arched opening center entry which has double-leafed eastlake detailed doors. There are rectangular windows on first story with granite lintels; arched window openings on second story and a 3-part, semicircular arch window in center of second story. Windows have 6/6 and 4/4 sash. The second story has arched brick panels, the bays are divided and corners are articulated by brick doric pilasters with wood capitals. The towers have ventilator panels with cast iron ornamental grates. Wood-paneled caps and rounded roofs. The main roof is hipped and sheathed in slate and has a box cornice.

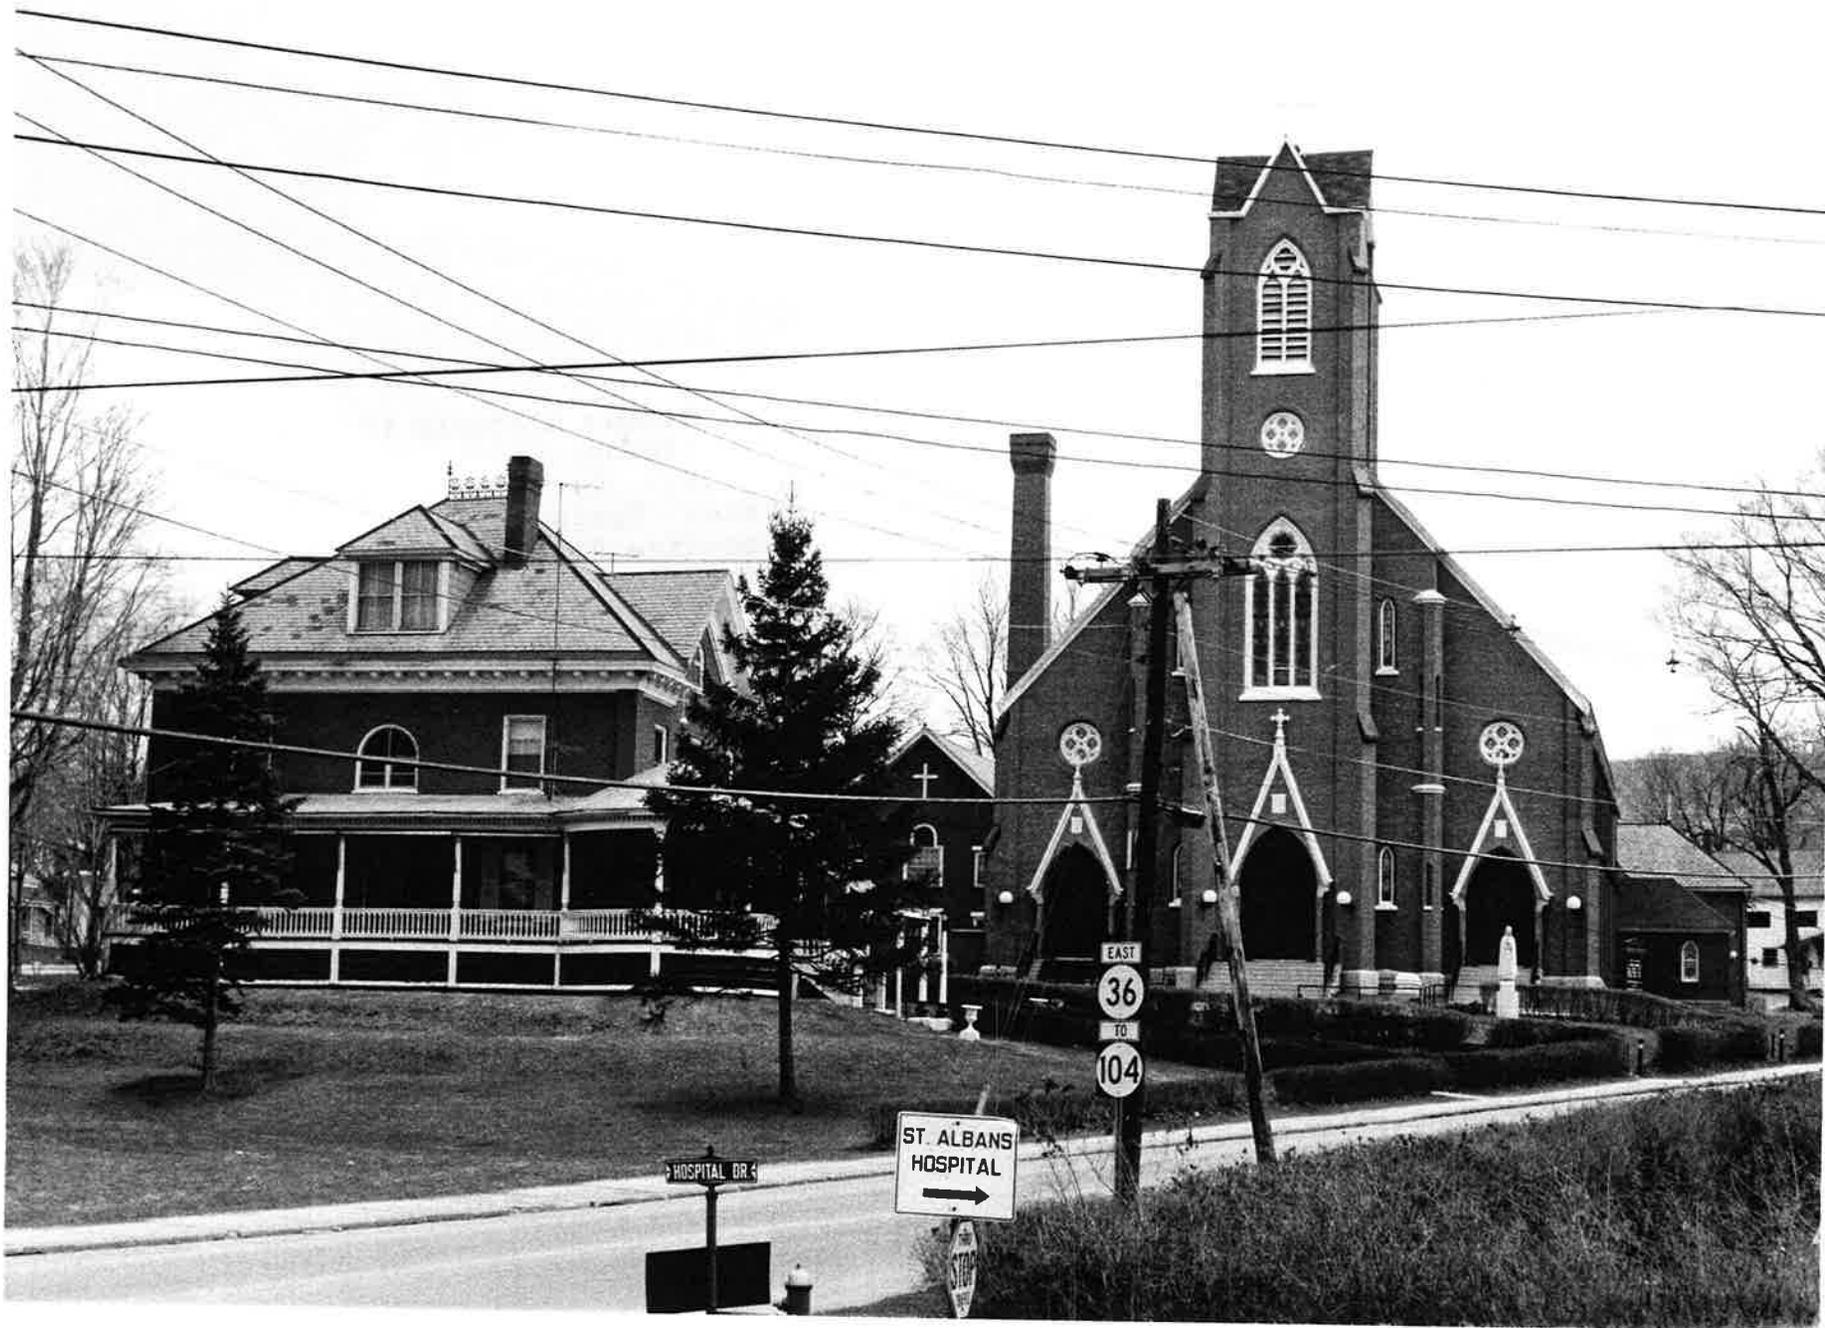
79A 44 9

St. Albans Historic District
St. Albans, Vt
Credit: C. Richard Morsbach
Date: Spring 1979
Negative filed at Vermont Division for
Historic Preservation
Description: Buildings #3 and #2.
View facing East.
Photograph 10

2. St. Mary's Church (44 Fairfield Street), 1849. The oldest church within the district. St. Mary's picturesque Gothic Revival vertical forms of a bell tower and buttresses anchor the eastern edge of the district also helping to enclose Taylor Park. William H. Hoyt, an Episcopal clergyman who converted to Catholicism, was instrumental in raising funds for the church. He commissioned Patrick J. Keelly, a noted New York architect to design St. Mary's. Mr. Hoyt supervised the construction that was done by members of the parish.

The church is 3 x 7 bays. The four level bell tower sets the vertical orientation of the structure that is reinforced by stepped buttresses on the tower and side elevations. Tall lancet windows also contribute to this verticality. The common bond brick building rises from a granite foundation with granite wash. It is rectangularly massed, has a gable slate roof and a pentagonal apse on the east (rear) elevation.

Ornamental detailing includes stained glass windows with Gothic tracery, quatrefoil motifs in windows and on doors; oculus windows with this quatrefoil tracery in bell tower and above aisle entries.

After repeated damage by lightning the spire was removed in 1922. Overall the building is neatly maintained; however, the brick has been sandblasted and unsympathetically repointed.

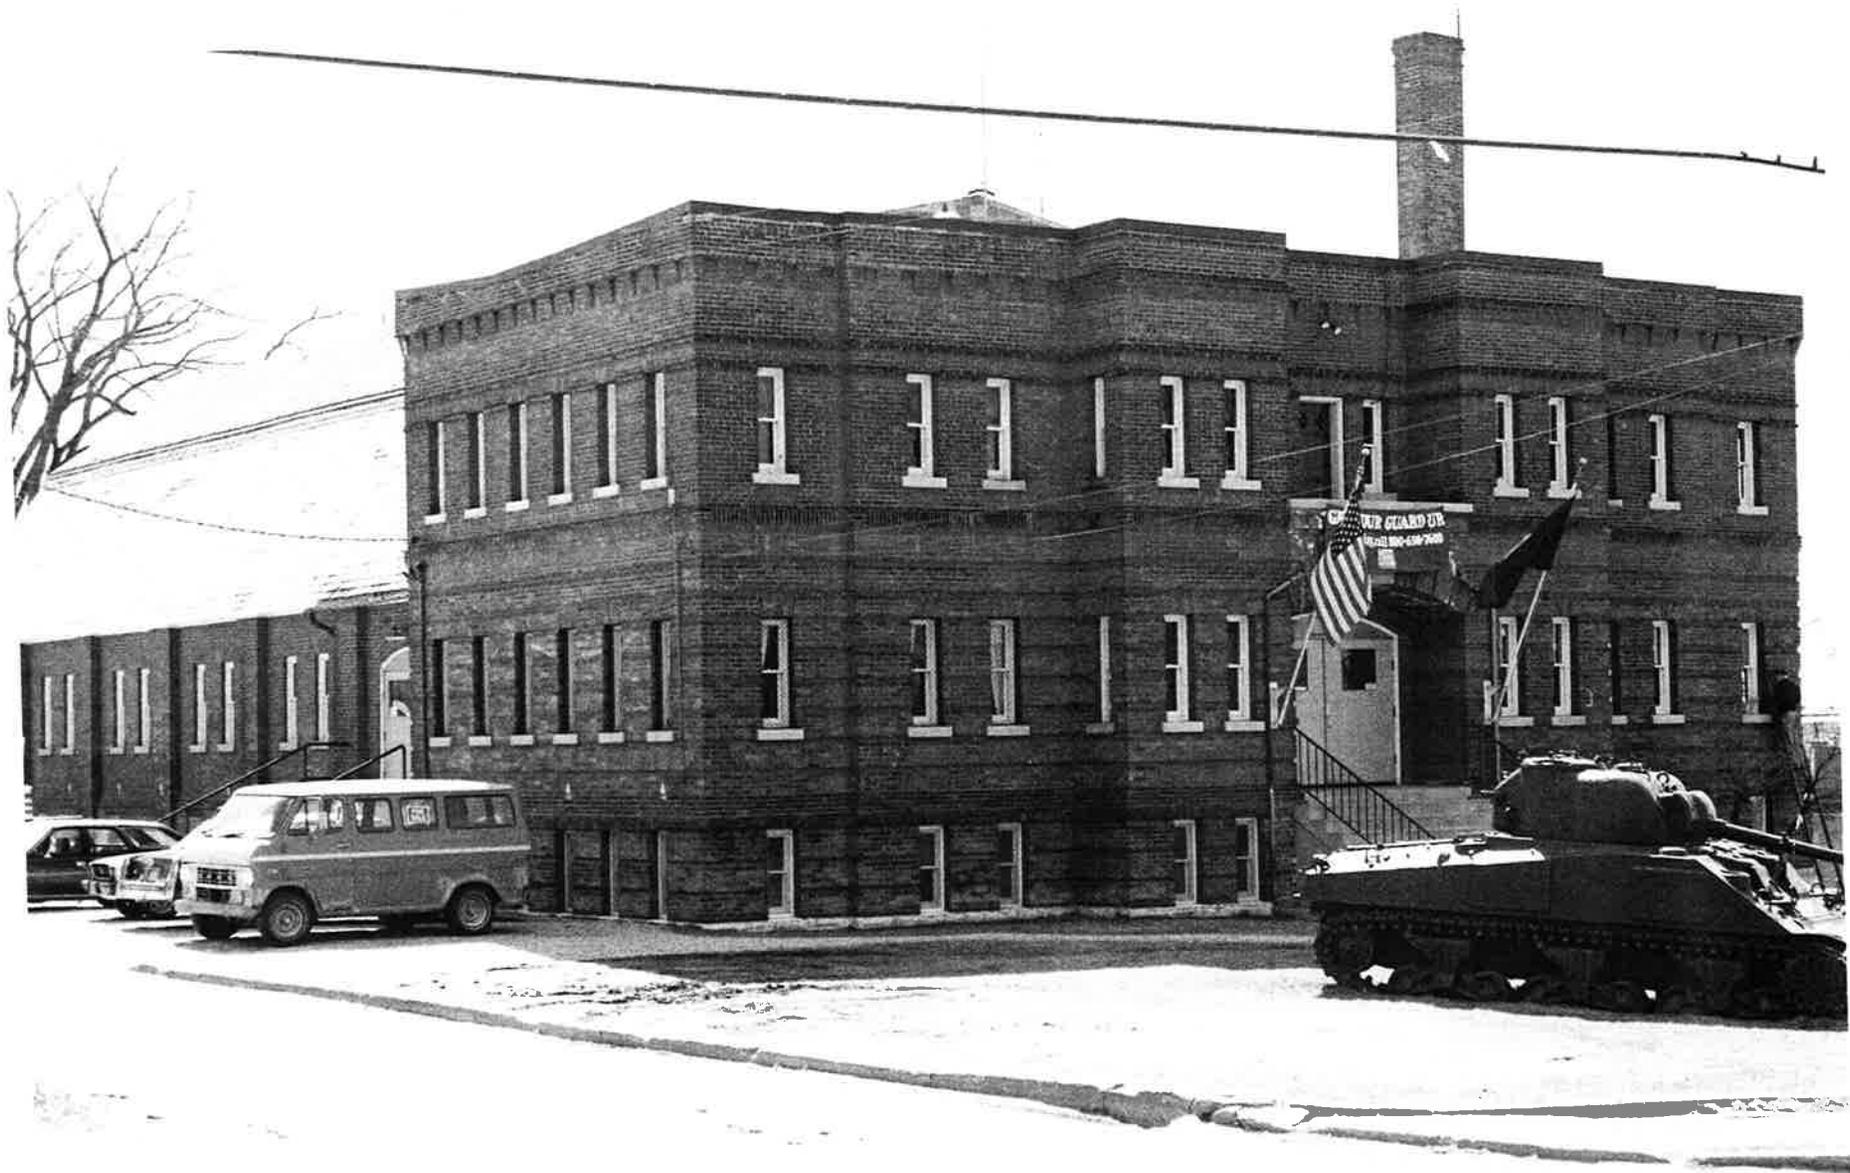
79A 43 18A

St. Albans Historic District
St. Albans, VT
Credit: C. Richard Morsbach
Date: Spring 1979
Negative filed at Vermont Division for
Historic Preservation
Description: St. Albans Armory #109.
View facing southwest.
Photograph 27

109. St. Albans Armory, 1915. This 7 x 6 bay, two-story brick military style building has a 4 x 5 bay drill hall on the rear (south) elevation. The first and second stories have rusticated brick. There is a corbelled brick wash around the perimeter of building. Narrow slit windows create a fortress-like appearance. The segmentally arched, recessed entry has a deck above. A gambrel roof characterizes the rear ell. The rear of this wing (south elevation) is buttressed. Recessed panels define the side elevation bays. Windows have flat arches, marble sills, and 1/1 sash. The roof is slate and tin.

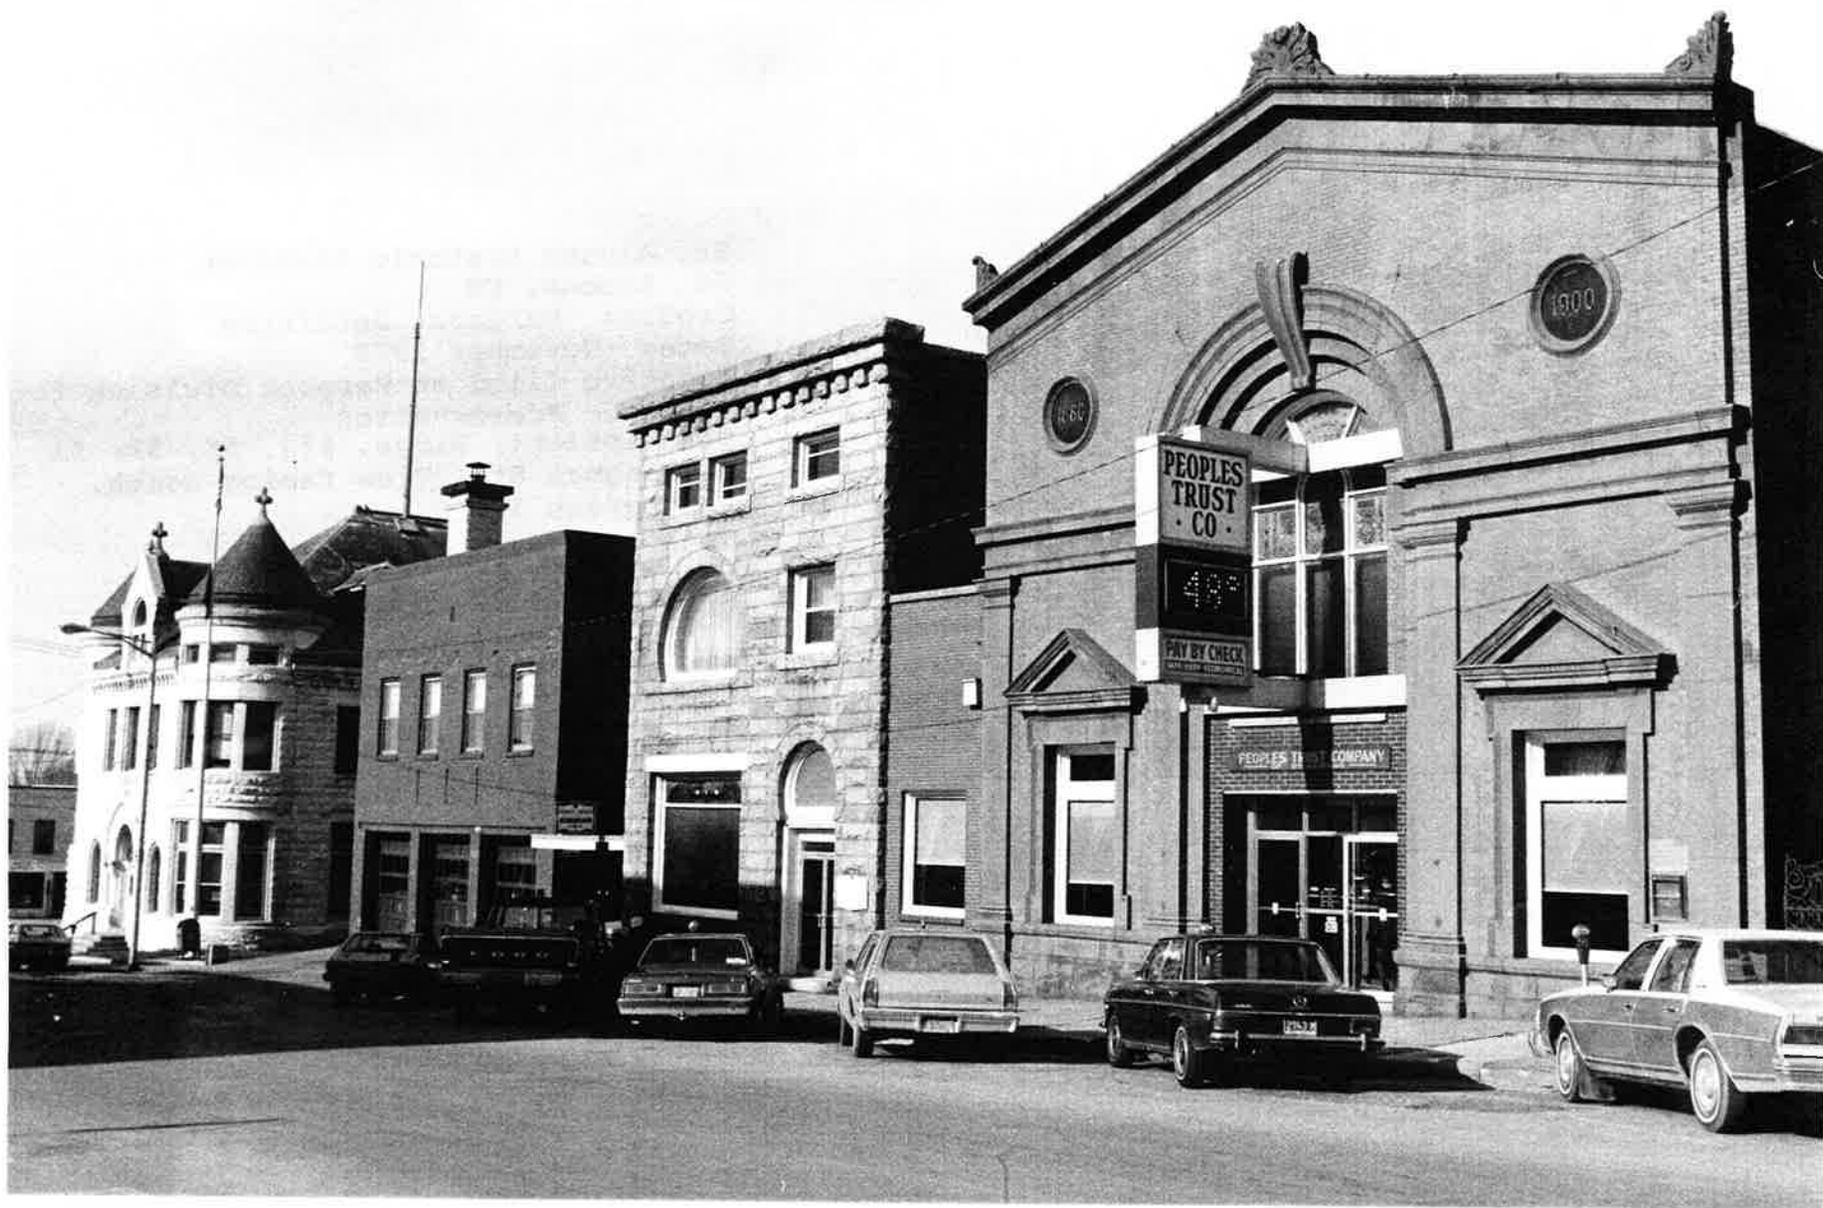
79A 303

St. Albans Historic District
St. Albans, VT
Credit: Margaret DeLaittre
Date: November 1979
Negative filed at Vermont Division for
Historic Preservation
Description: Bldgs. #54, 53, 52, 51
on Kingman St. View facing north.
Photograph 18

51. Peoples Trust Bank (25 Kingman Street) c. 1896. This superb building is a distinctive example of Renaissance Revival architecture. Three bays wide, 2½ stories high, and gable-fronted to Kingman Street. The most outstanding feature is a round arch centered on the facade that is outlined in brownstone; this arch contains an altered entry and stained glass window. All trim on the building is done in brownstone creating a pleasing polychromatic contrast against the brick. The entry is flanked by windows with pedimented, crossetted surrounds. The gable includes a boxed cornice with gable returns, and acroteria and antifixae. There are also two circular date stones in the gable.

52. Peoples Trust (29 Kingman Street) c. 1896. This 2 x 3 bay eclectic three-story building has a rock faced granite stone veneer facade and common bond brick construction on the side elevation. There are distinctive horse shoe arched window and door openings; a stained glass window on the facade and 1/1 sash characterize the windows. There are altered entry doors and corbelled stone blocks below the roof curb. A drive-in bank addition is on left (west) elevation. A c. 1930, 4 x 2 bay Georgian Revival, hip roofed addition rests on a concrete foundation on the rear (north) elevation. The building has a denticular cornice and windows with wood lintels, stone sills, and 12/12 sash.

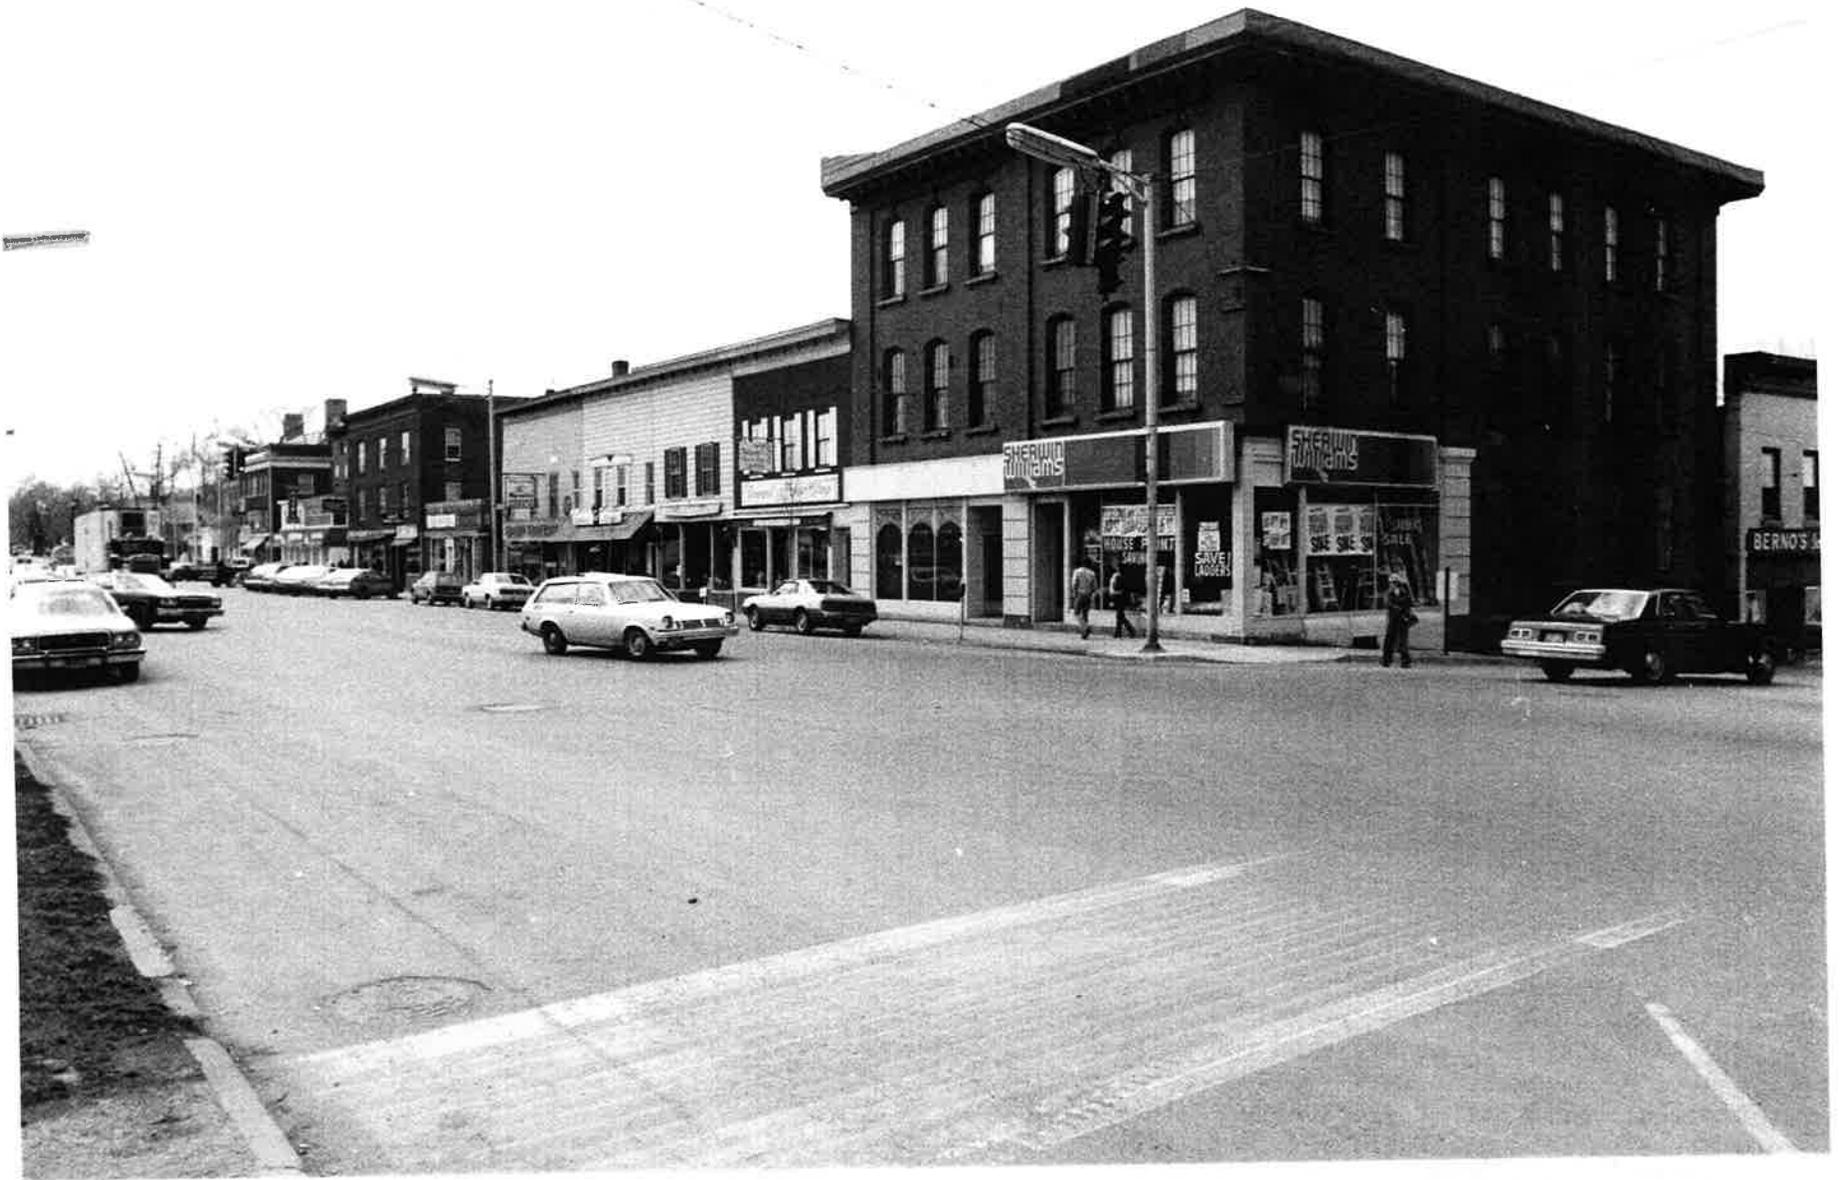
79-A-49

Description: Main Street Block Between Lake
and Stebbins Streets; Buildings (R-L) #88,
89, 90, 91, 92, 93, 94, 95, 96; View West
Photograph 25

88. Farrar Block (2-8 South Main Street), c. 1870. This three-story, 6 x 6 bay, Italianate commercial building makes an excellent anchor building for this major intersection. The common bond brick building rests on a rock faced, ashlar coursed stone foundation; the stones have tooled margins. The altered ground-level store front has recessed entries. Recessed brick panels define facade elements. Segmental arched windows have radiating voussoirs; third story windows have keystoned arches, the sash is 6/6. The cornice has brick dentils and is supported by brackets.

Except for the altered store fronts, this structure is in excellent condition and makes a significant contribution to the district by virtue of its quality of design, scale, and massing.

93. 24-28 South Main Street, c. 1925. This is a four-bay, one-story, brick, building. The roof curb is crenelated. Large fixed glass display windows flank a center entry with a broken pediment architrave.

96. 38-40 South Main Street, c. 1926. This is a three-story, 5 x 8 bay, common bond brick Colonial Revival commercial building with a poured concrete foundation. Windows have flat arched openings; there are paired windows on third floor with 8/1 sash. An entablature divides the first and second floors. There is a pentenne and modillion cornice beneath the parapeted roof curb.
